N.Z. DEPARTMENT OF SCIENTIFIC AND INDUSTRIAL RESEARCH.

BULLETIN No. 43.

REPORT
OF THE
HAWKE'S BAY EARTHQUAKE
(3rd FEBRUARY, 1931).

**THE HAWKE'S BAY EARTHQUAKE OF
3rd FEBRUARY, 1931.**

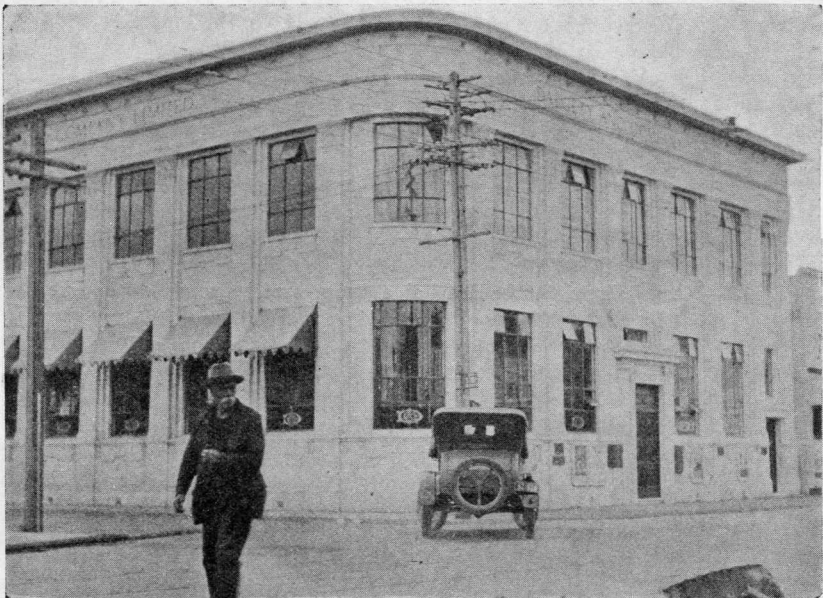
The chief lesson of the earthquake is forcibly illustrated by contrasting figures 2 and 4 on pages 9 and 10, which indicate that though the earthquake was of such severity as to wreck completely many buildings, there were others which withstood the shocks almost without any damage. It is therefore obviously possible to construct at no great additional cost buildings which will withstand very severe earthquakes, provided due consideration is given to design and care exercised in workmanship.

Had the buildings of Napier and Hastings been constructed on lines similar to that illustrated in fig. 2, the loss of life resulting from the earthquake would have been reduced to a very small figure, and the damage to property would have been comparatively slight.

FIG. 2.—Dalgety's Building, Napier. An example of a well-constructed building which withstood the effects of the earthquake without damage. This view was taken some days after the shock.

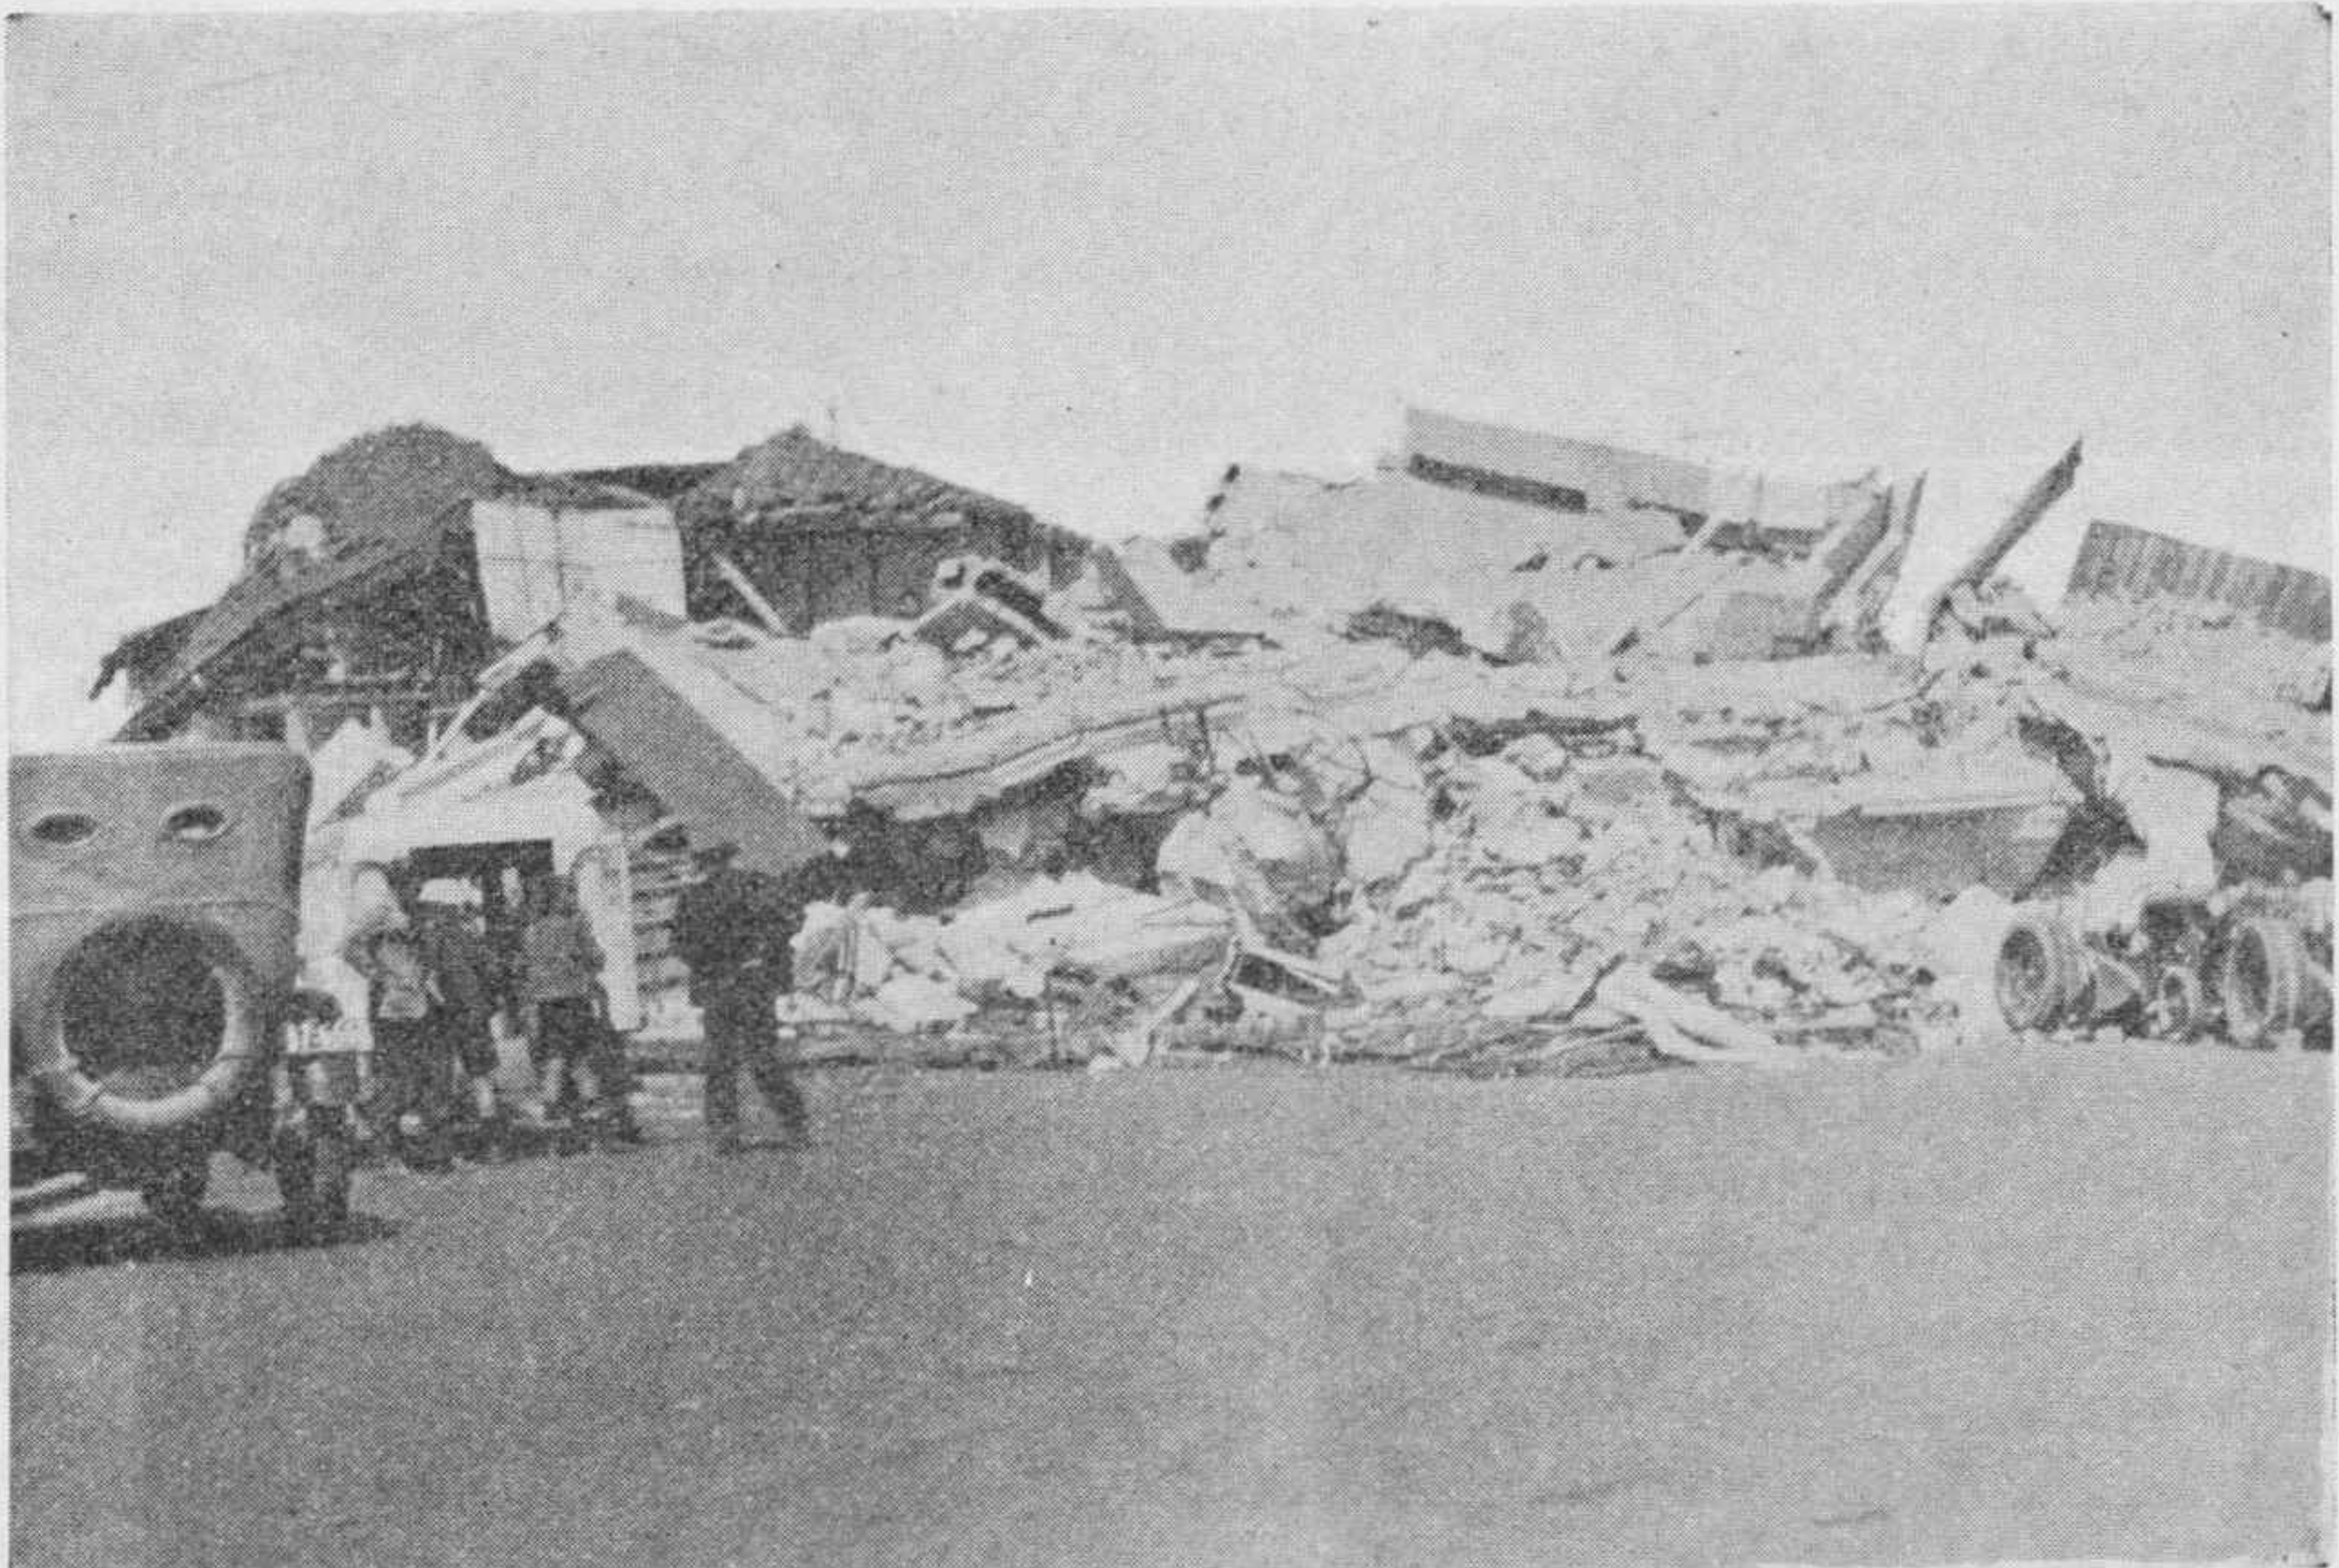
FIG. 4.—Nurses' Home, Napier Hospital, immediately after the earthquake, taken from approximately the same position as fig. 3.

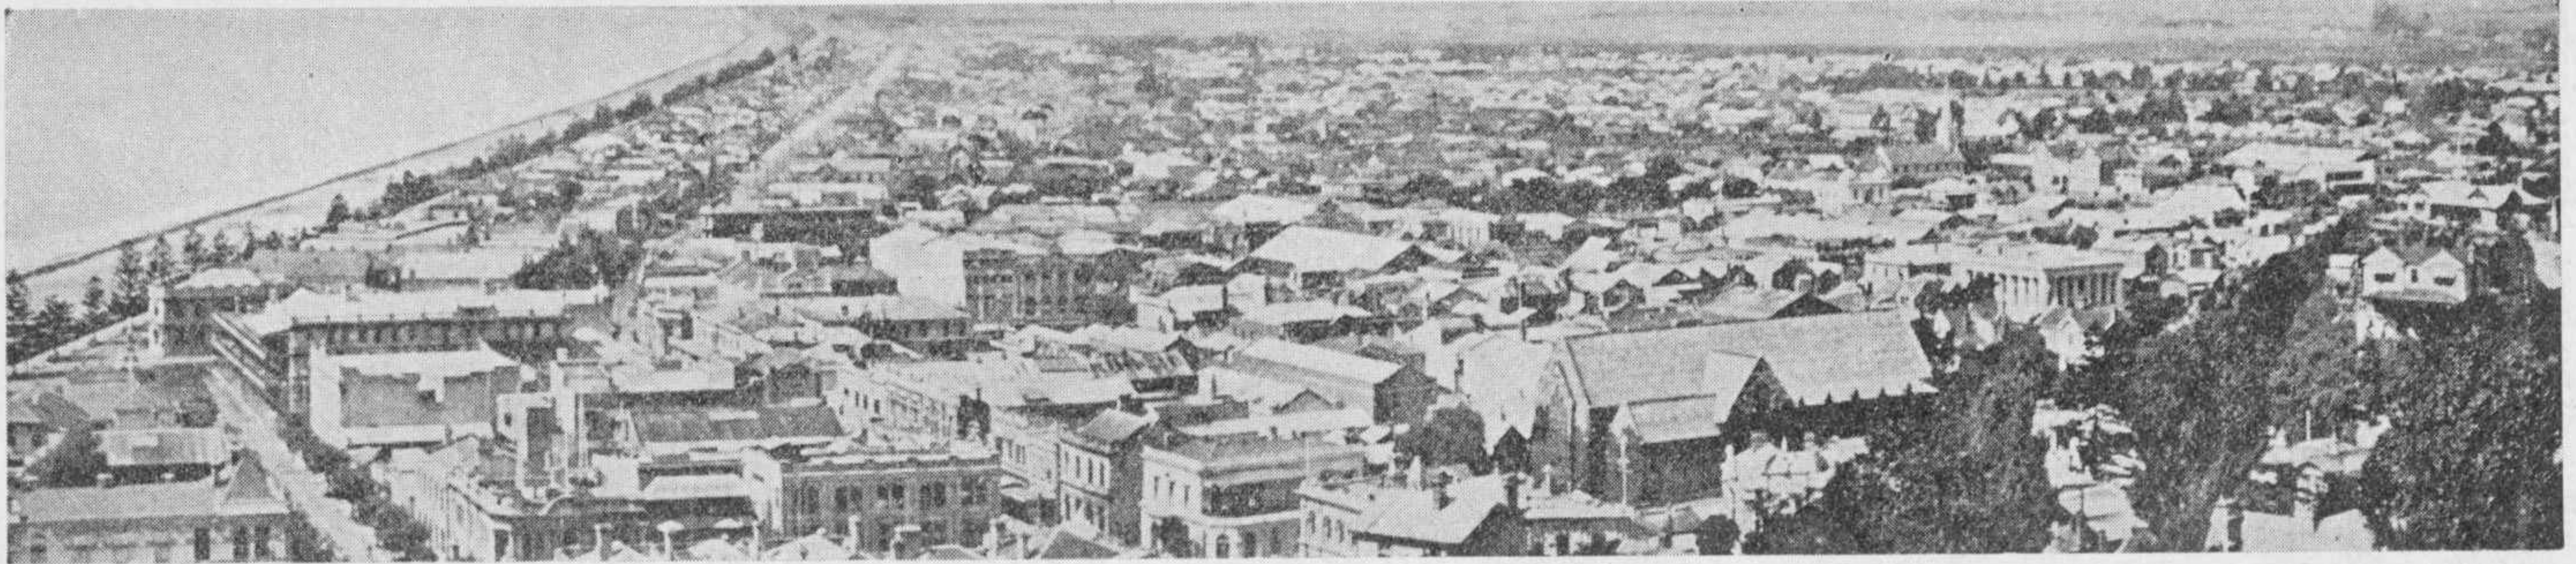
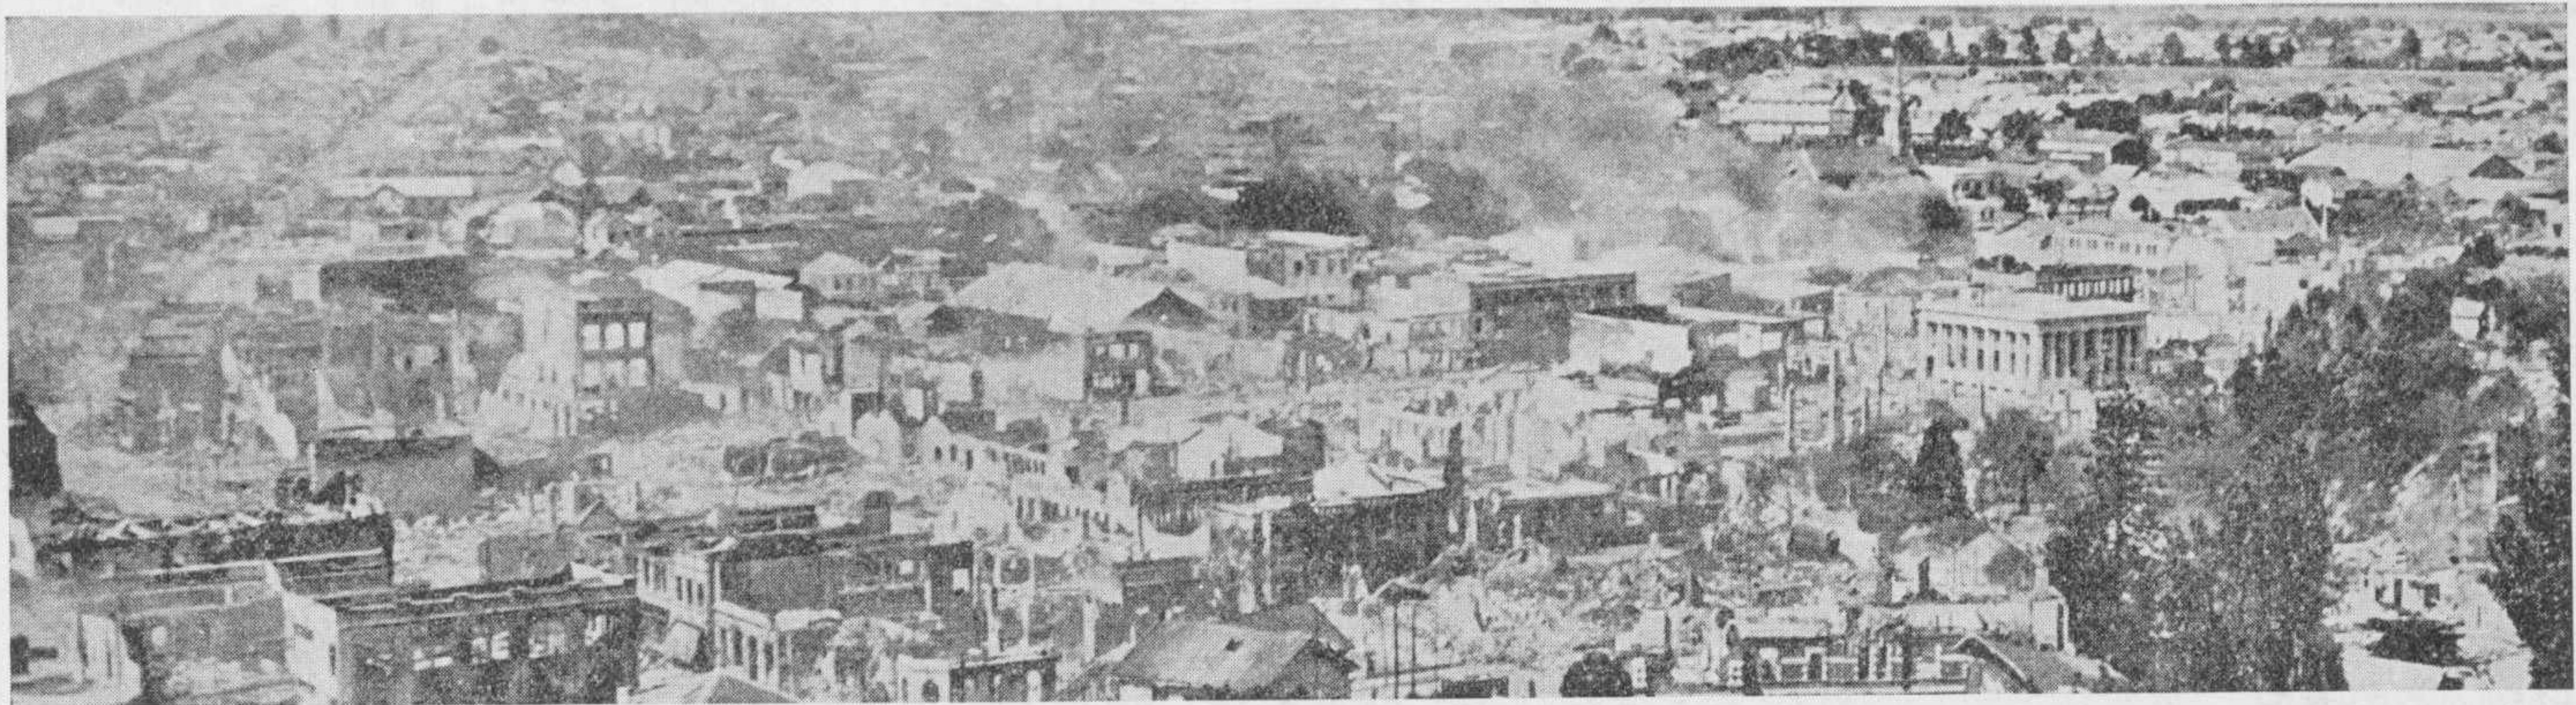
FIG. 5.—General view of Napier taken from the Bluff Hill. The upper view shows the town as it appeared before the earthquake and the lower photo was taken from approximately the same position on the day following.

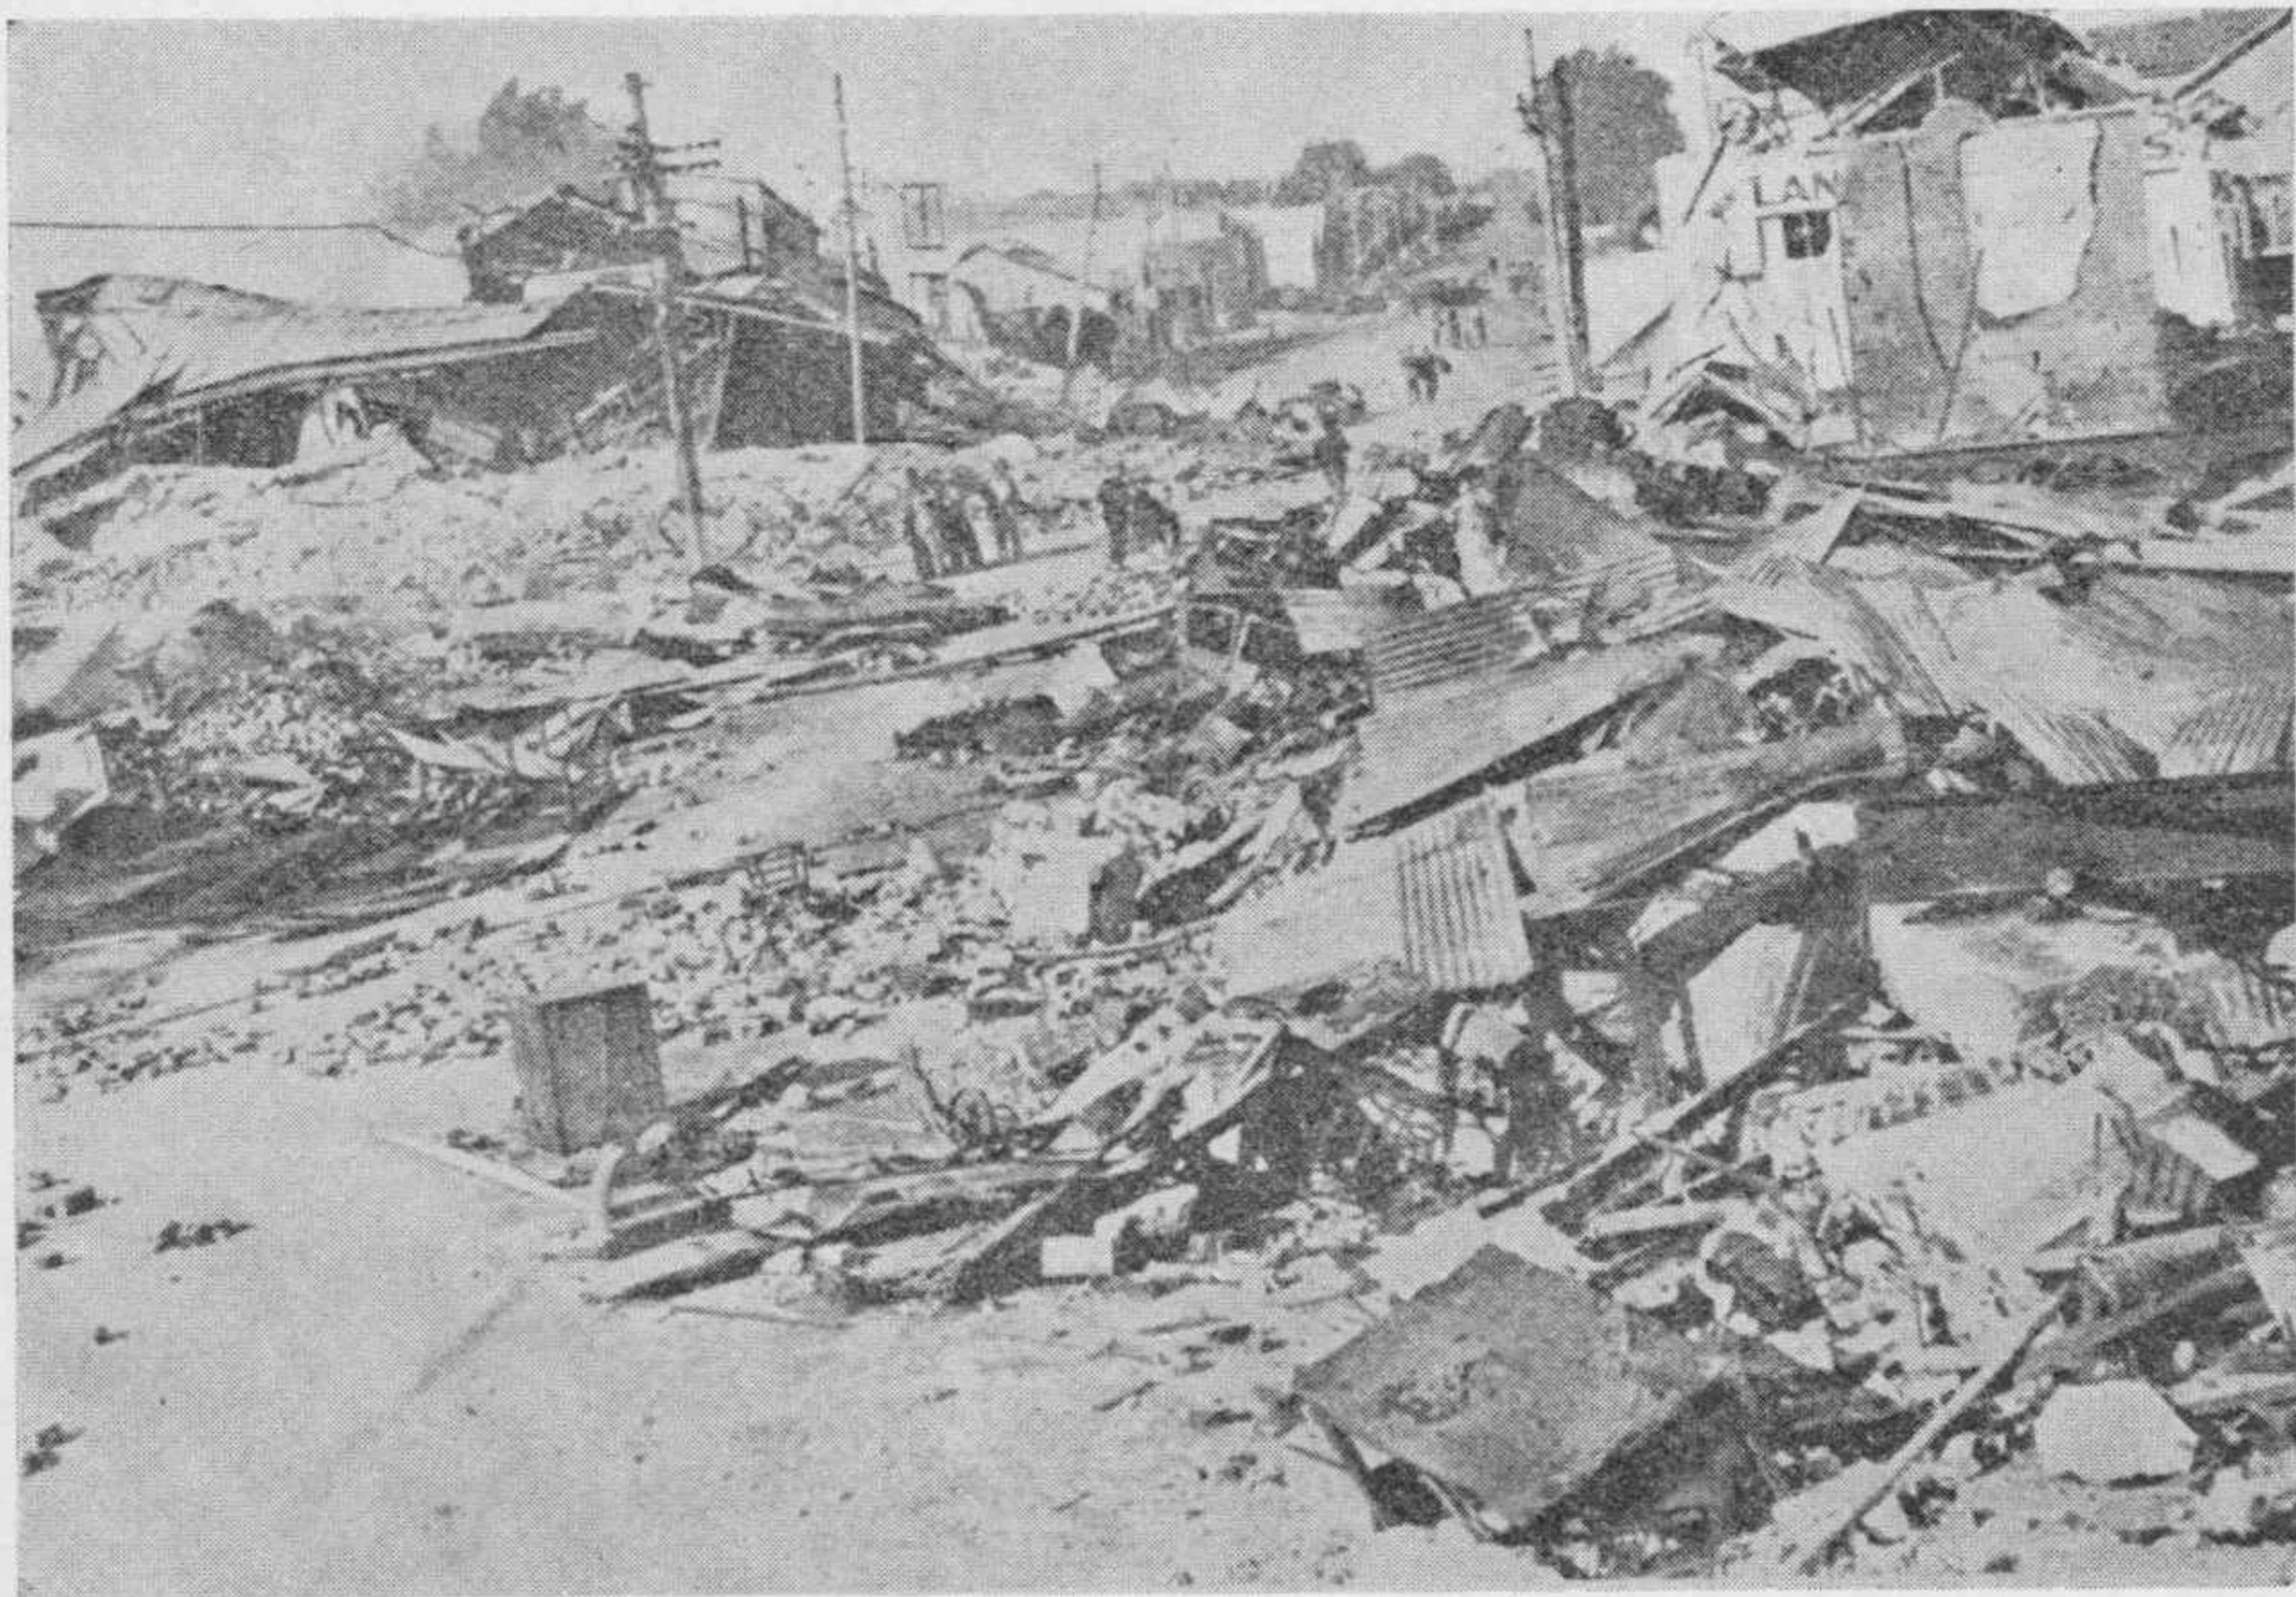
In Hastings the circumstances of the earthquake were very similar to those in Napier. The business portion of Hastings was less confined than that of Napier. Nevertheless, scarcely a building in this portion of the town escaped damage. The main business street, Heretaunga Street, immediately after the first severe shock, became fringed with buildings in all stages of destruction, in accordance with their varied capacity to withstand the severe jolting shocks which afflicted the whole area. The earthquake in Hastings was stated to have a motion which could be described as a corkscrew twist. (Fig. 7.)

FIG. 7.—Street scene in Hastings after the earthquake.

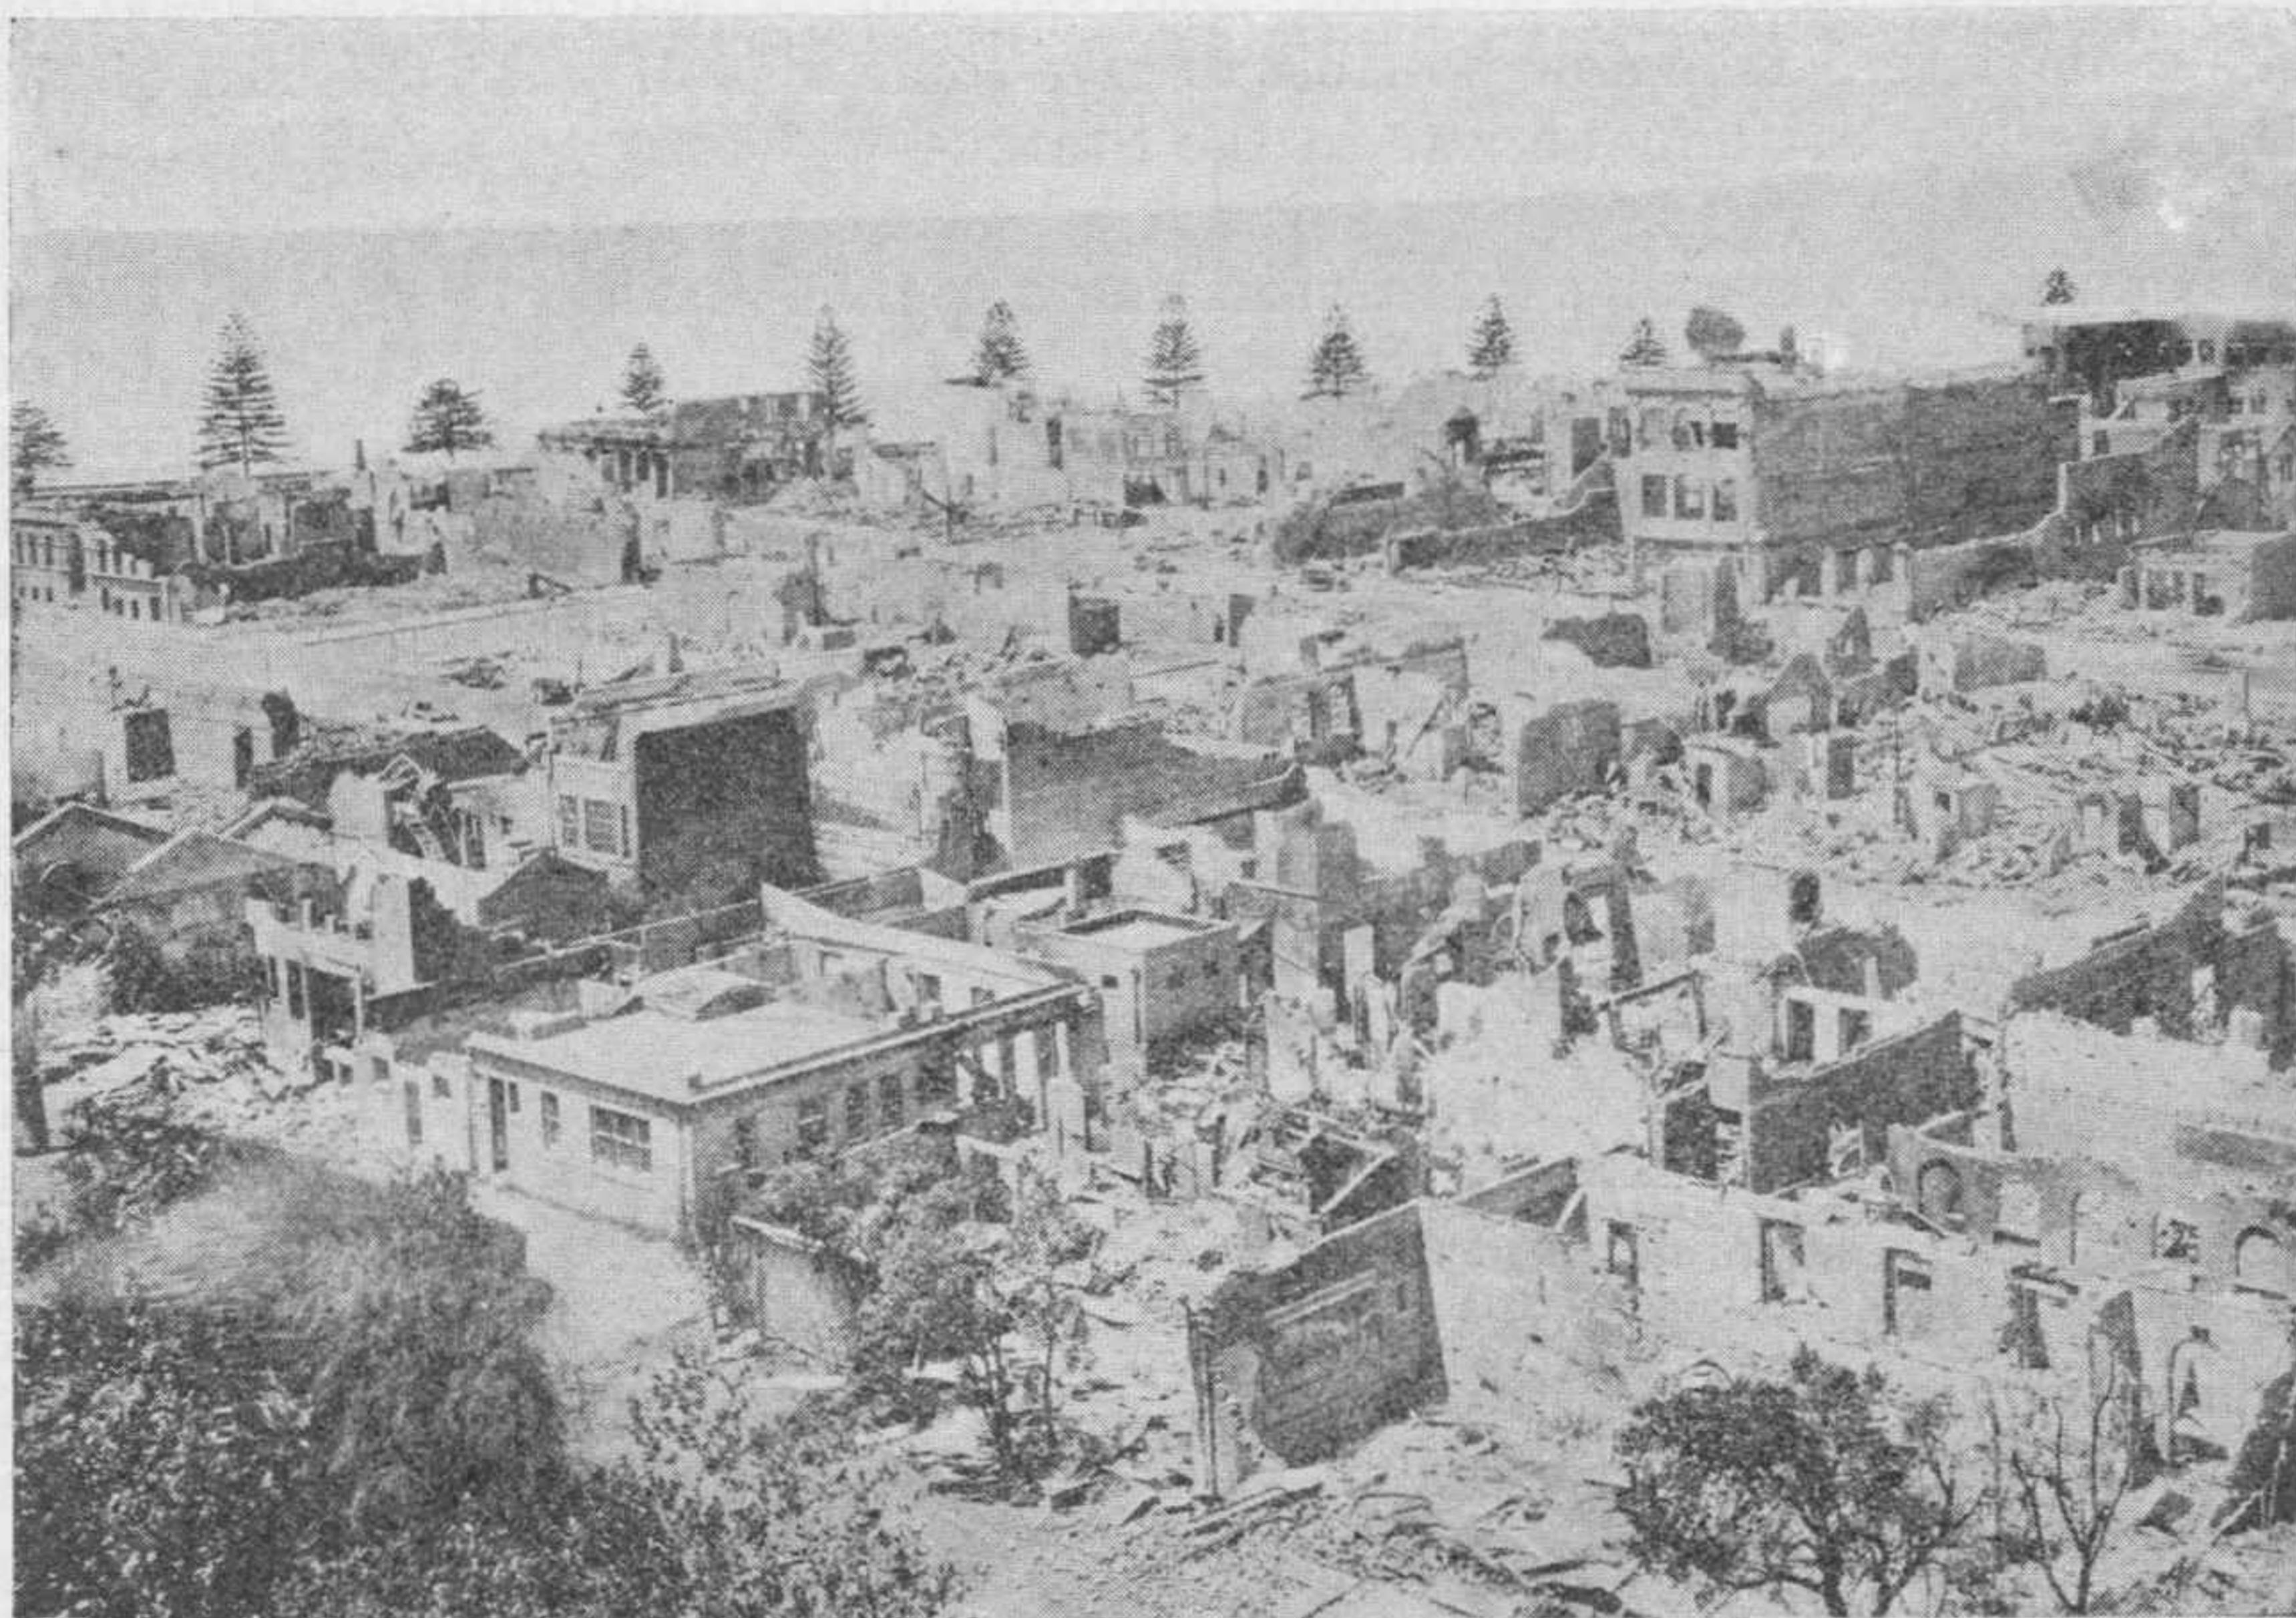
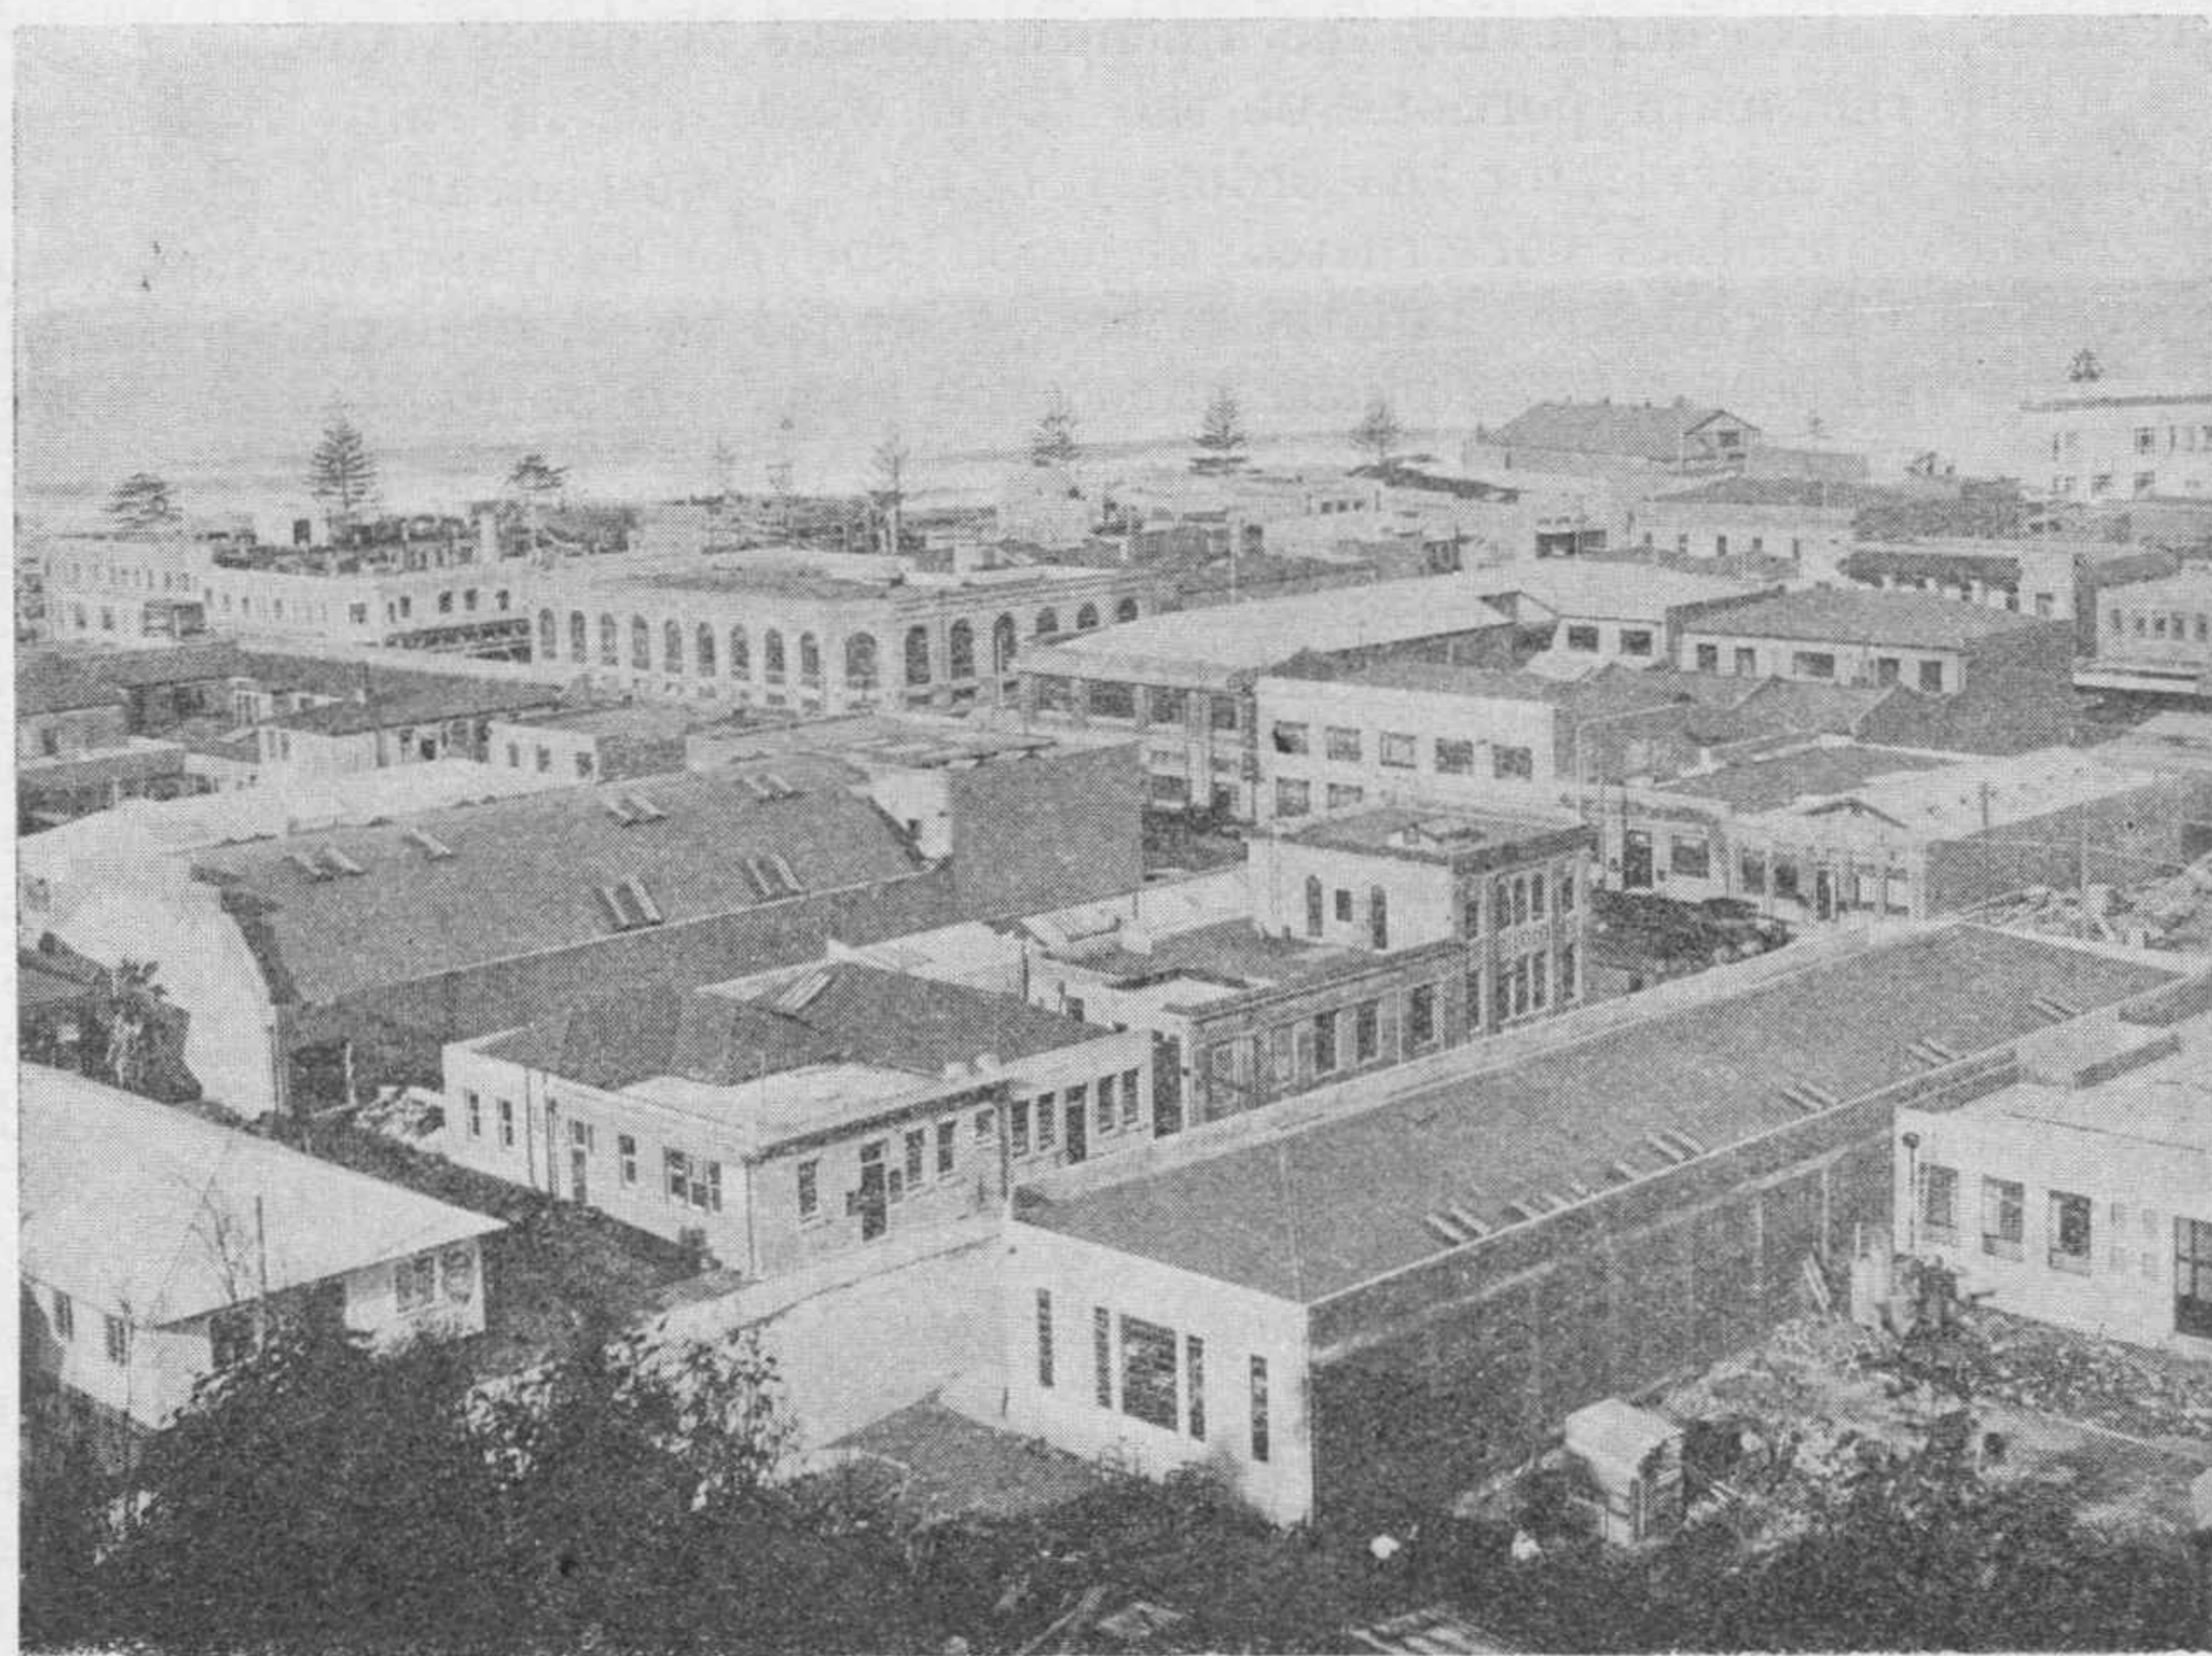
FIG. 9.—Views of part of the business area of Napier showing the town as it appeared after the earthquake and fire, and the appearance of the same area two years later.

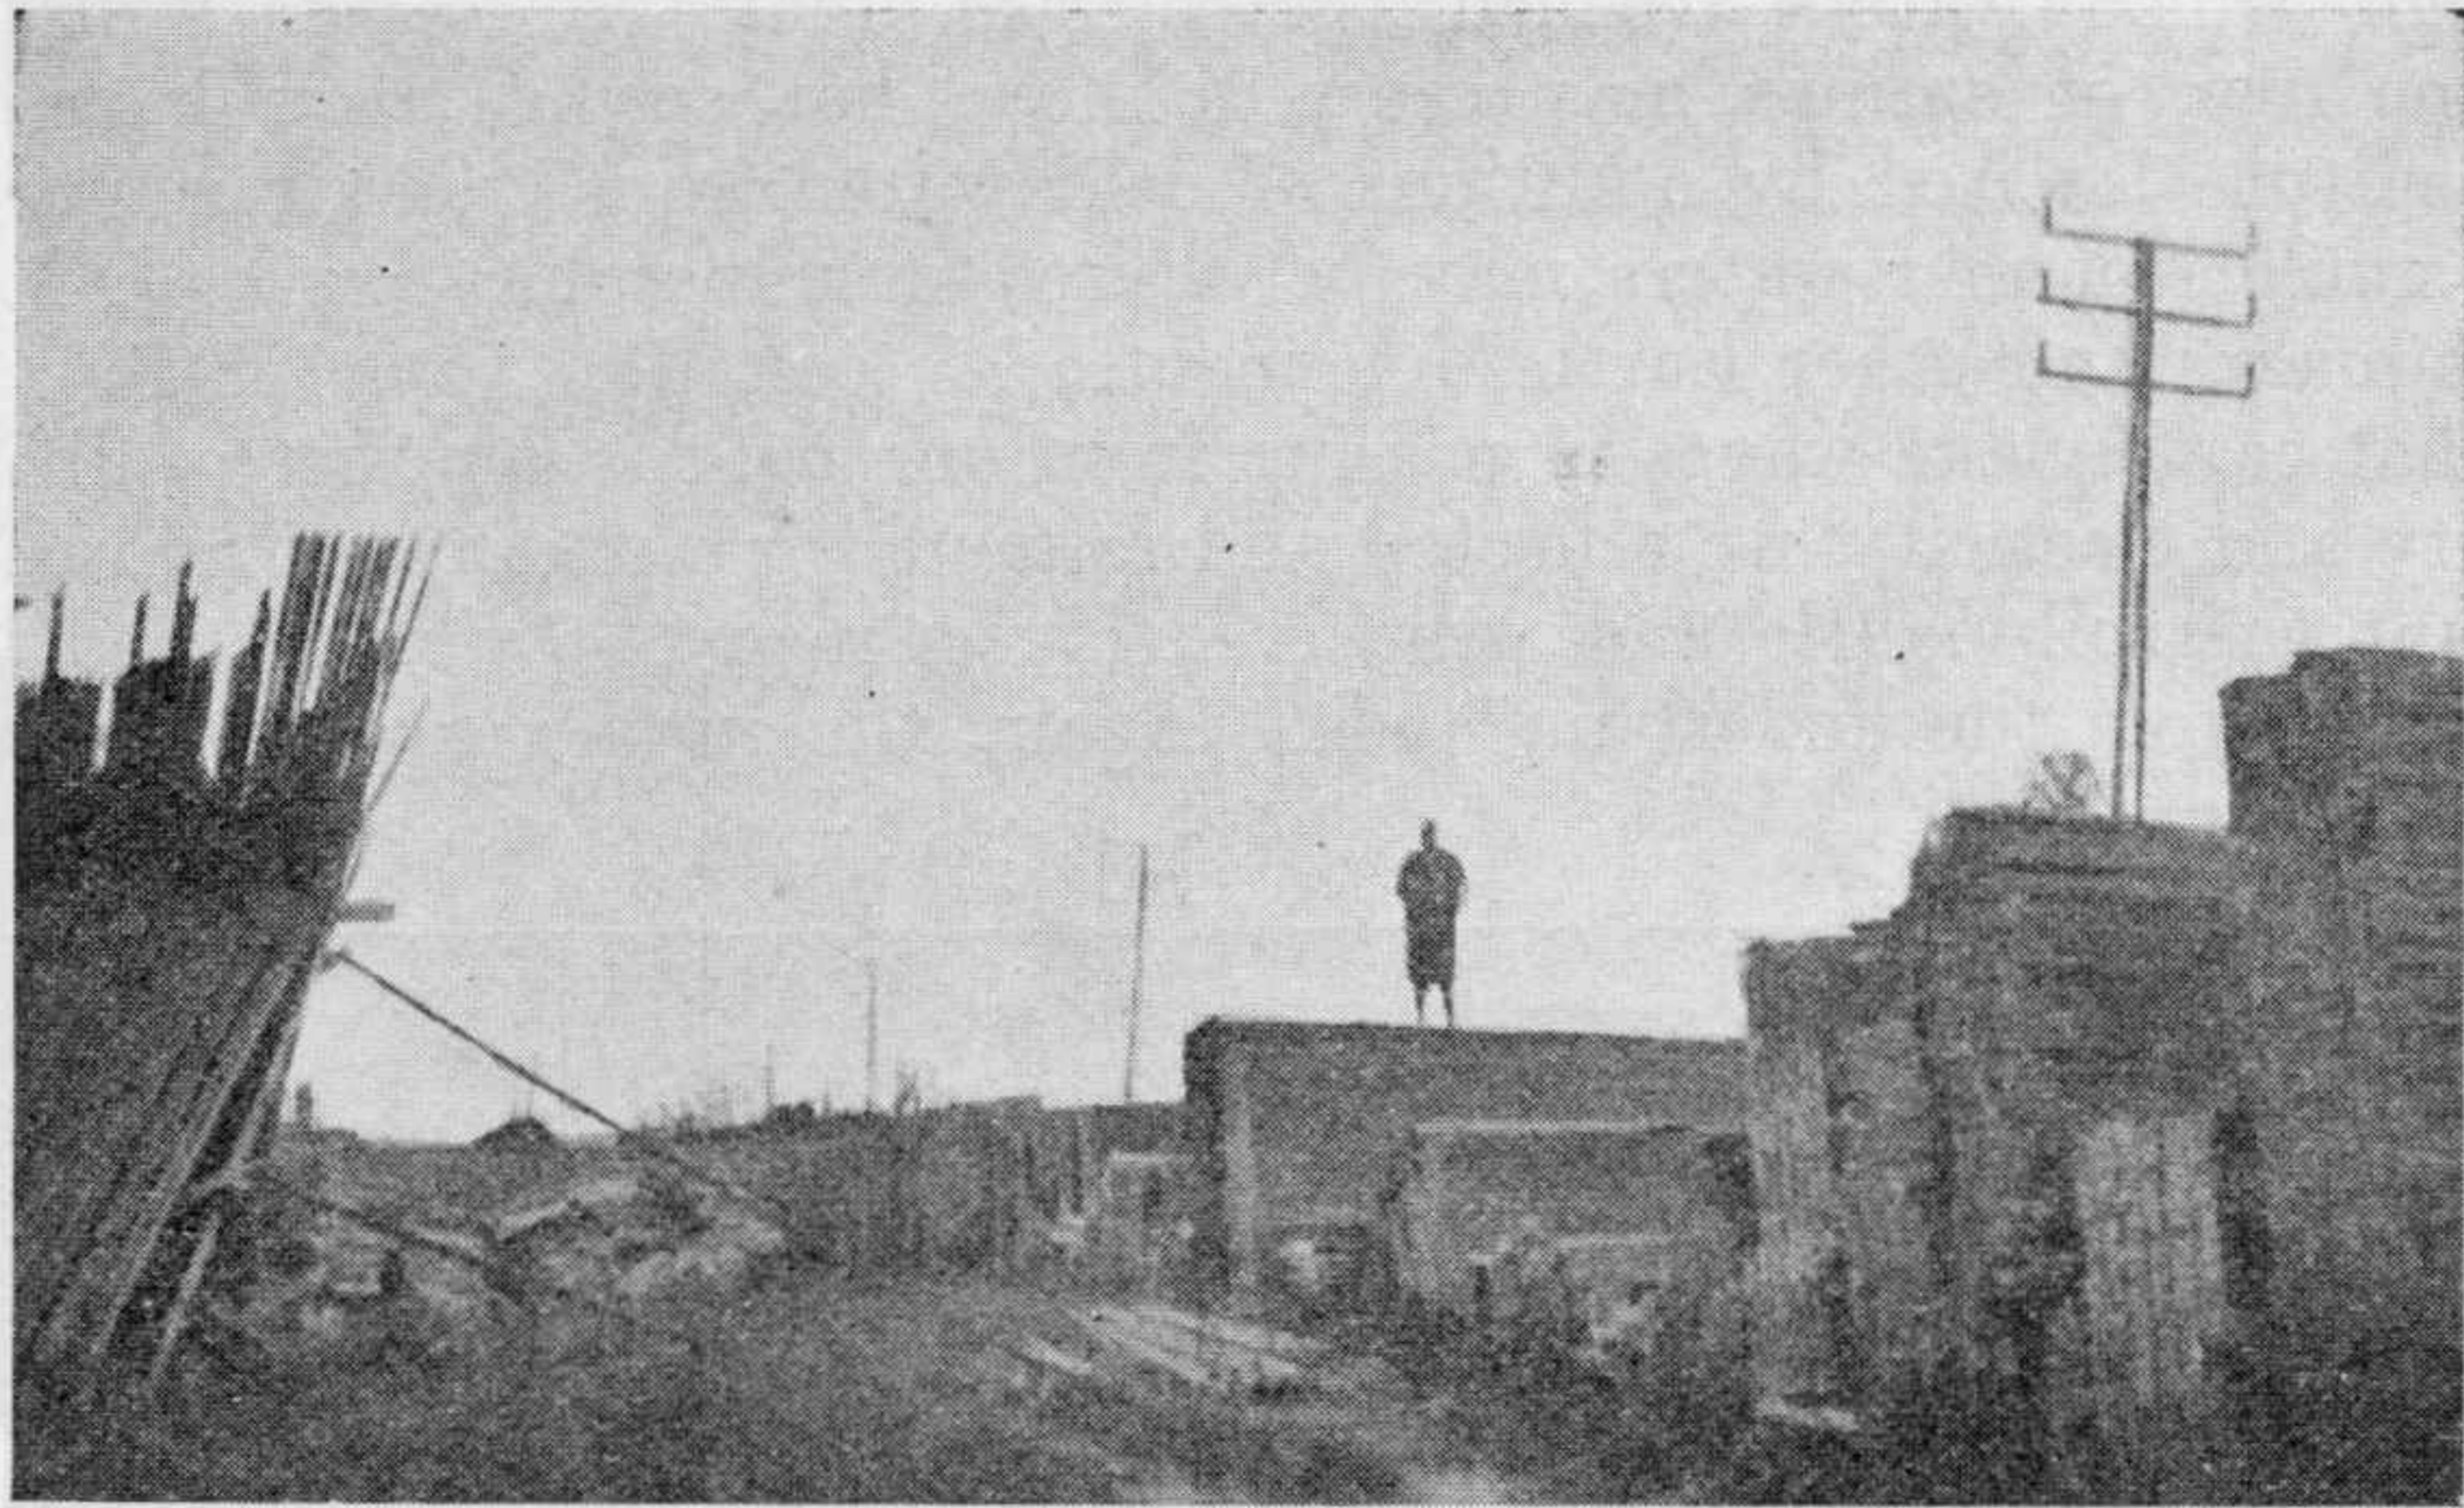
PLATE IV.—(a) Timber-yard, Napier. The standing piles of lumber extend a little west of north; those at right angles collapsed.
