N.Z. DEPARTMENT OF SCIENTIFIC AND INDUSTRIAL RESEARCH.

BULLETIN No. 43.

REPORT
OF THE
HAWKE'S BAY EARTHQUAKE
(3rd FEBRUARY, 1931).

**THE HAWKE'S BAY EARTHQUAKE OF
3rd FEBRUARY, 1931.**

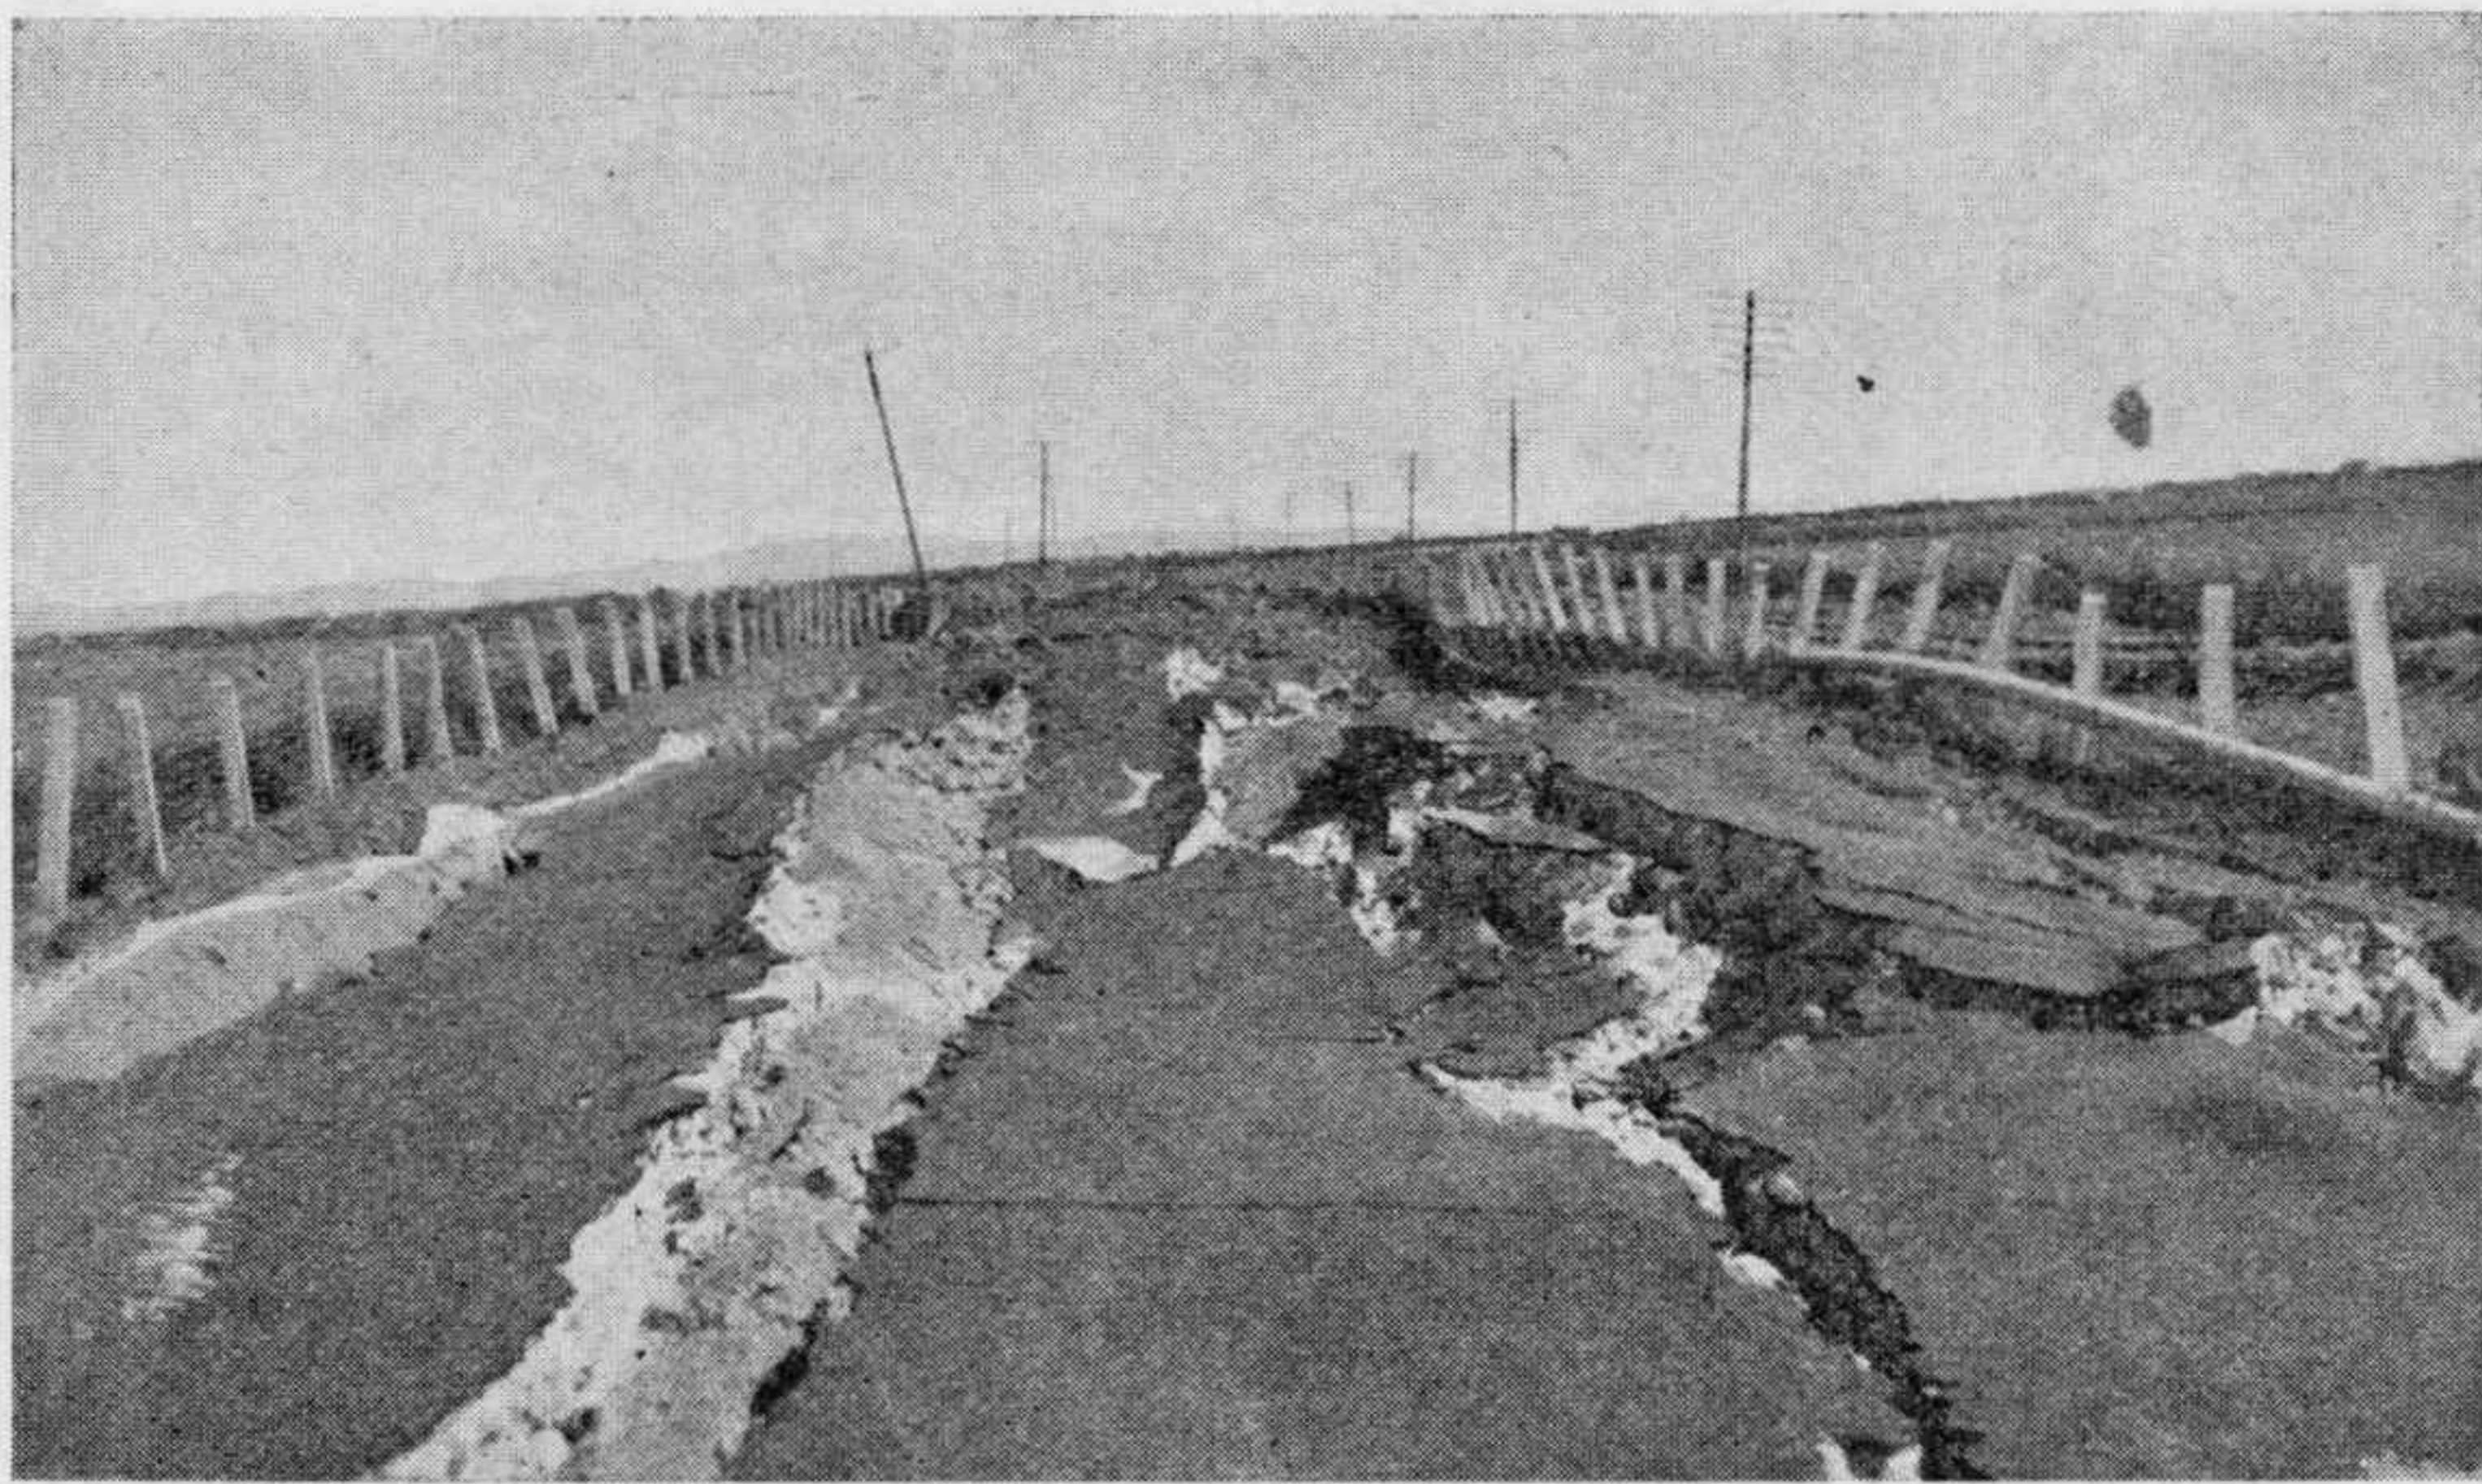
PLATE IV.—(b) West Shore Causeway, Napier. The embankment spread laterally.

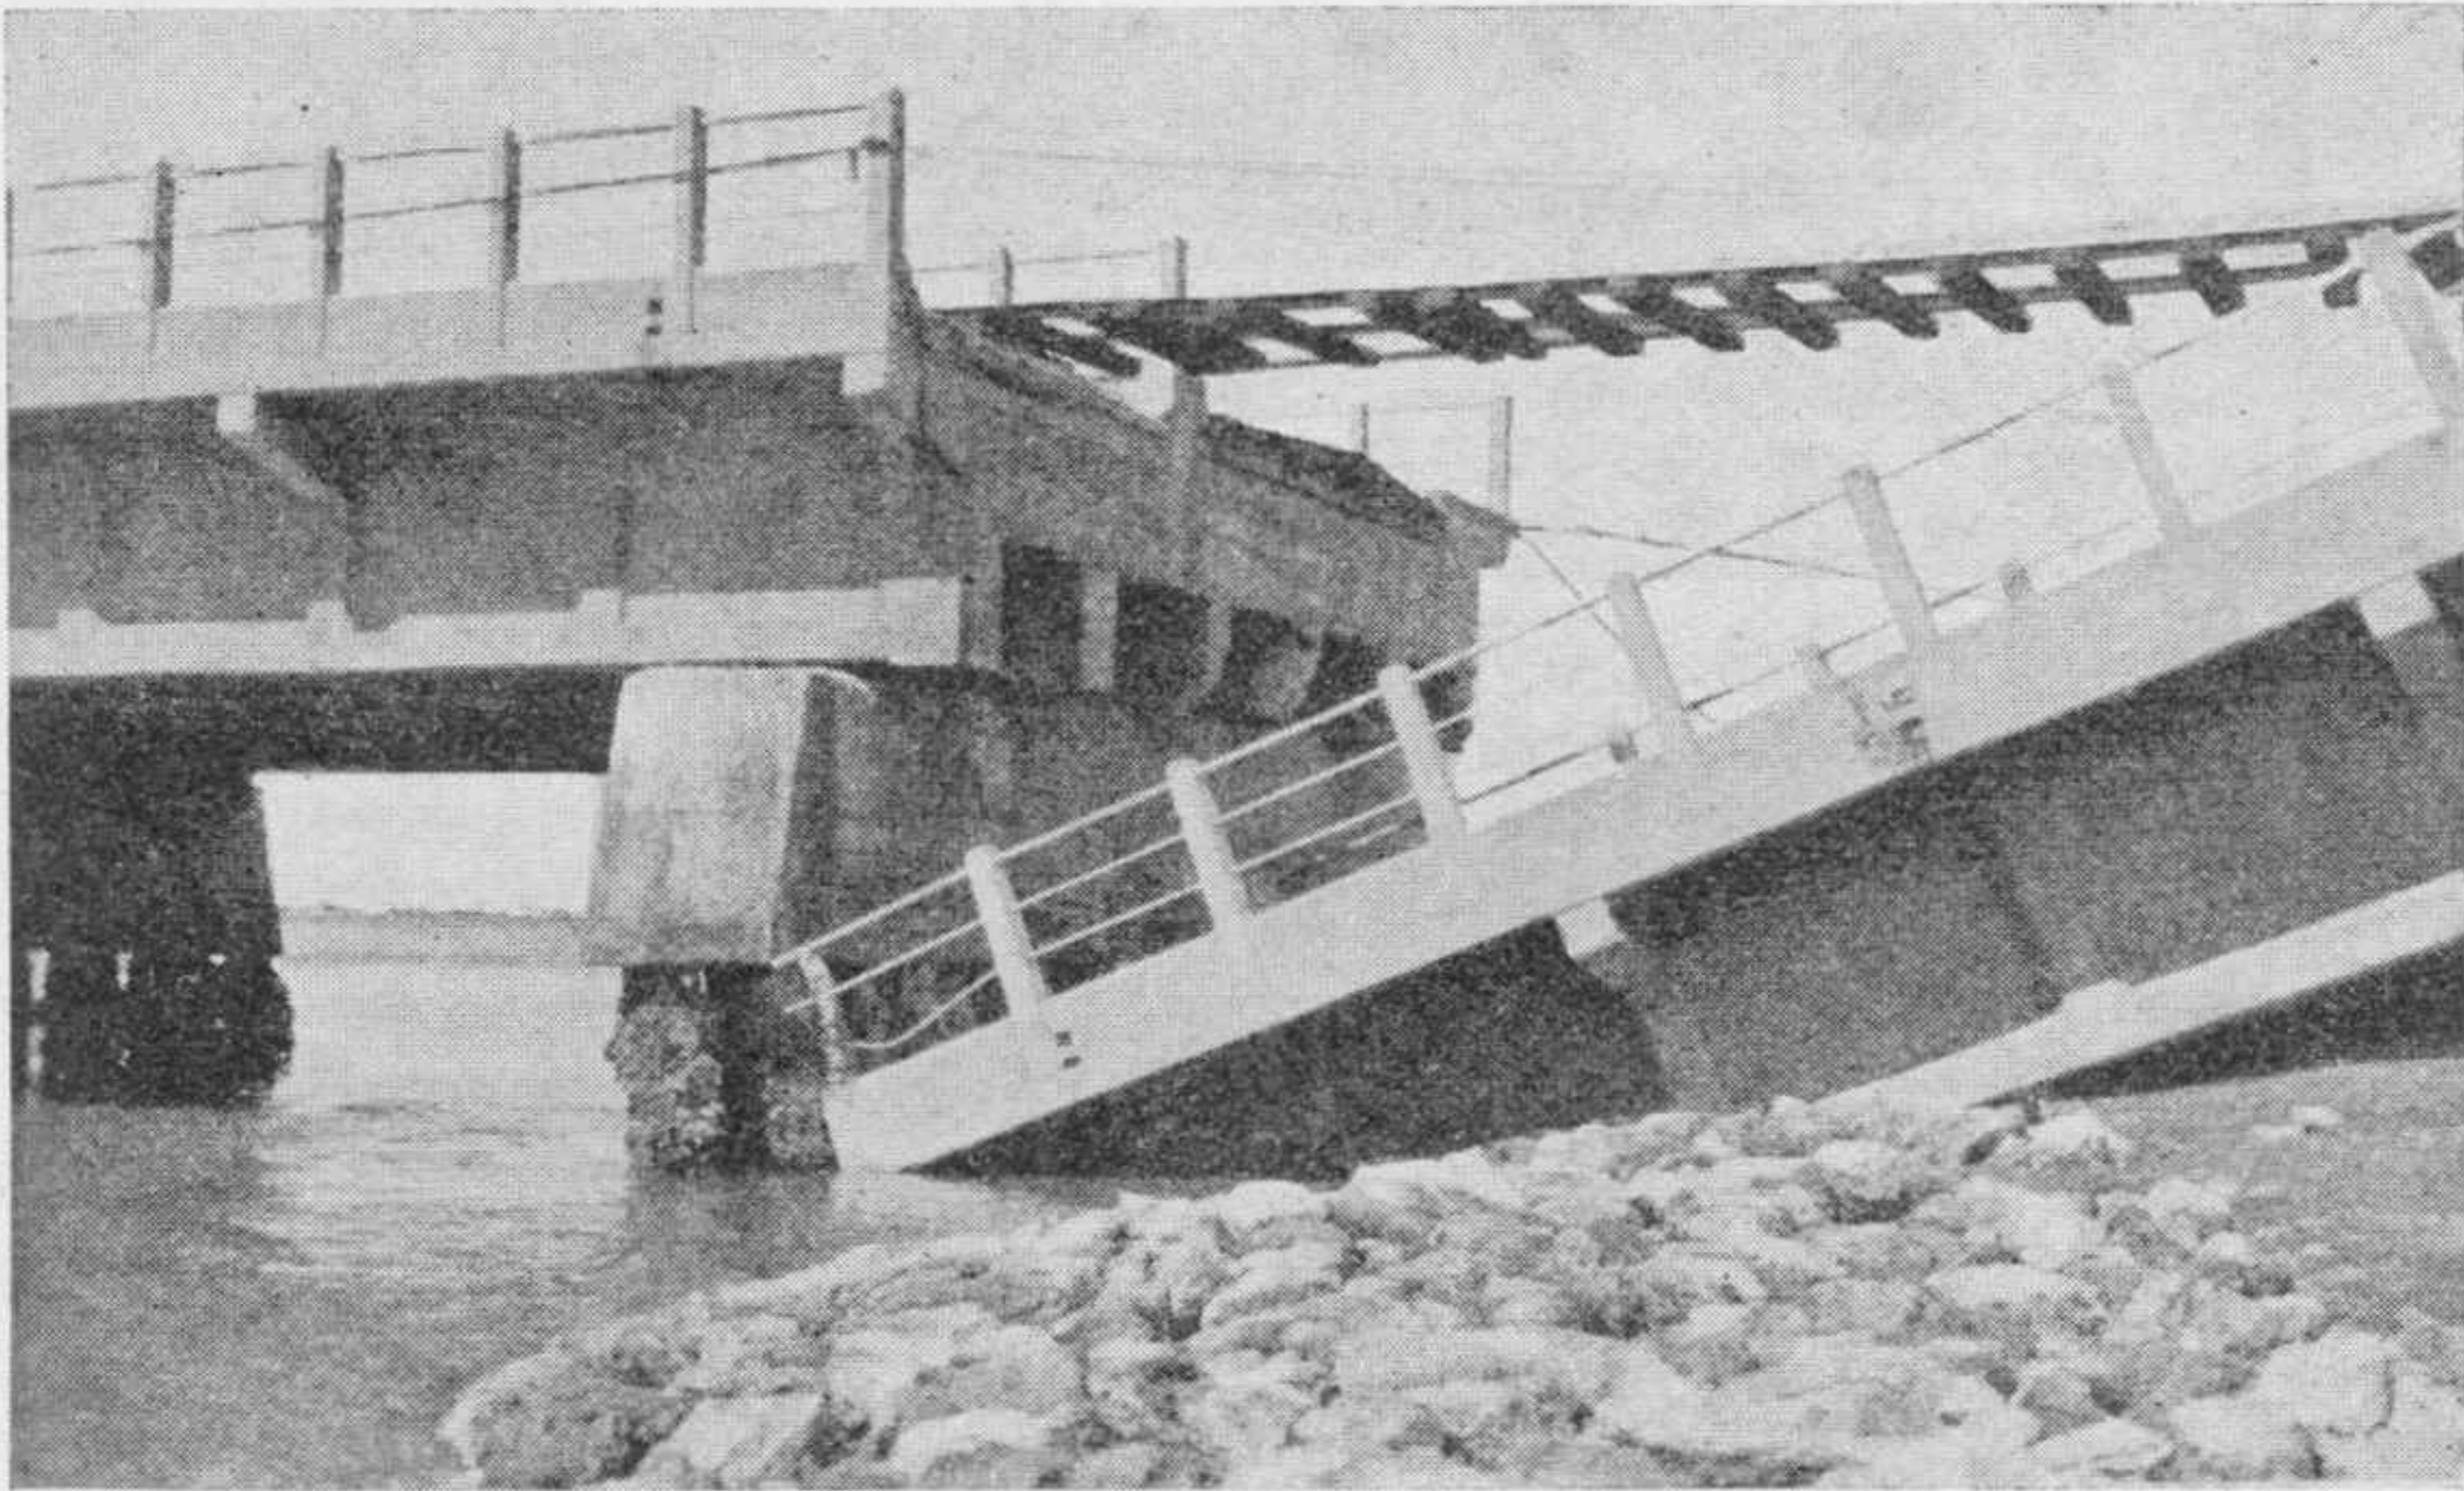
PLATE IV.—(c) West Shore bridge, Napier. The mud-bank to the right of the channel slumped and forced a group of piles from under the end of the span.

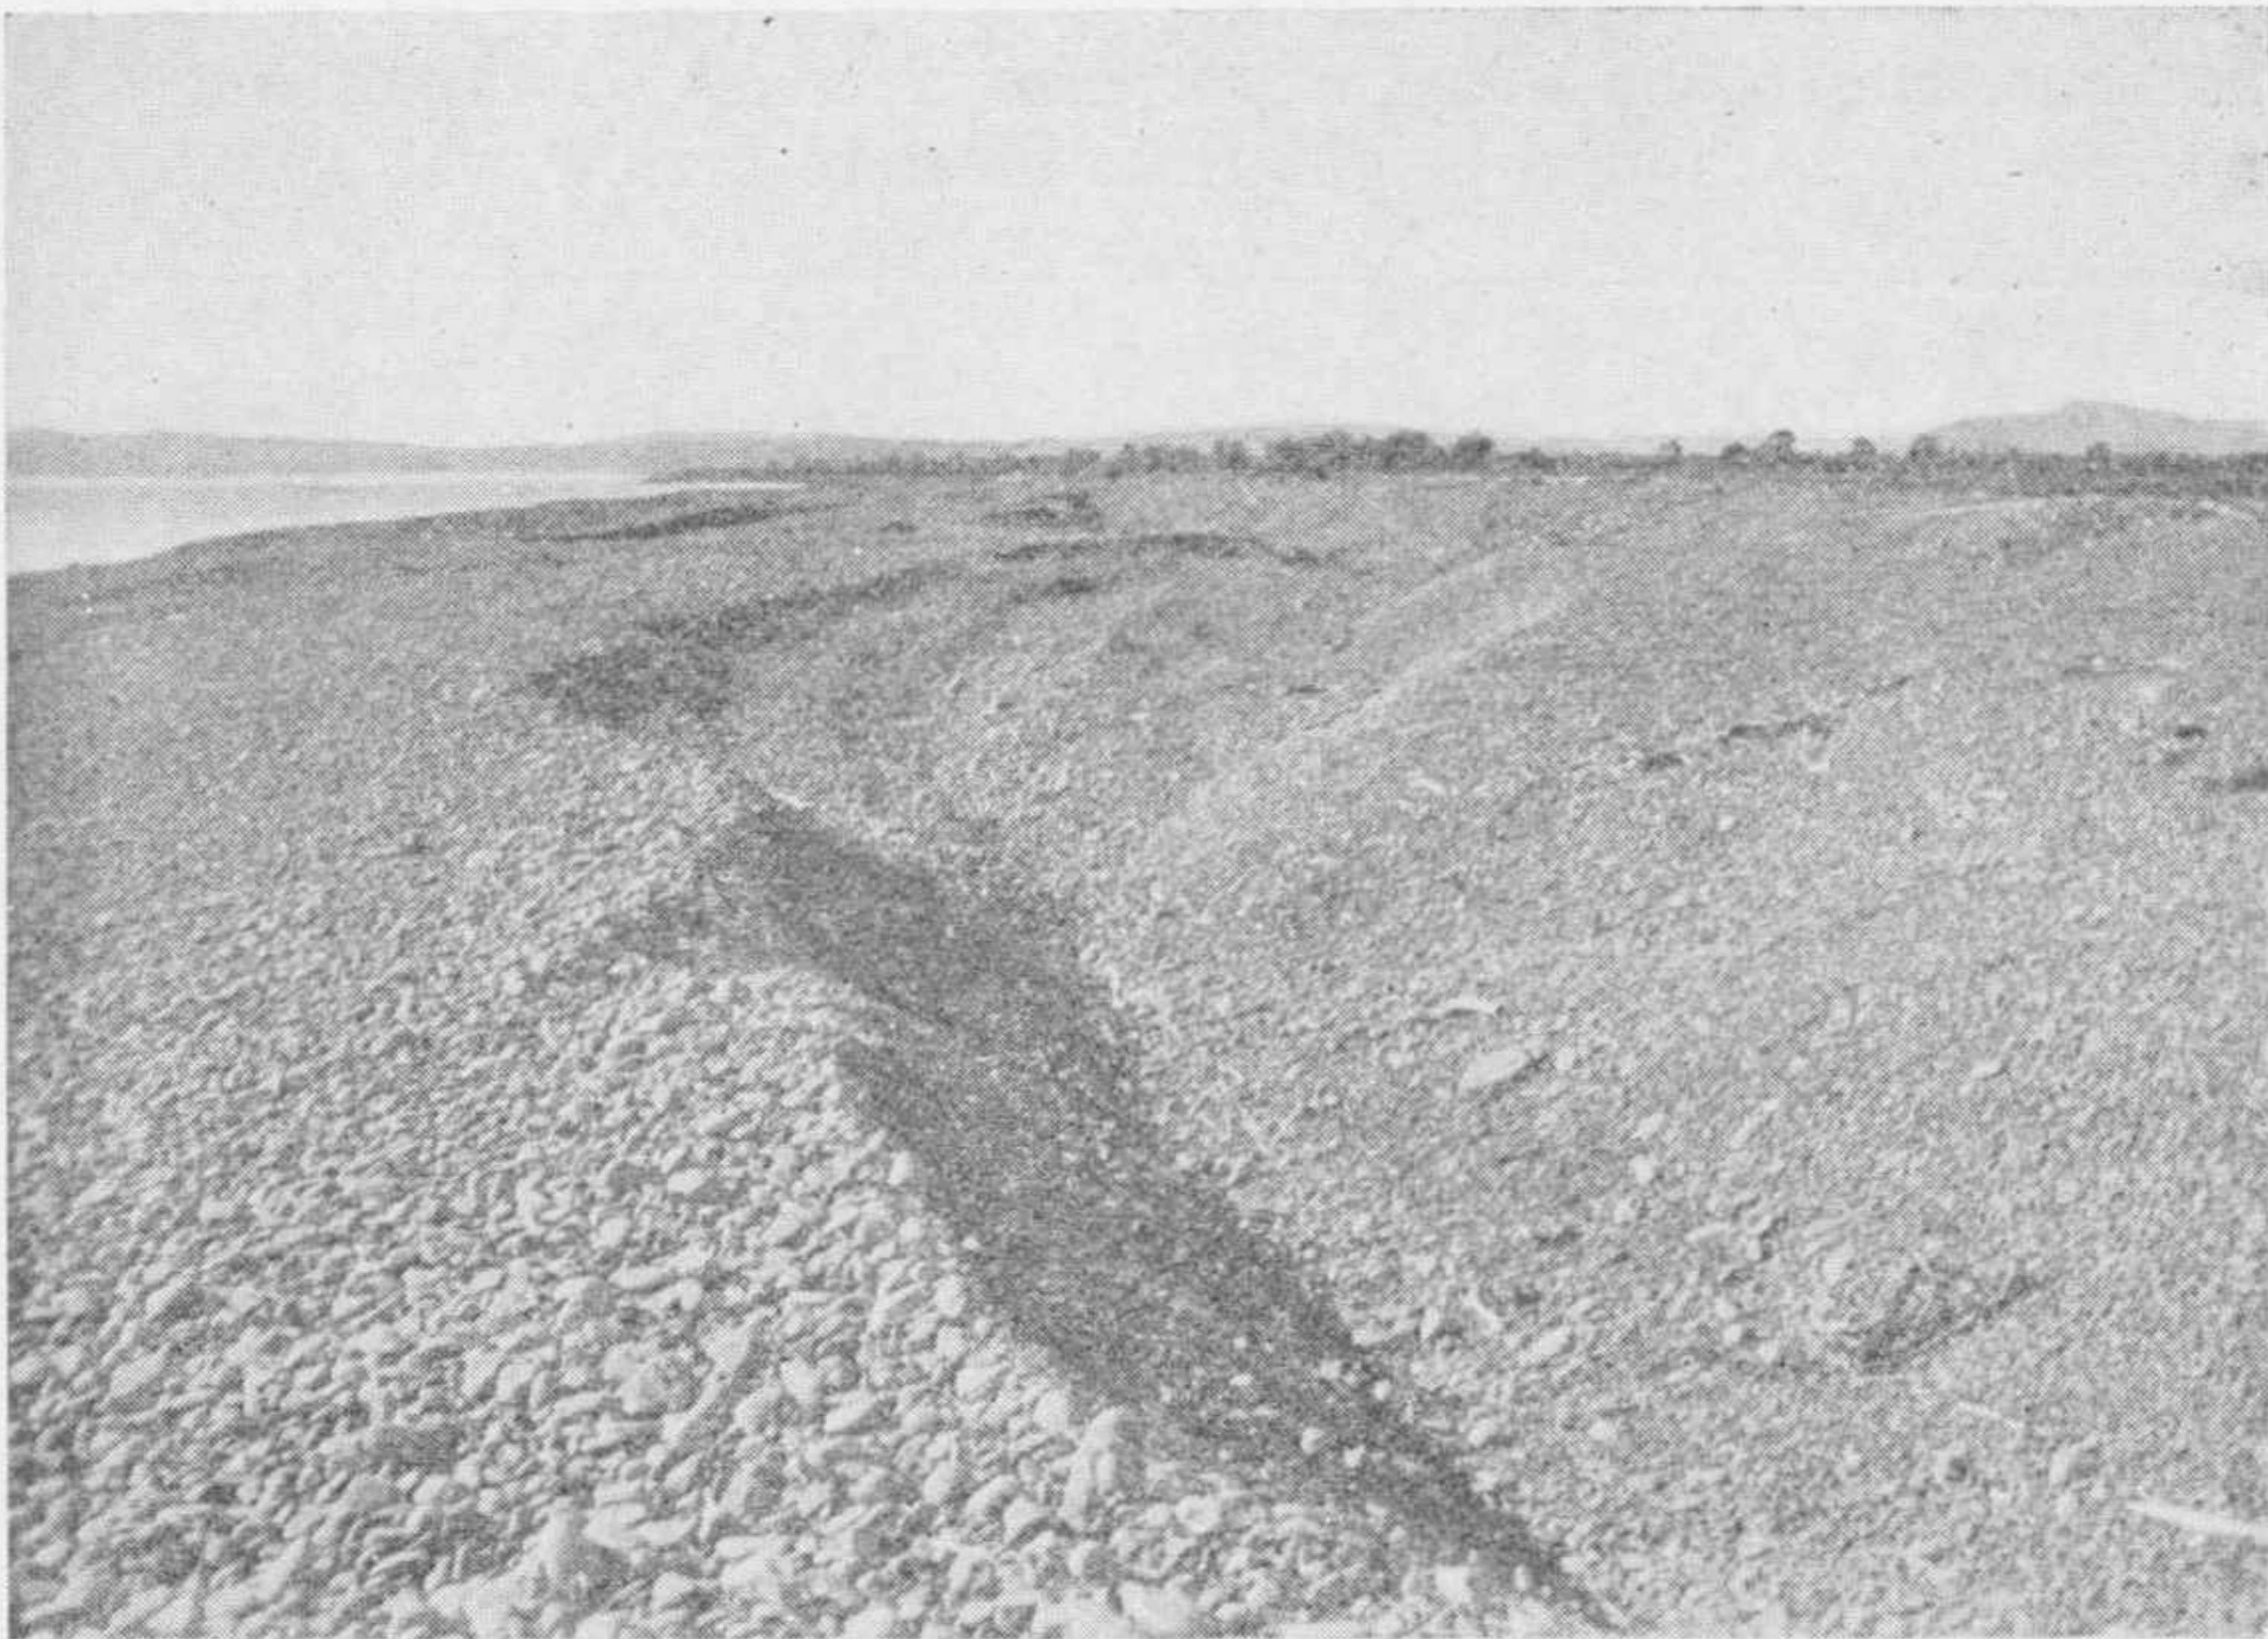
PLATE I.—Earthquake ridges on shingle beach one mile north of the mouth of the Ngaruroro looking south. The furrow in the foreground is 2 ft. 6 in. deep.

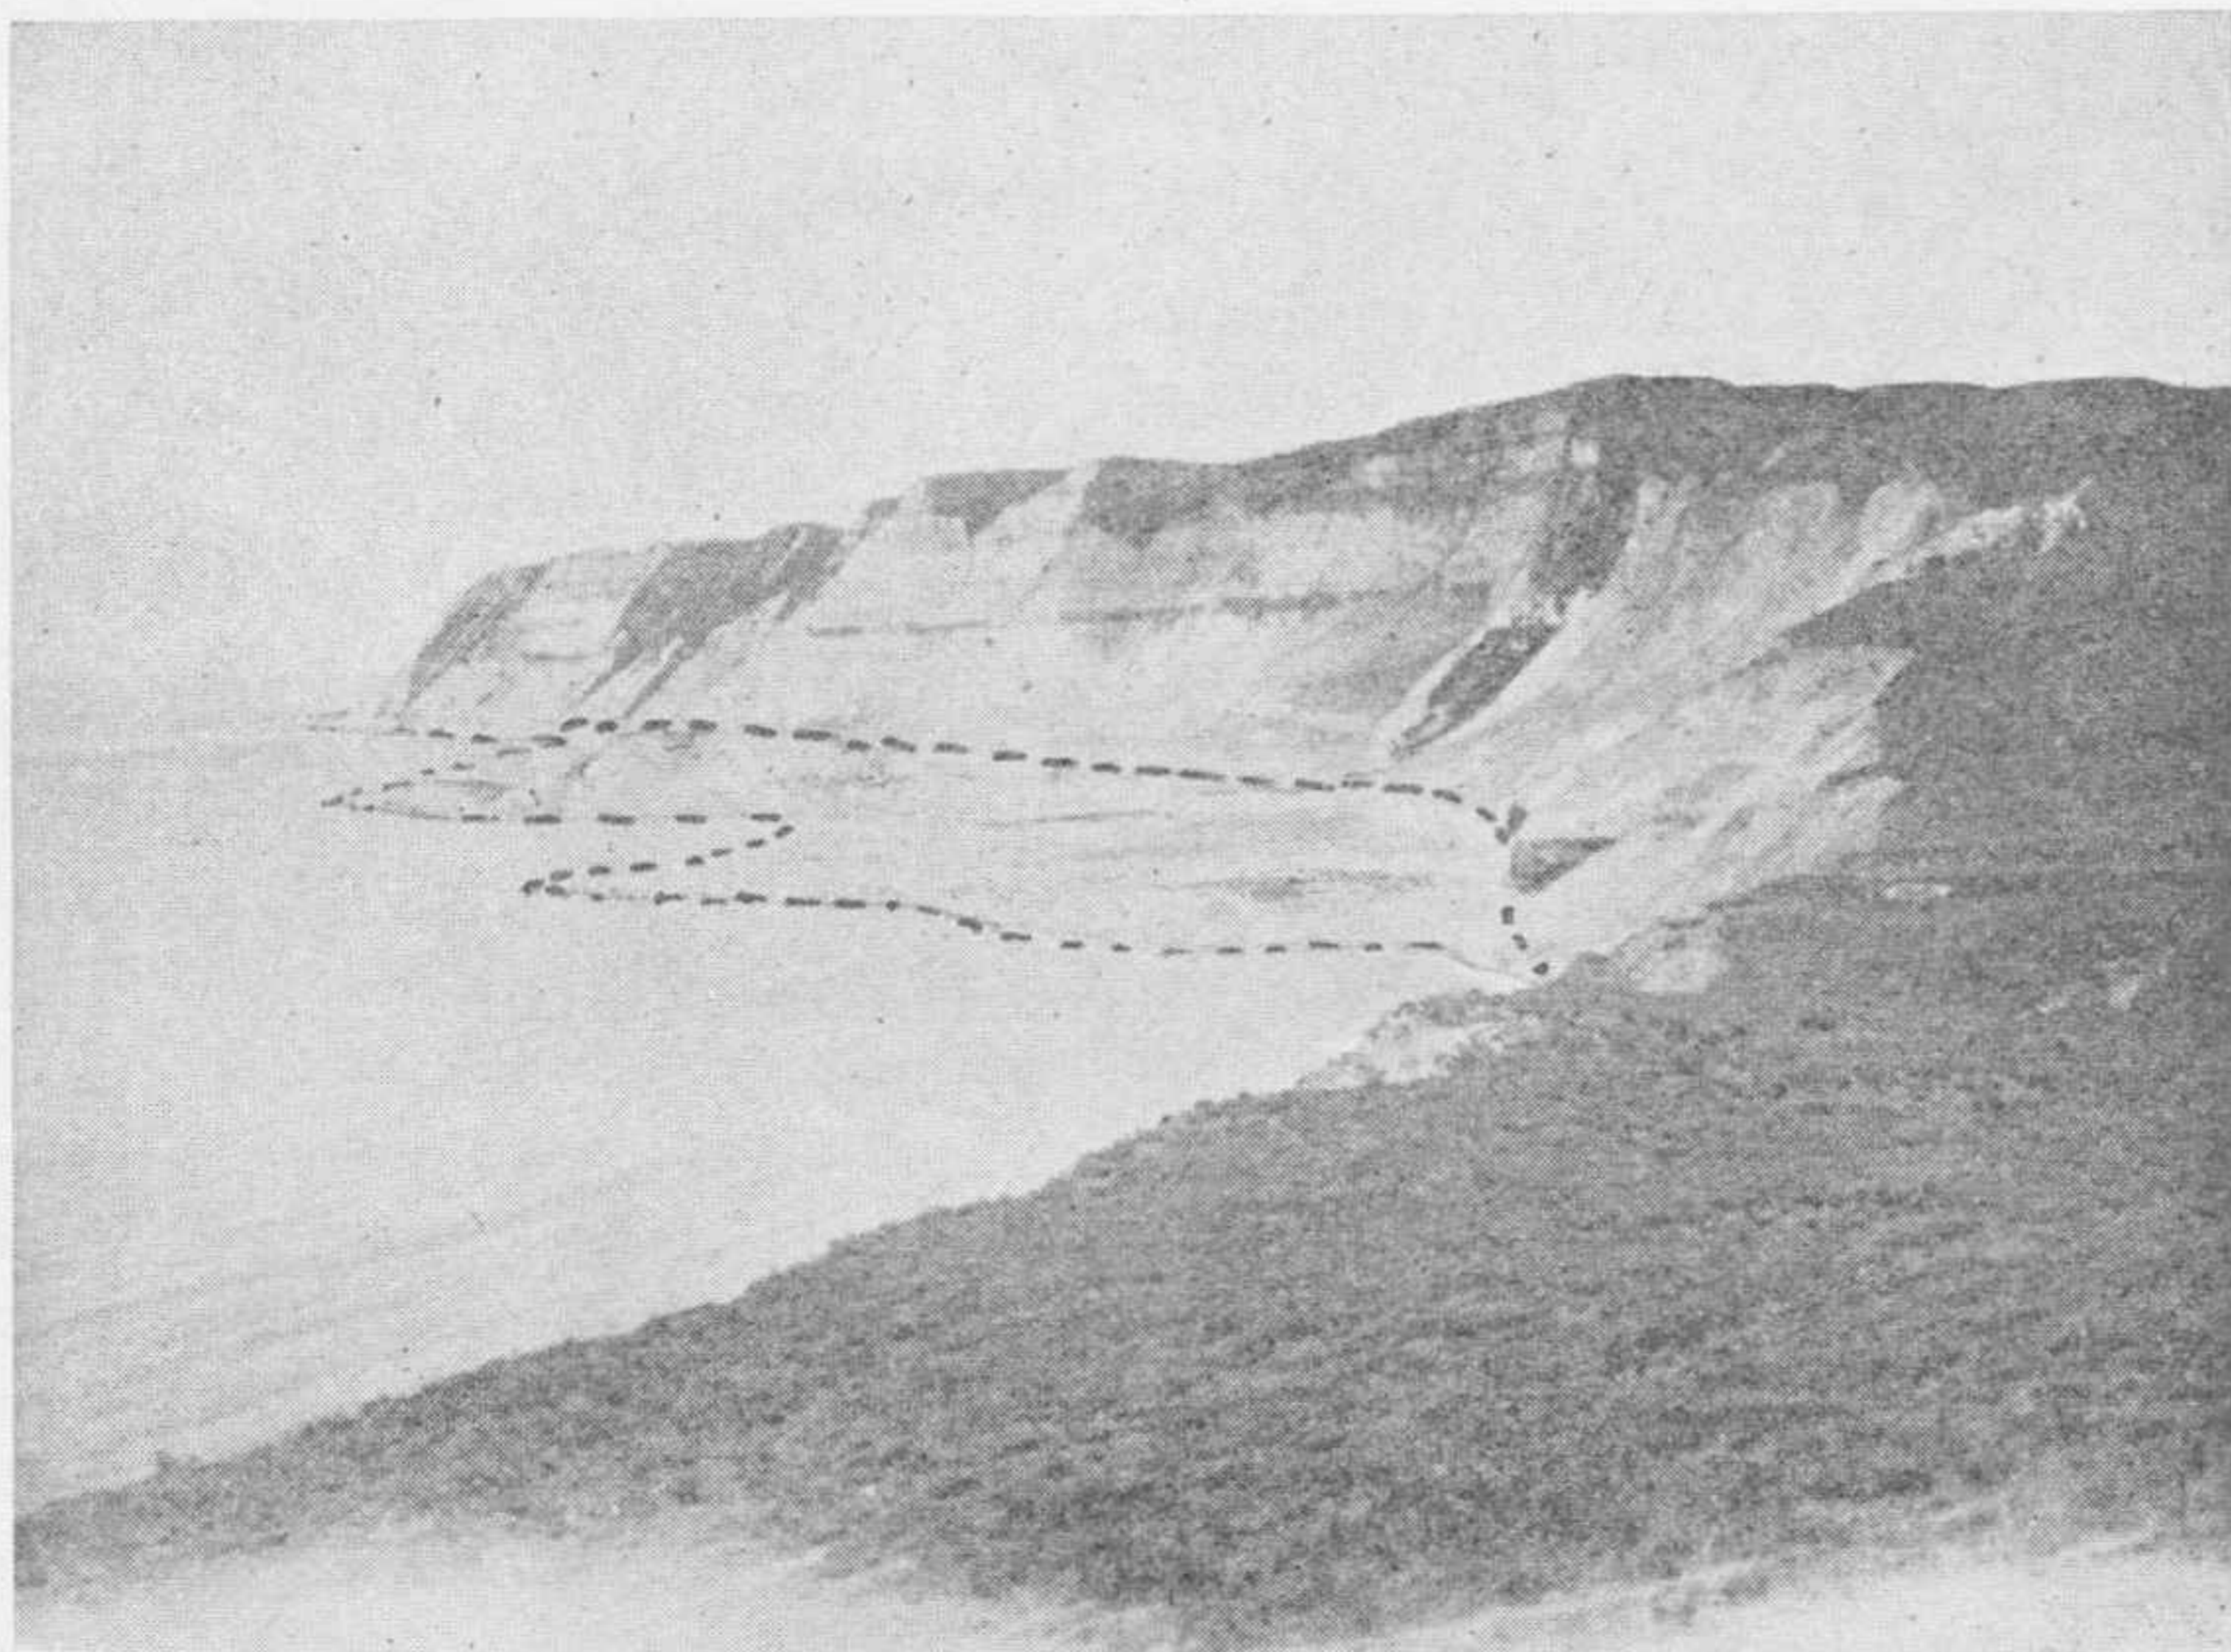
PLATE III.—Flow slip at Old Man's Bluff 1,282 ft. high. The area of flow slip is enclosed by the dotted line. It is half a mile wide and one and a half miles long. The rocks are uniform grey marl with little bedding.

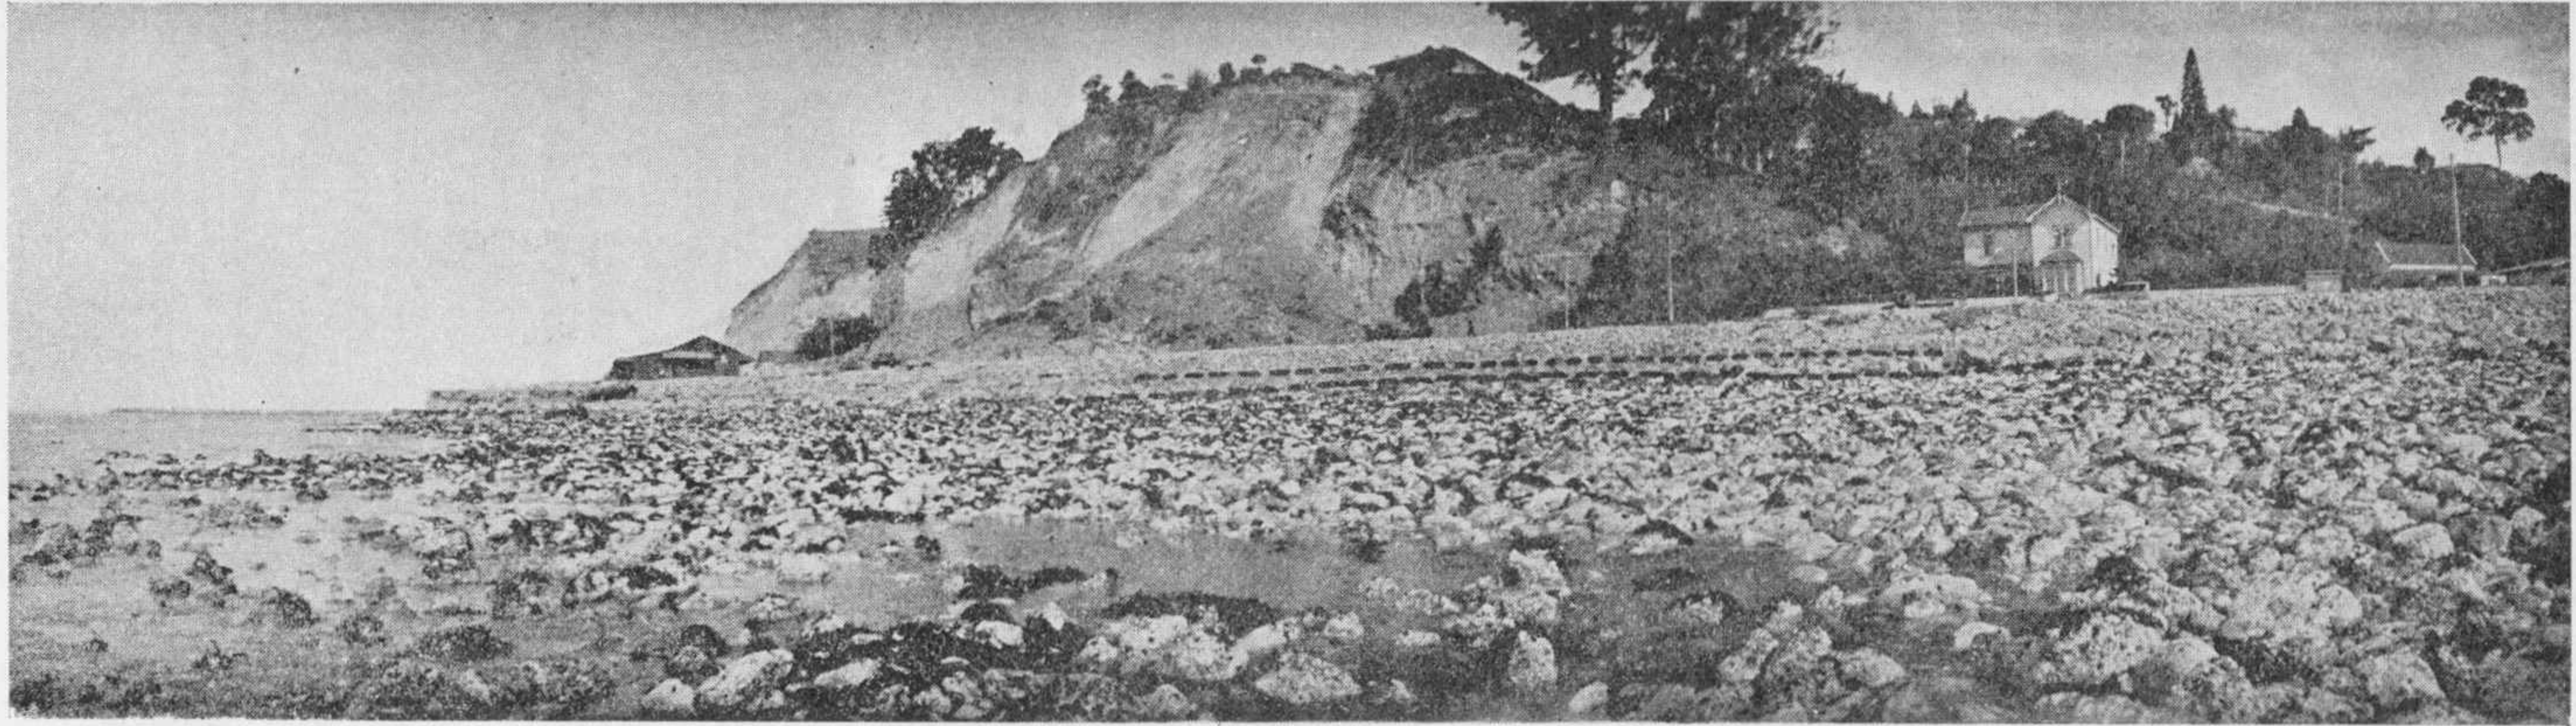
PLATE II.—Foreshore north of breakwater, Napier. Large slips thrown down from Scinde Promontory. The two dotted lines mark pre-earthquake high- and low-tide levels.

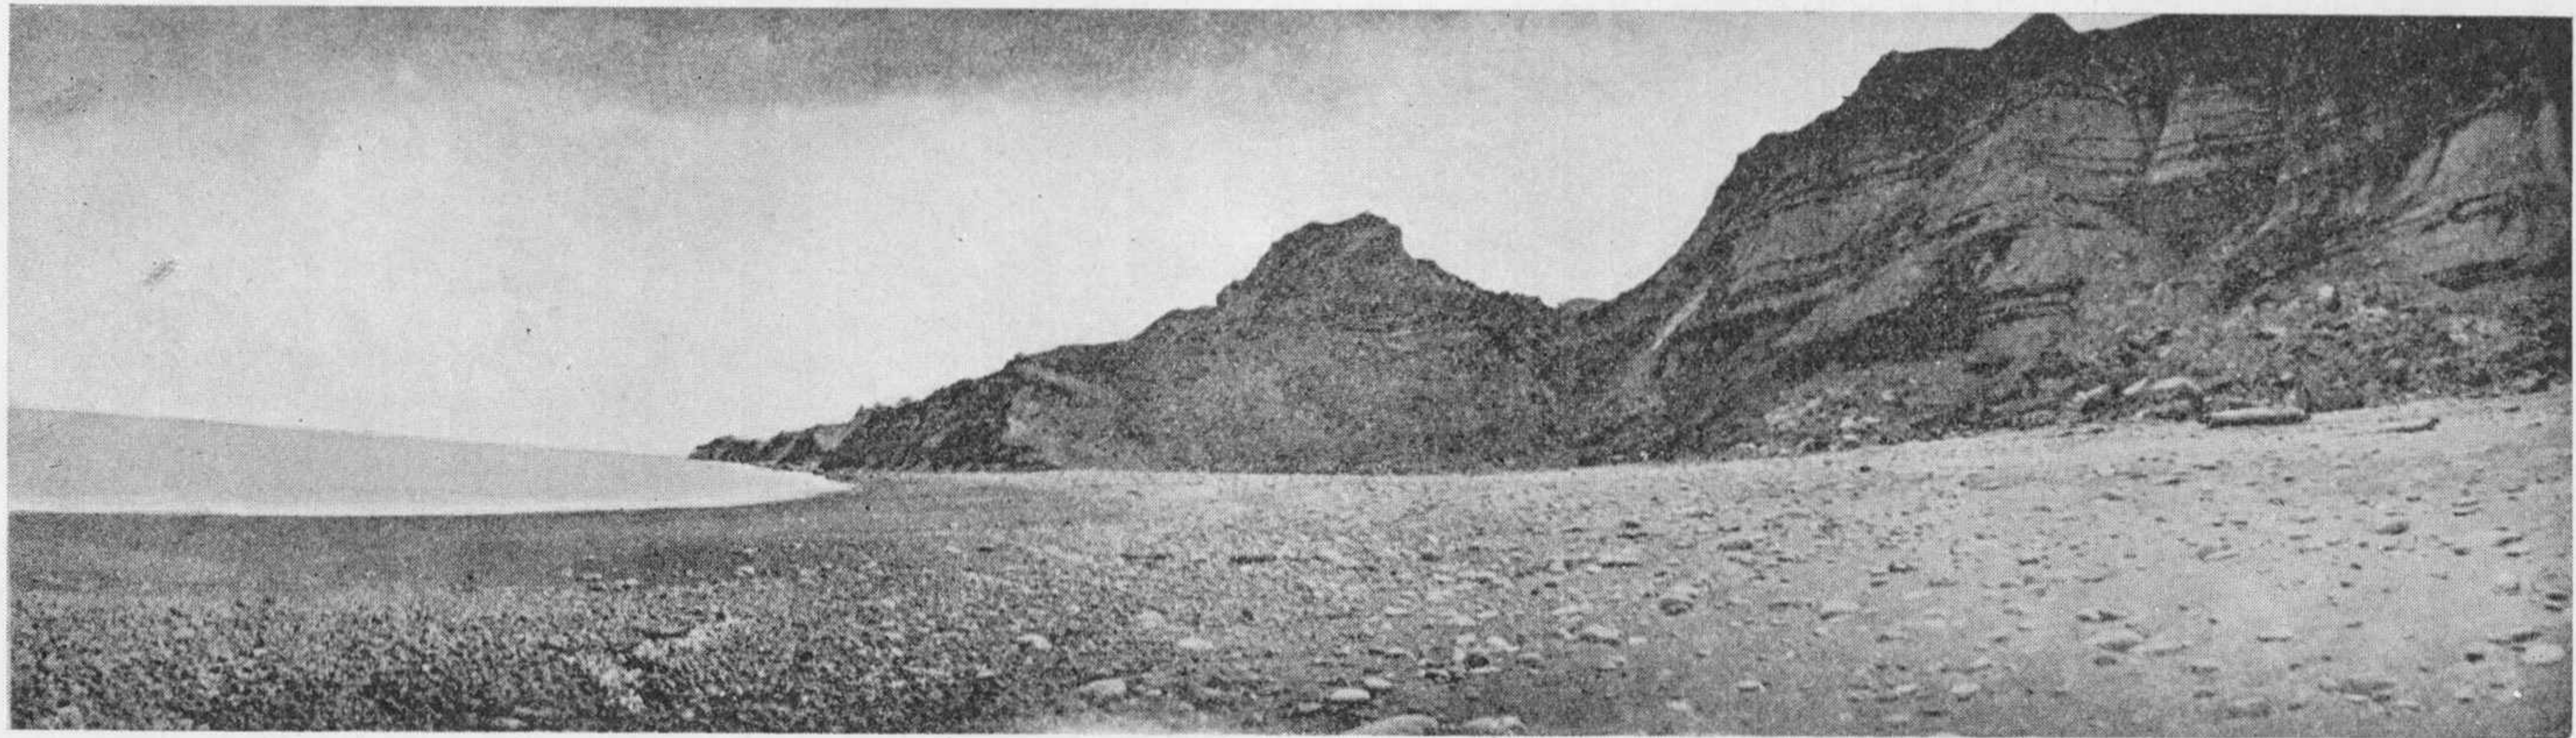
PLATE VI.—Large flow slip one mile south of Mohaka River. The line of cliff originally extended from the low saddle to the distant point just visible over it. View from north looking south-west,

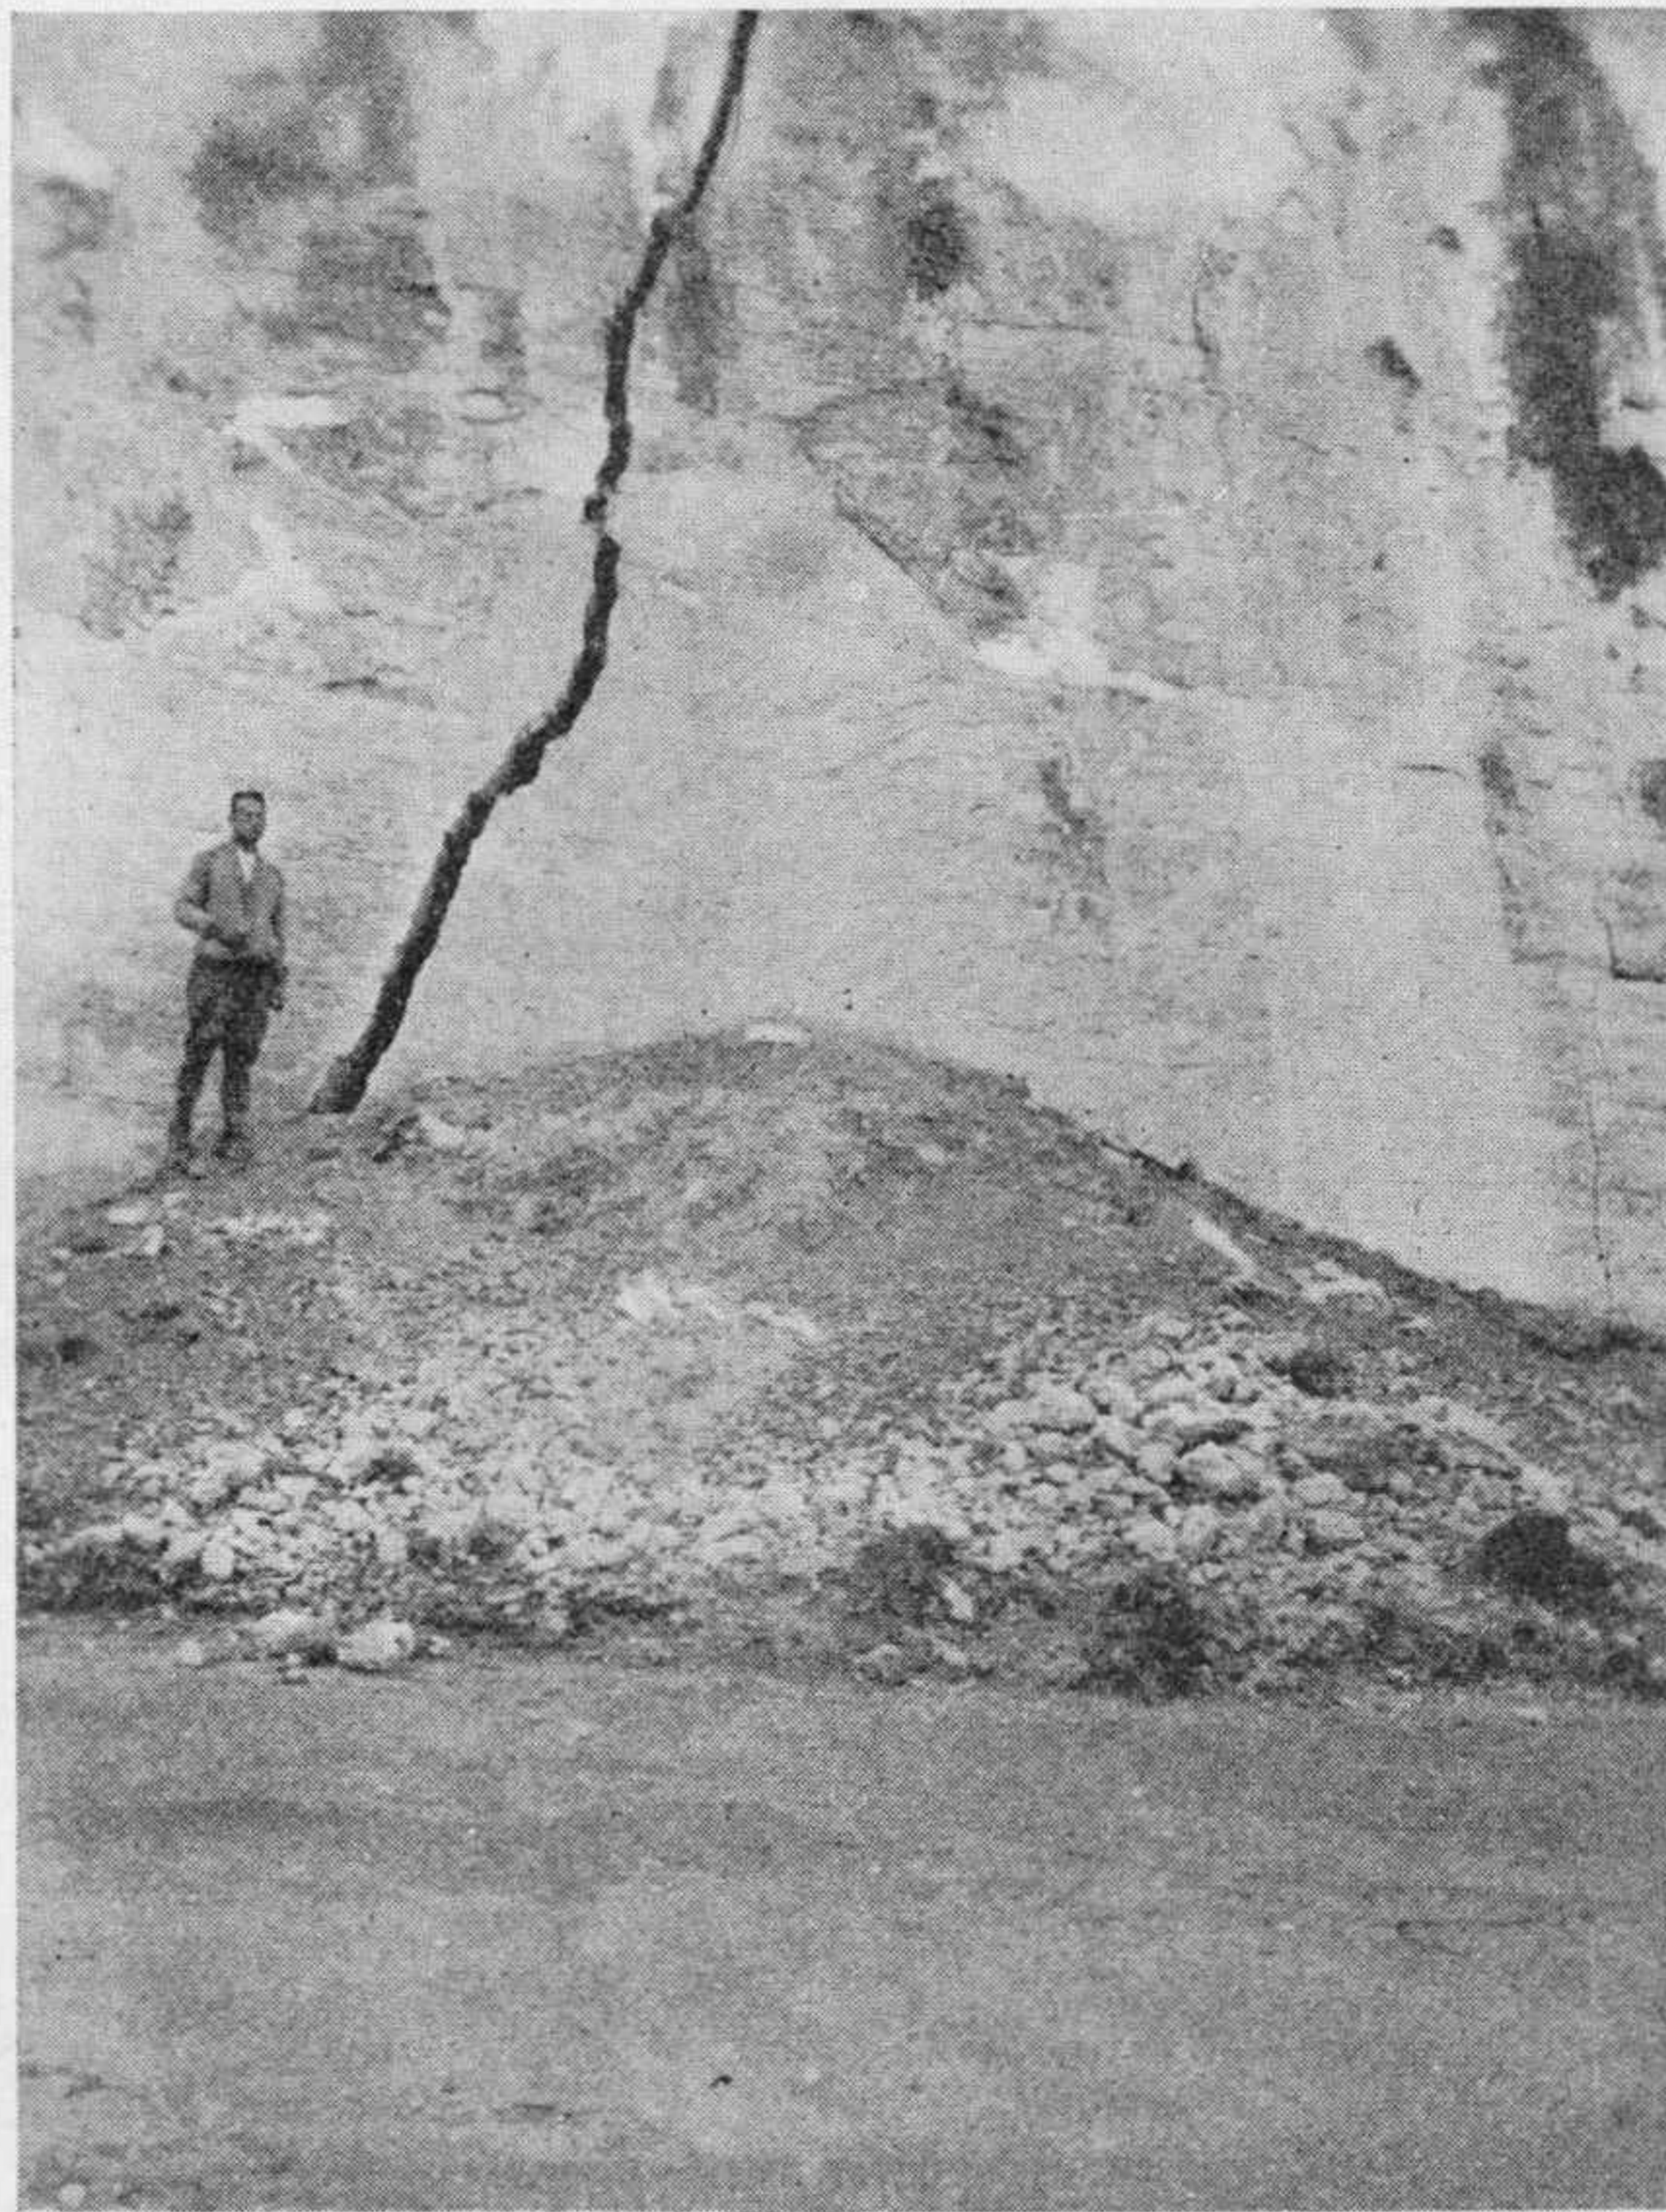
PLATE IV.—Crack in grey marl rock 9 in. wide in cliff north of Waikare, looking west.
