N.Z. DEPARTMENT OF SCIENTIFIC AND INDUSTRIAL RESEARCH.

BULLETIN No. 43.

REPORT
OF THE
HAWKE'S BAY EARTHQUAKE
(3rd FEBRUARY, 1931).

**THE HAWKE'S BAY EARTHQUAKE OF
3rd FEBRUARY, 1931.**

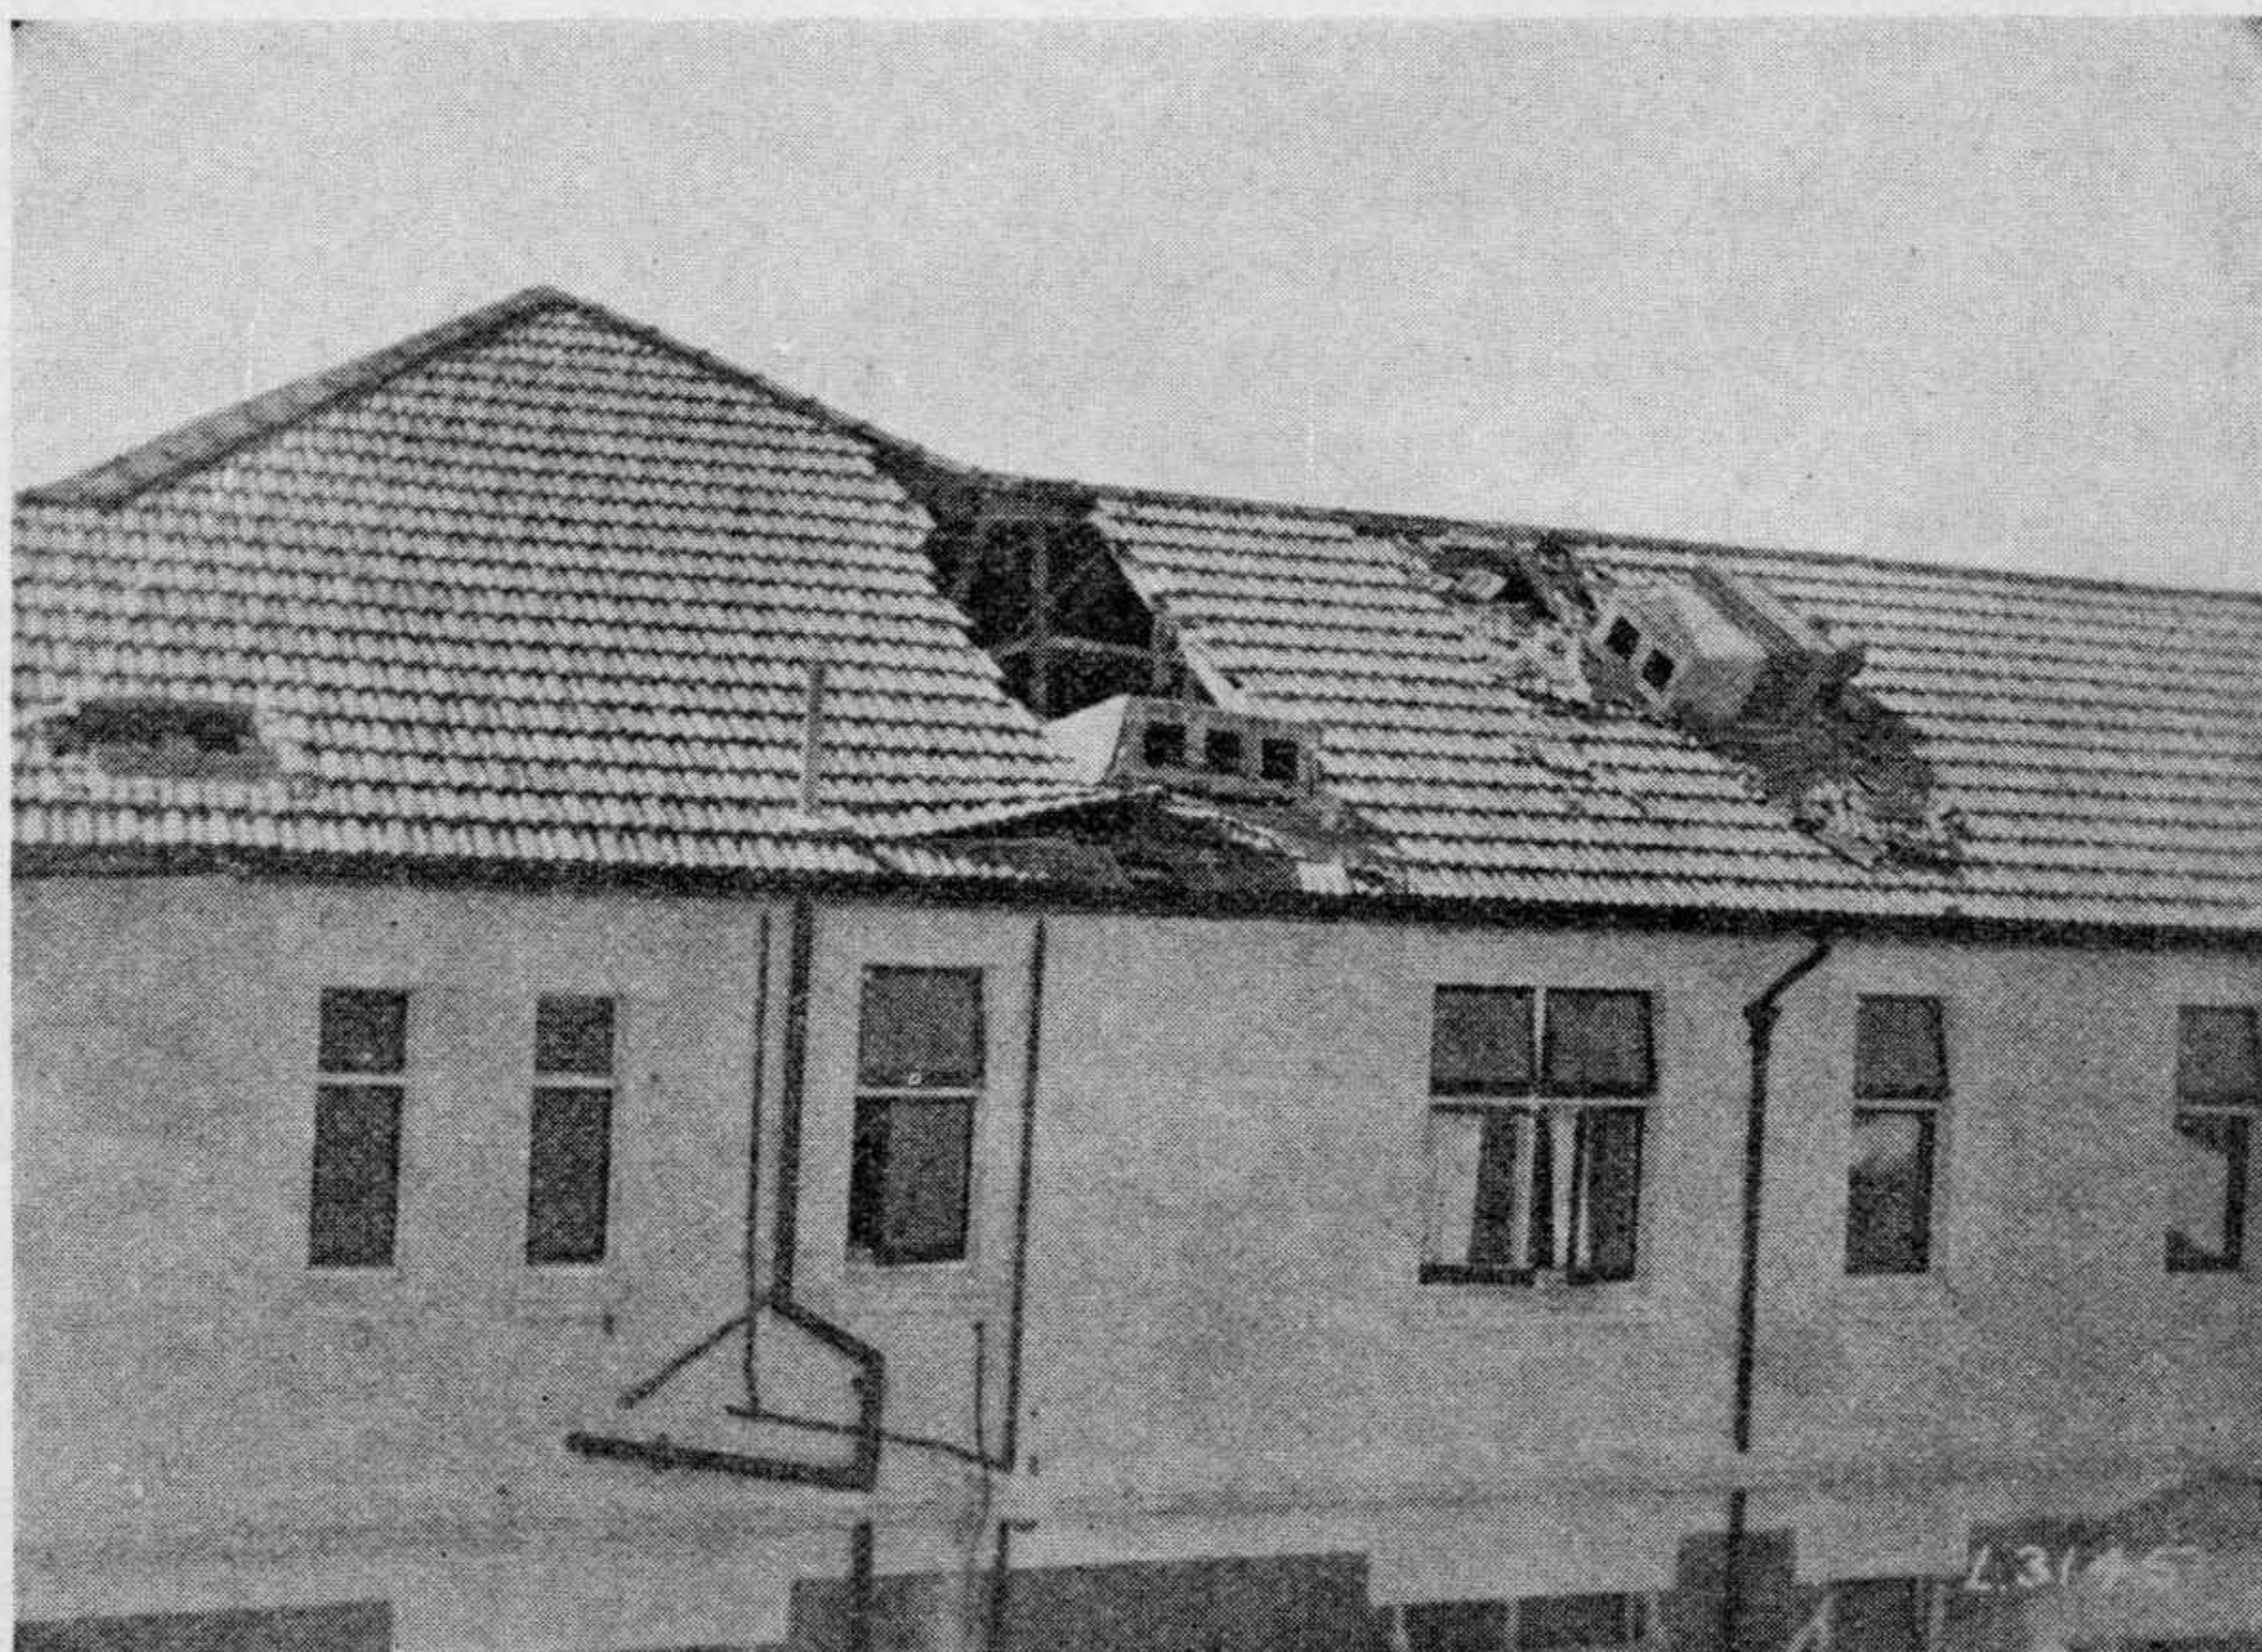
FIG. 1.—Damage caused by collapse of massive chimneys.

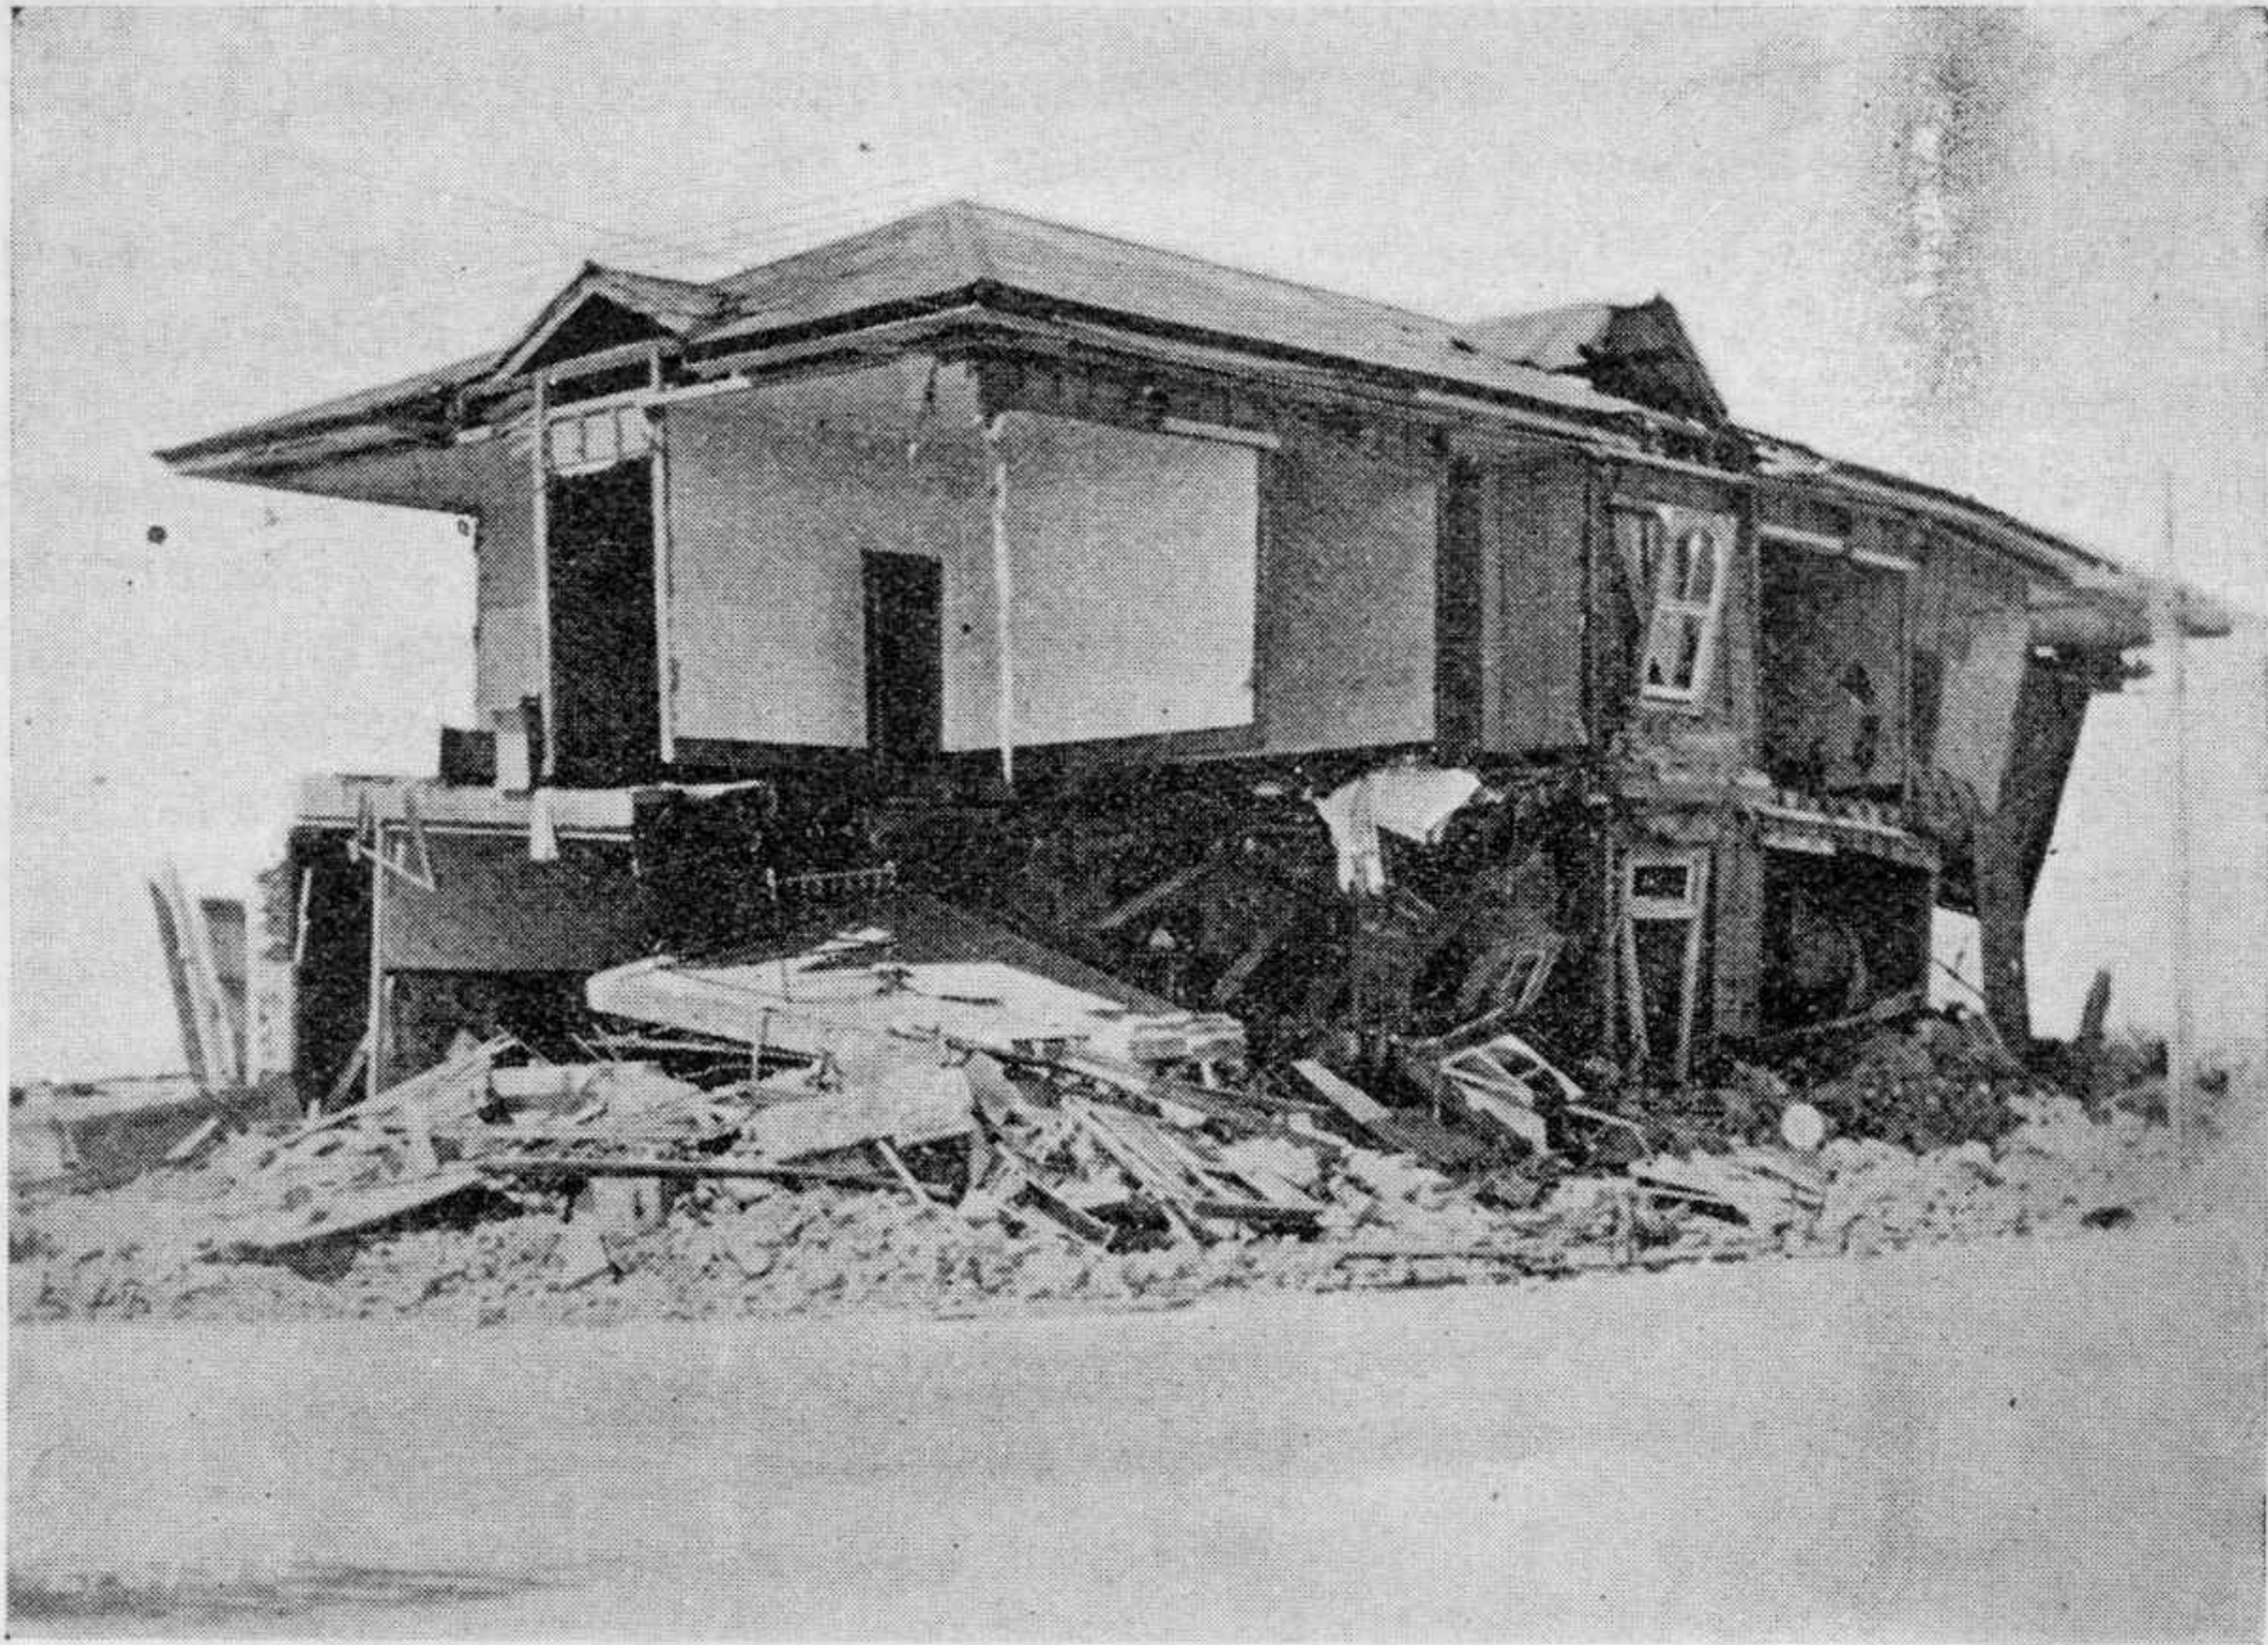
FIG. 2.—Brick building damaged through use of poor-quality mortar, and inadequate tying of interior partitions.

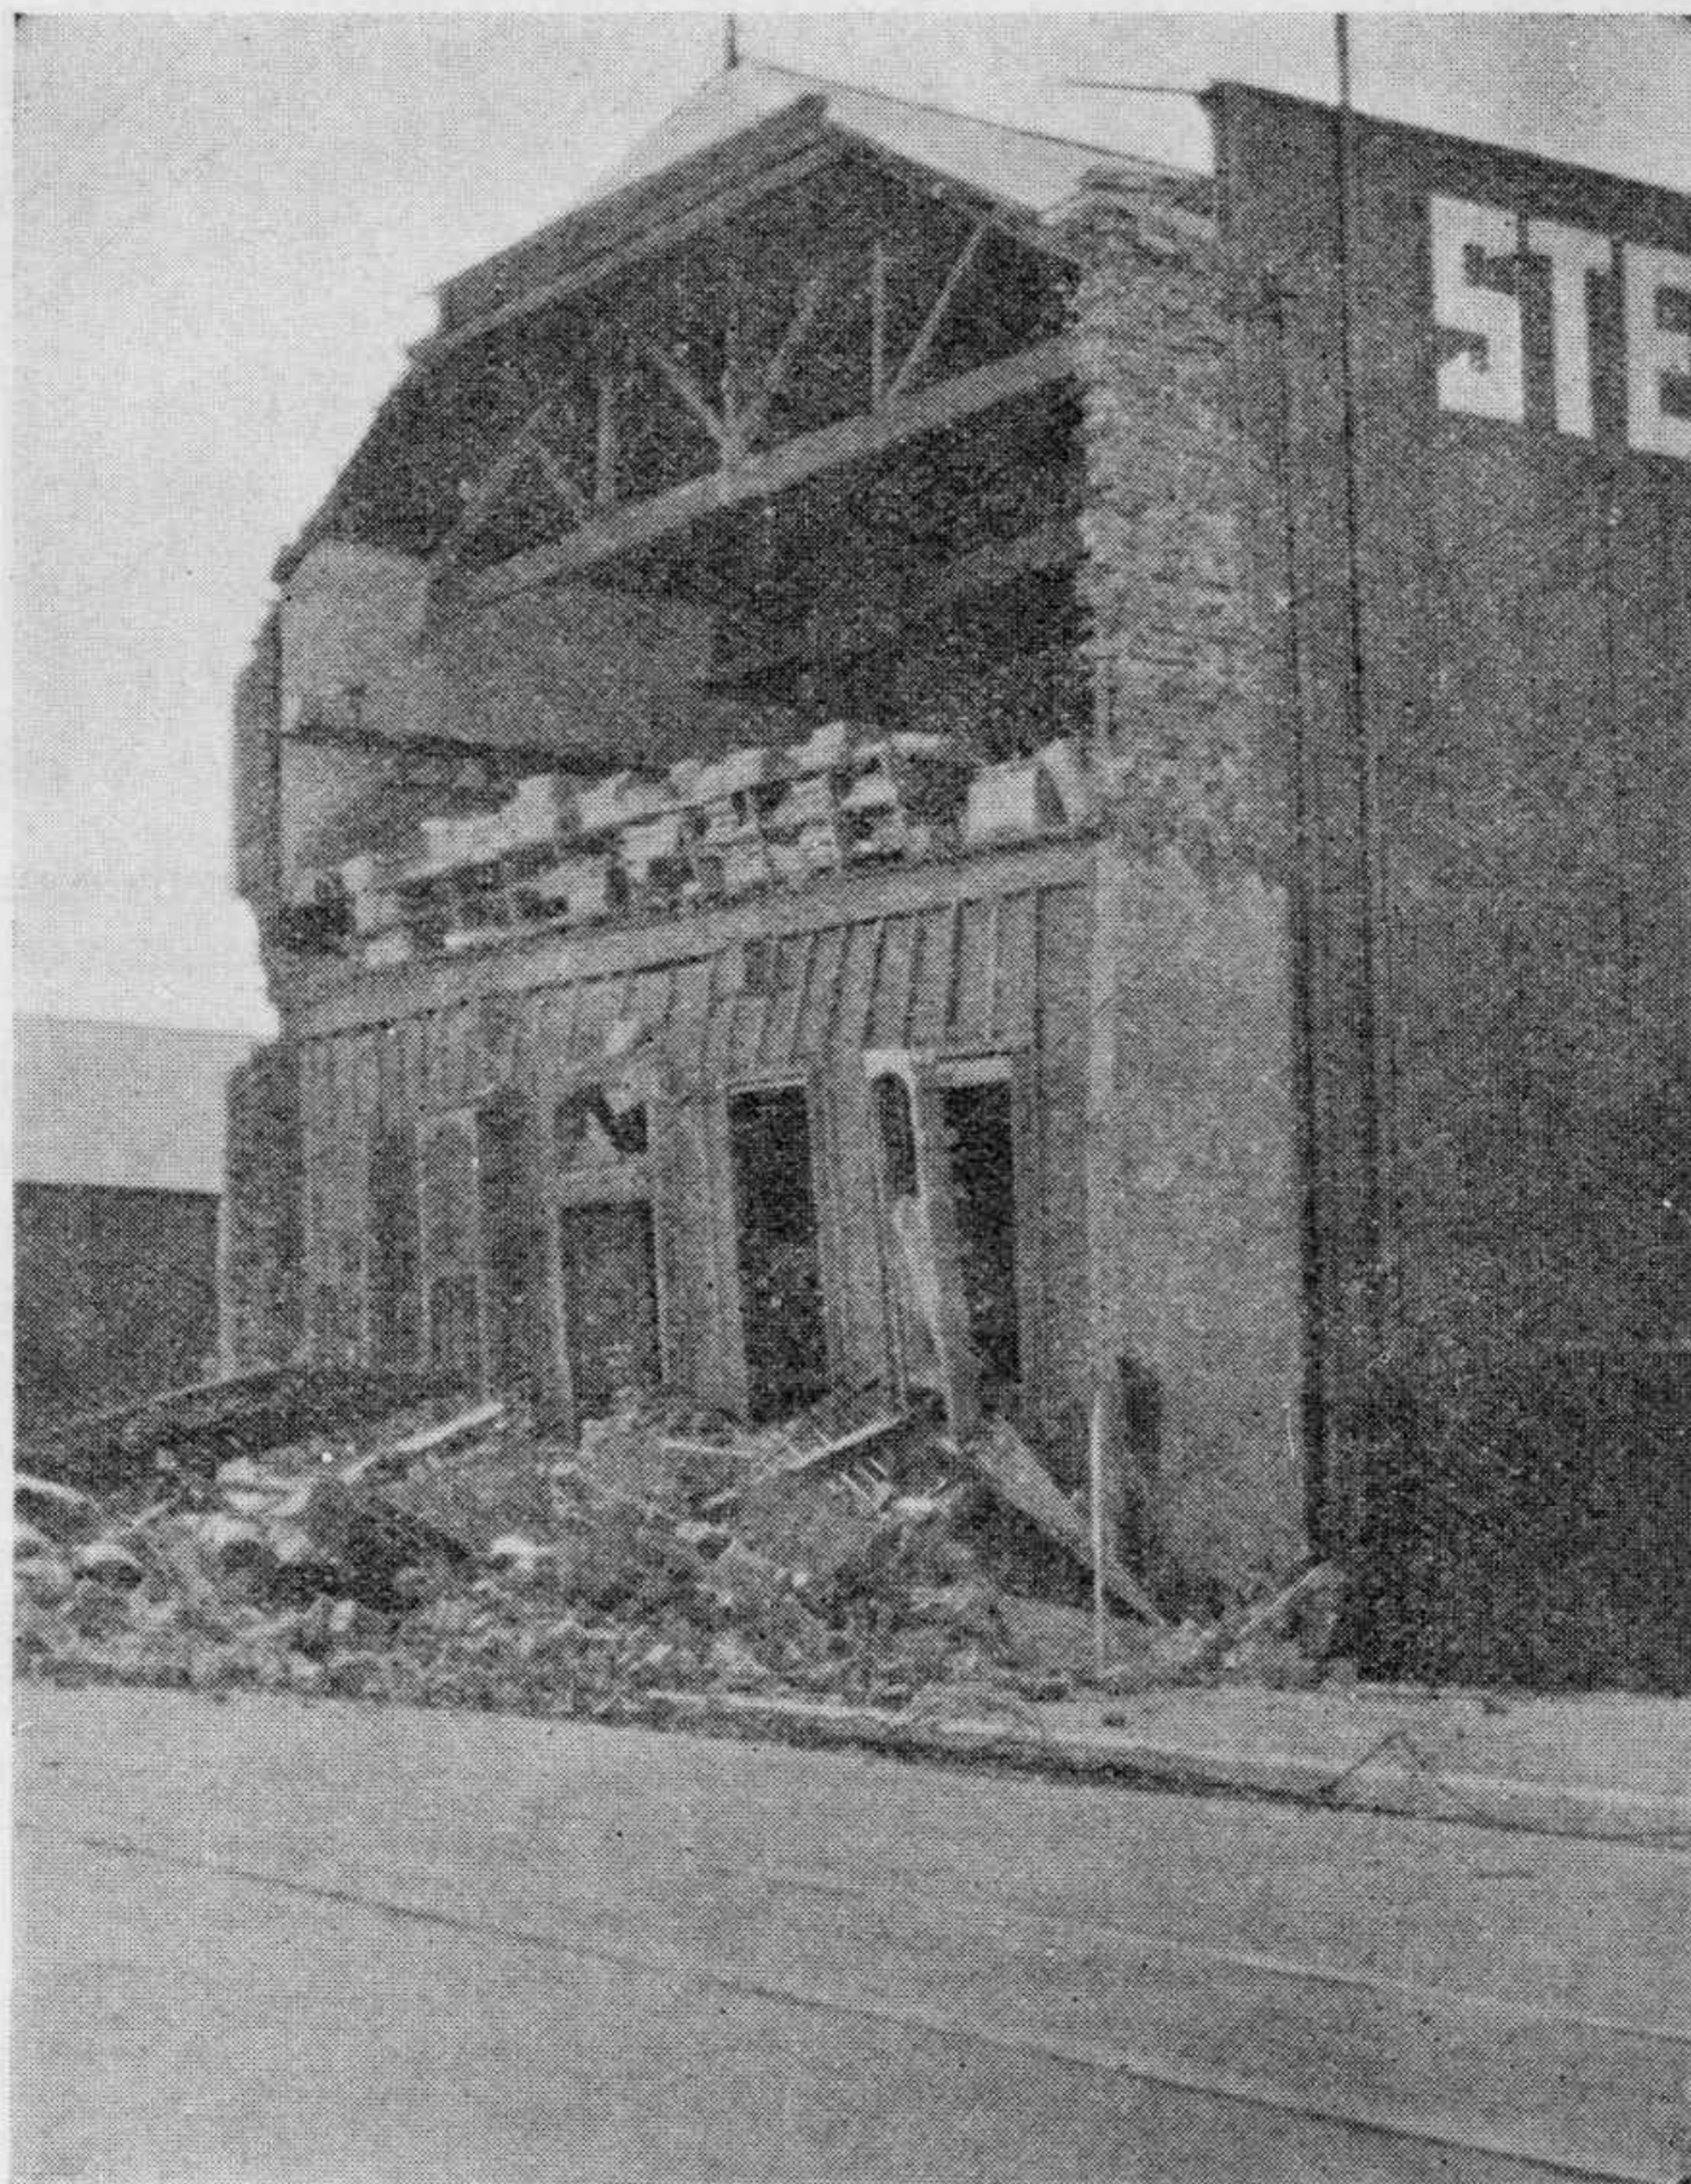
FIG. 3.—Collapse of brick façade inadequately tied to building.

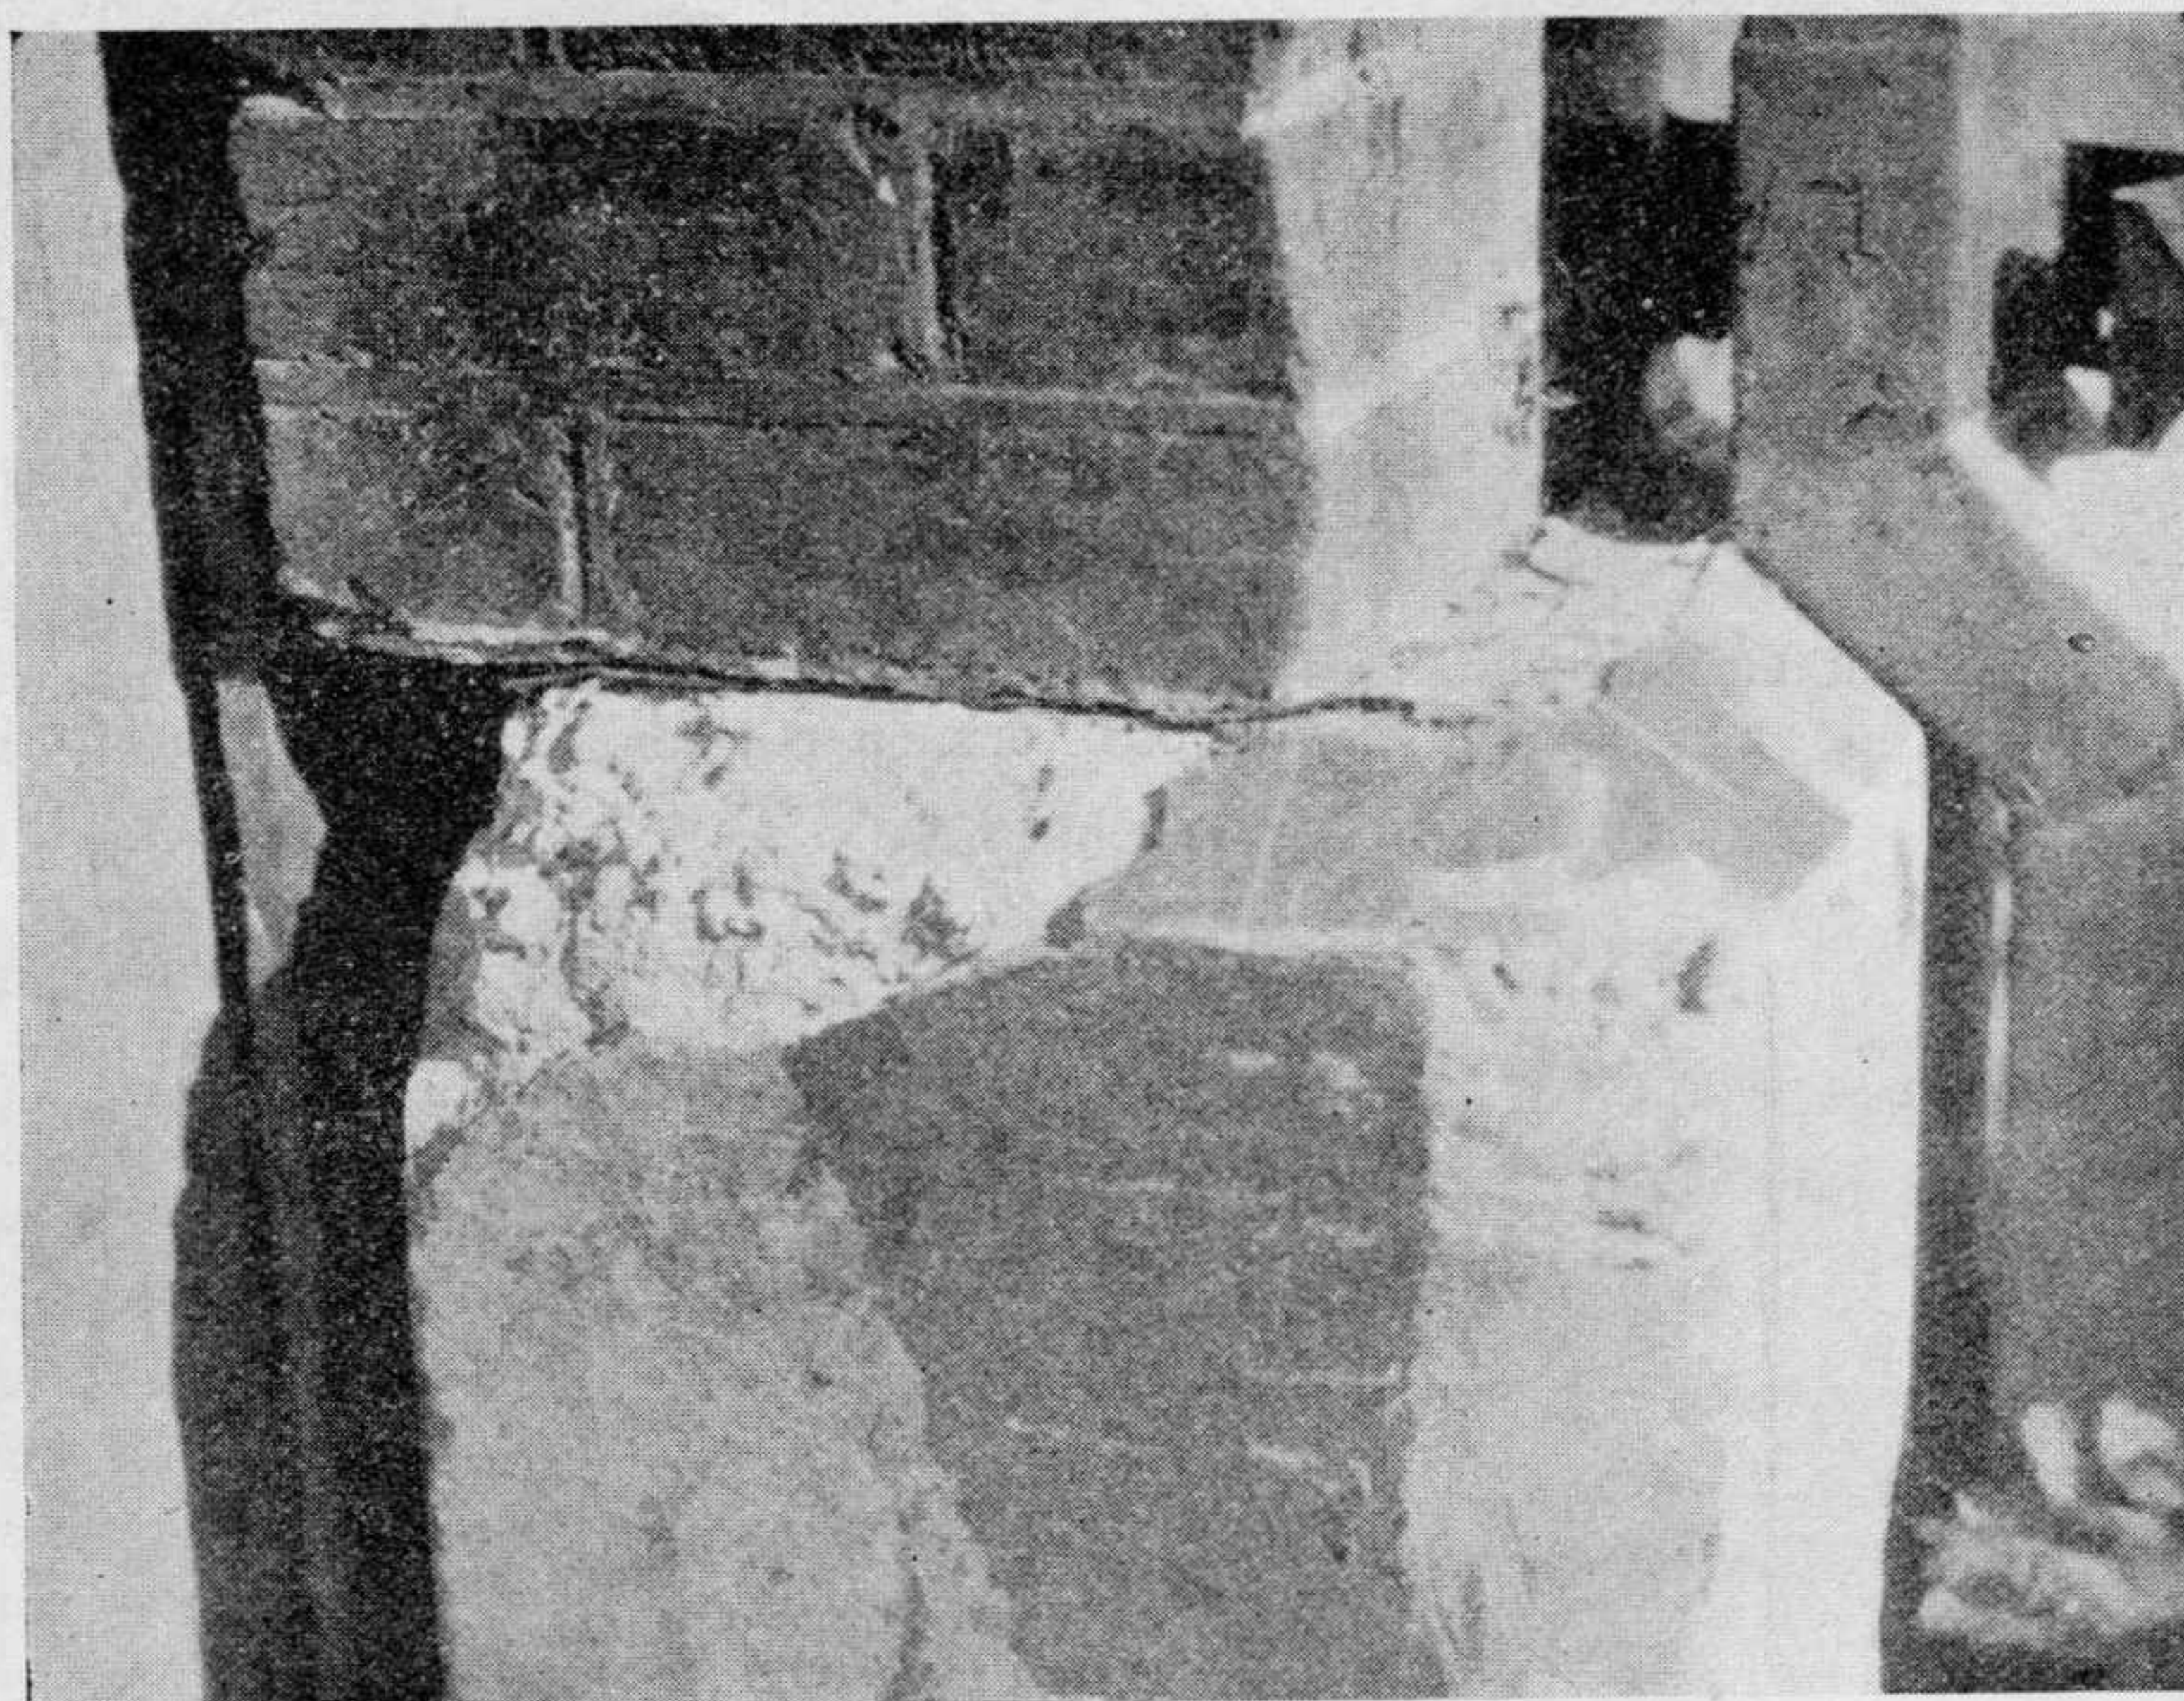
FIG. 4.—Movement along line of weakness located at bituminous damp-course.

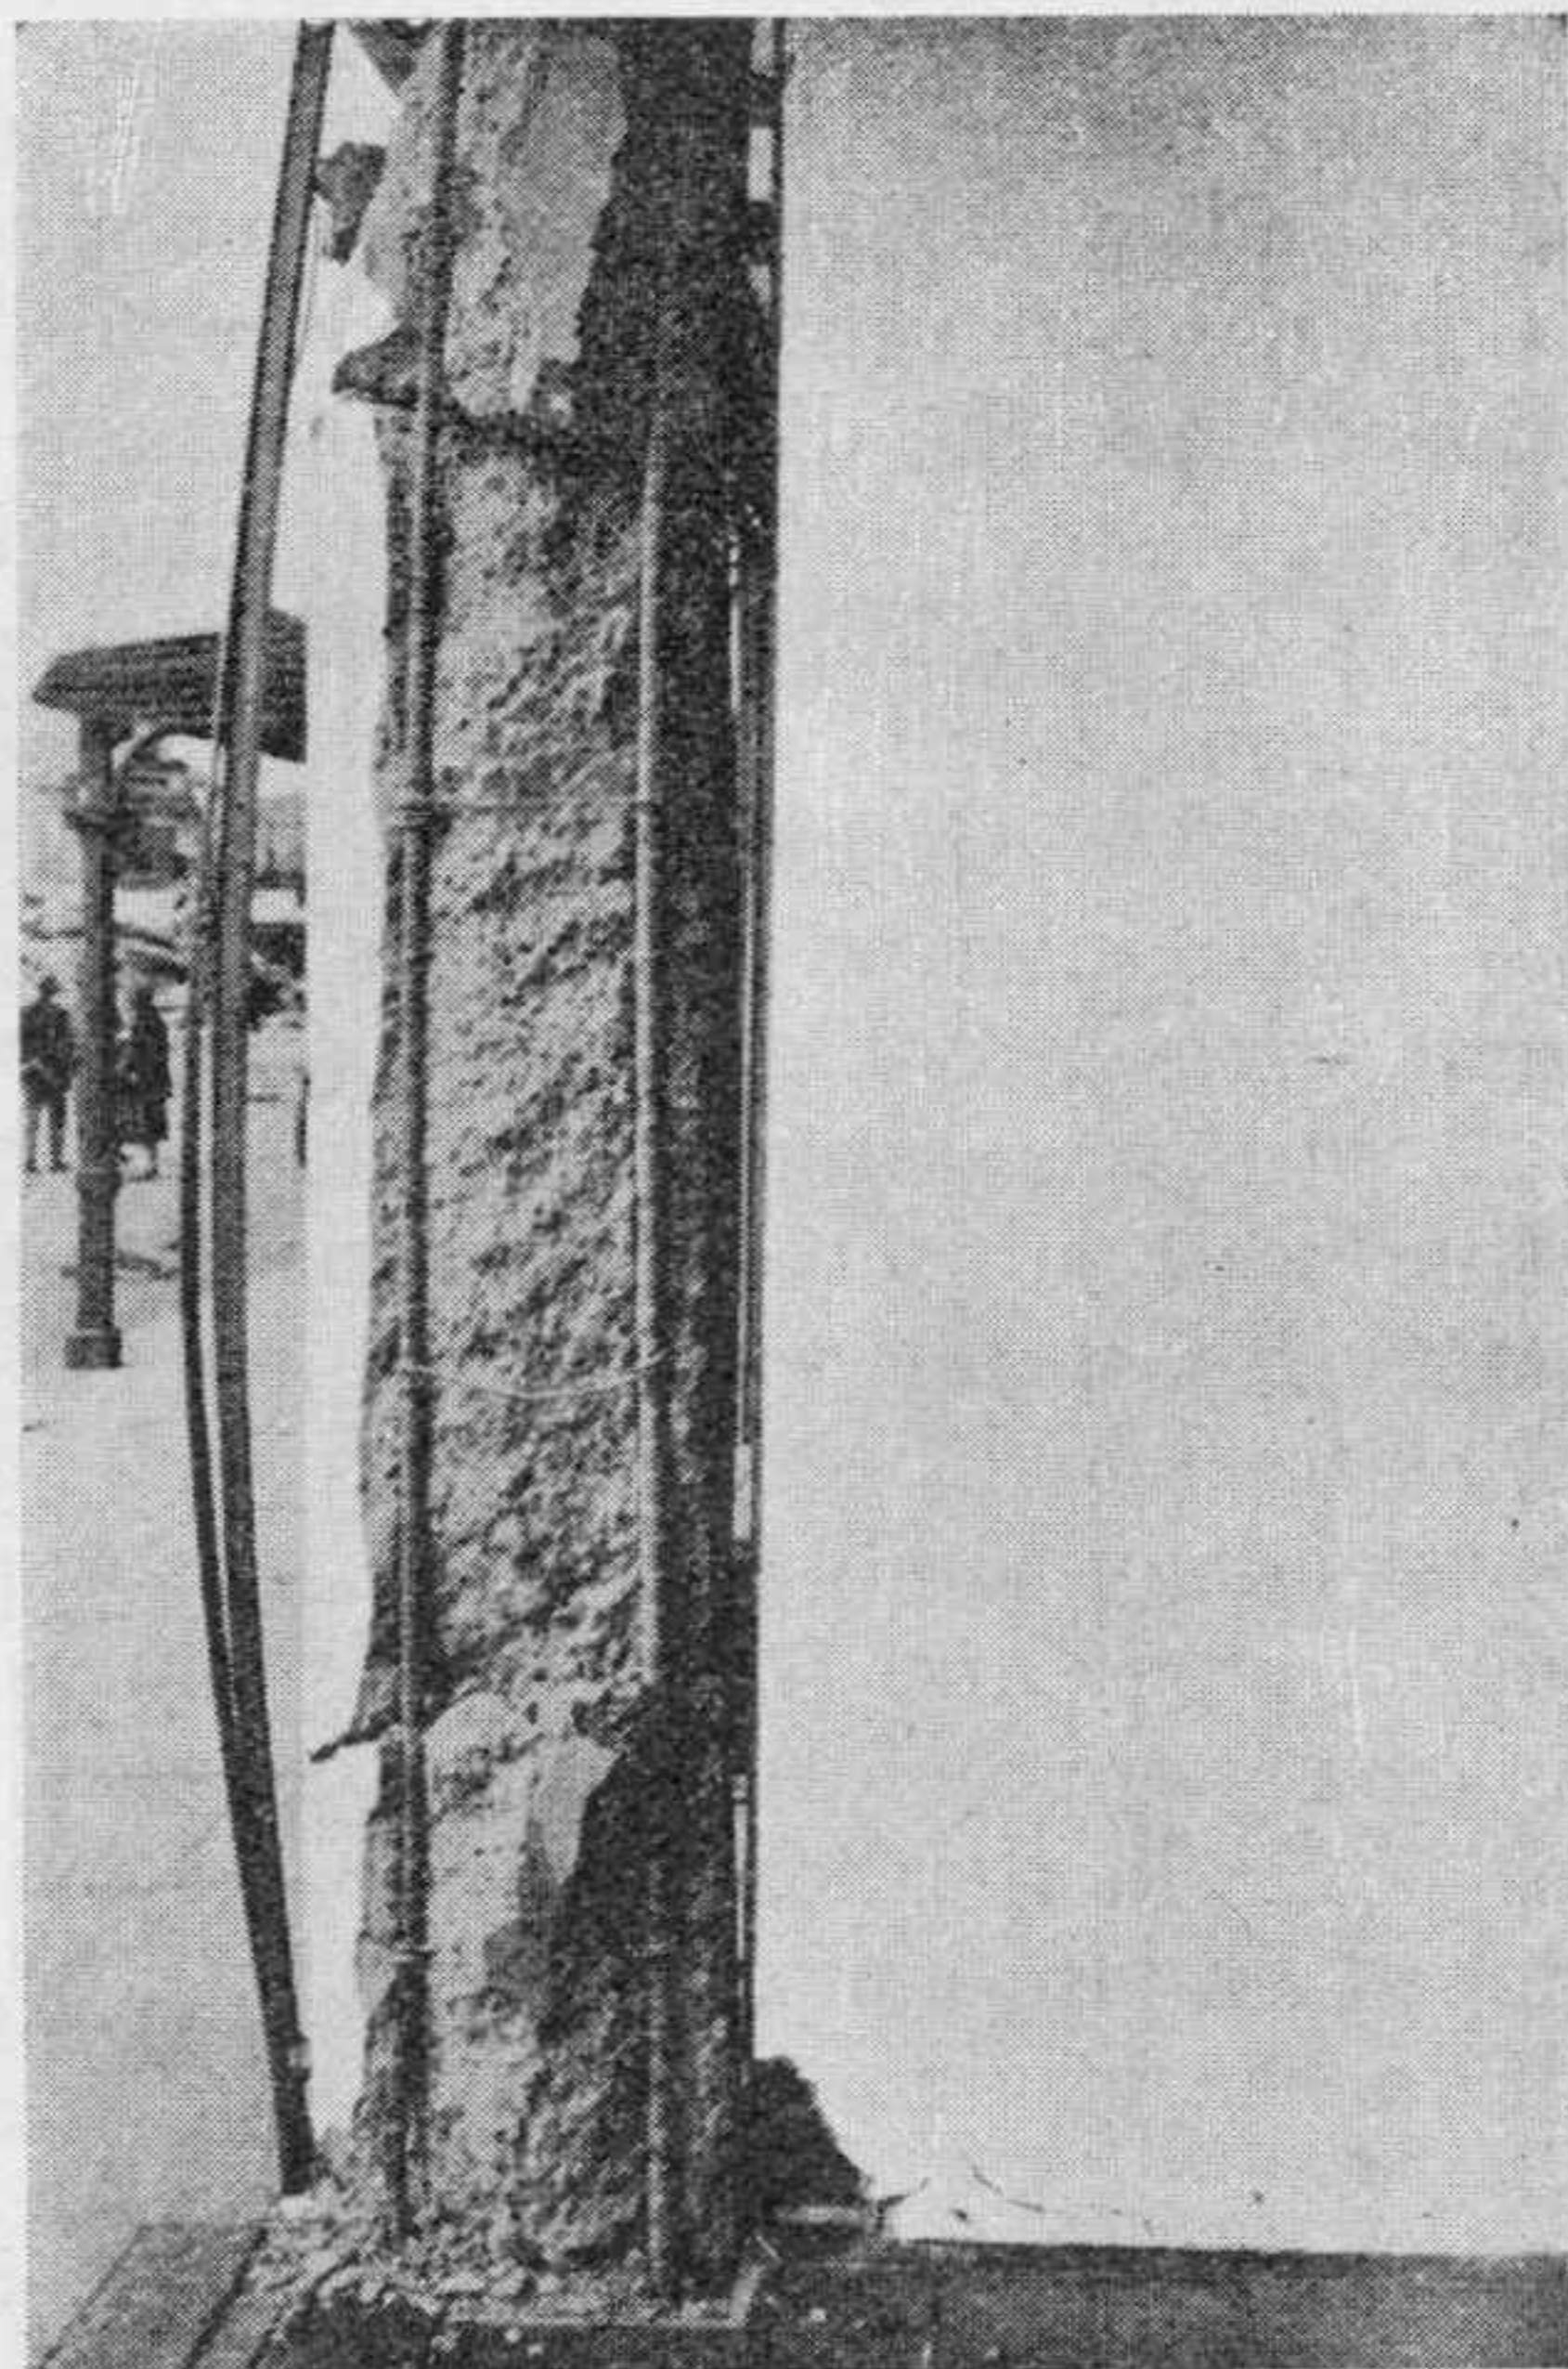
FIG. 5.—Typical failure of reinforced concrete column.
