N.Z. DEPARTMENT OF SCIENTIFIC AND INDUSTRIAL RESEARCH.

BULLETIN No. 43.

REPORT
OF THE
HAWKE'S BAY EARTHQUAKE
(3rd FEBRUARY, 1931).

**THE HAWKE'S BAY EARTHQUAKE OF
3rd FEBRUARY, 1931.**

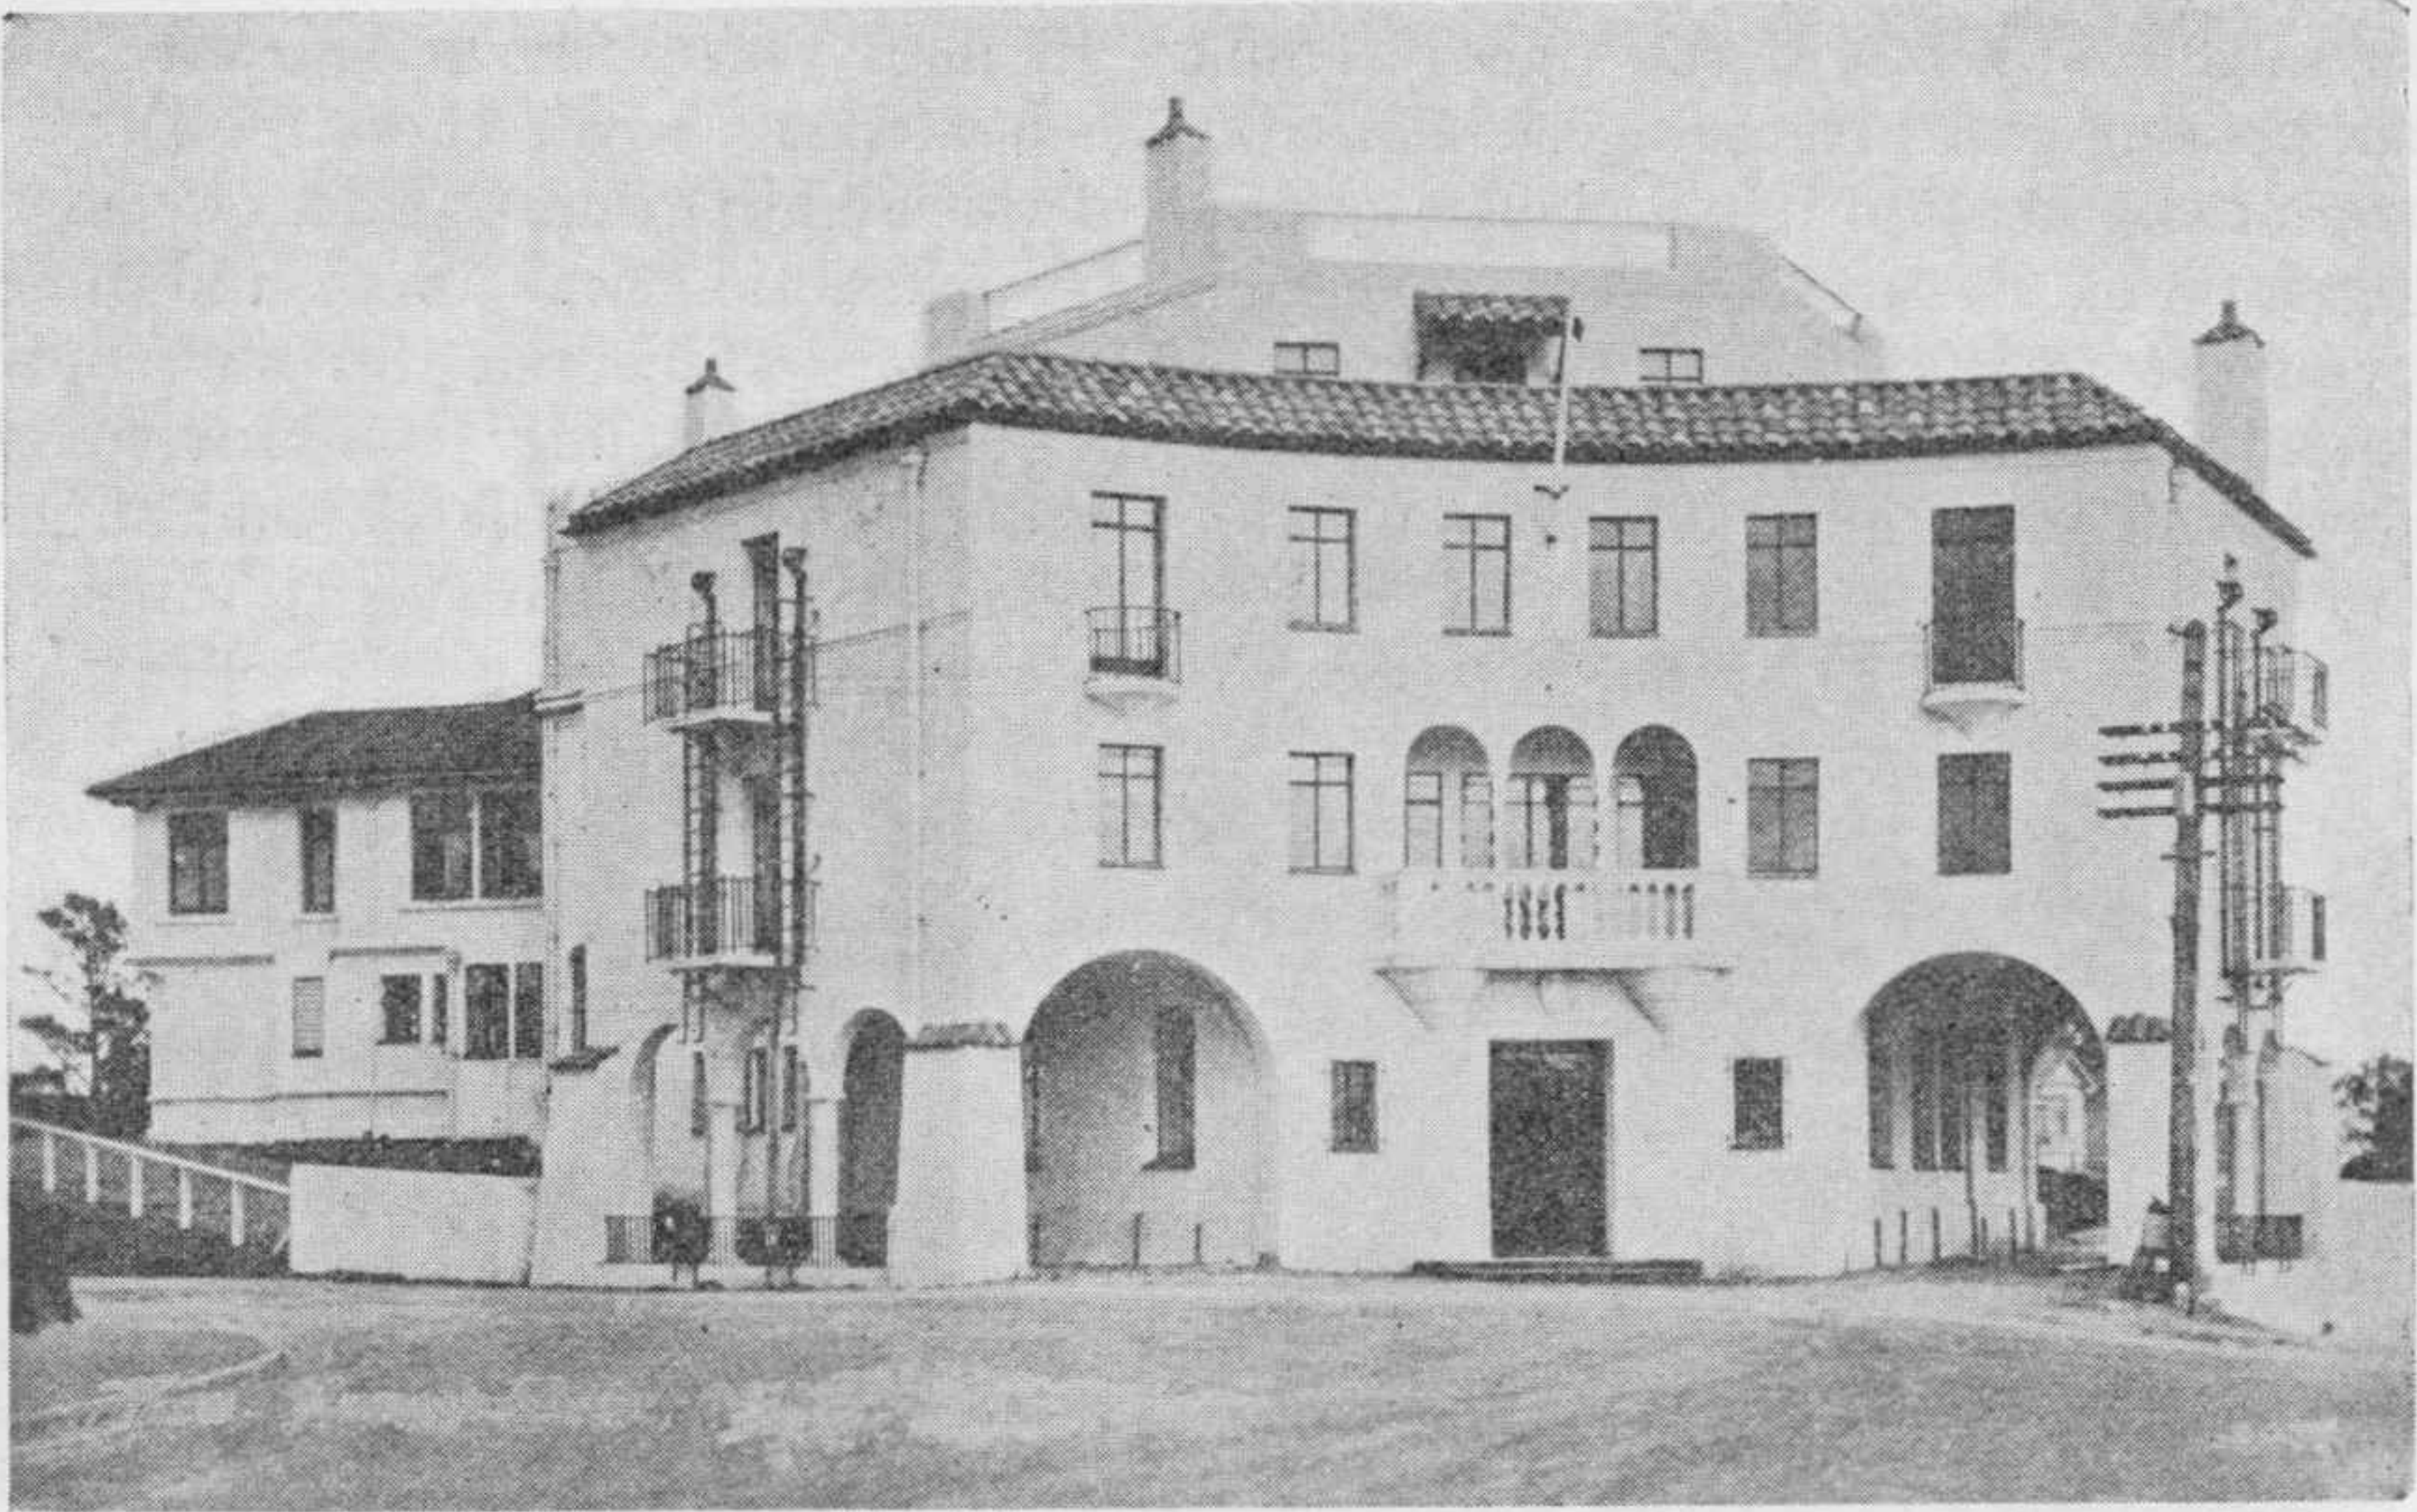
Outside the business area of Napier considerable damage occurred in some of the larger public buildings. The Hospital, situated on the western slopes of Scinde Island, was, unfortunately, the scene of one of the major tragedies of the earthquake, in that the three-storied Nurses' Home collapsed completely, entombing the night staff which was then asleep. Many of the wards at the Hospital were also so fractured by the movement that they had to be abandoned. The Park Island Home for the Aged, situated on the foothills to the west of Napier, collapsed in part and entombed a

FIG. 3.—Nurses' Home, Napier Hospital, as it appeared before the earthquake.

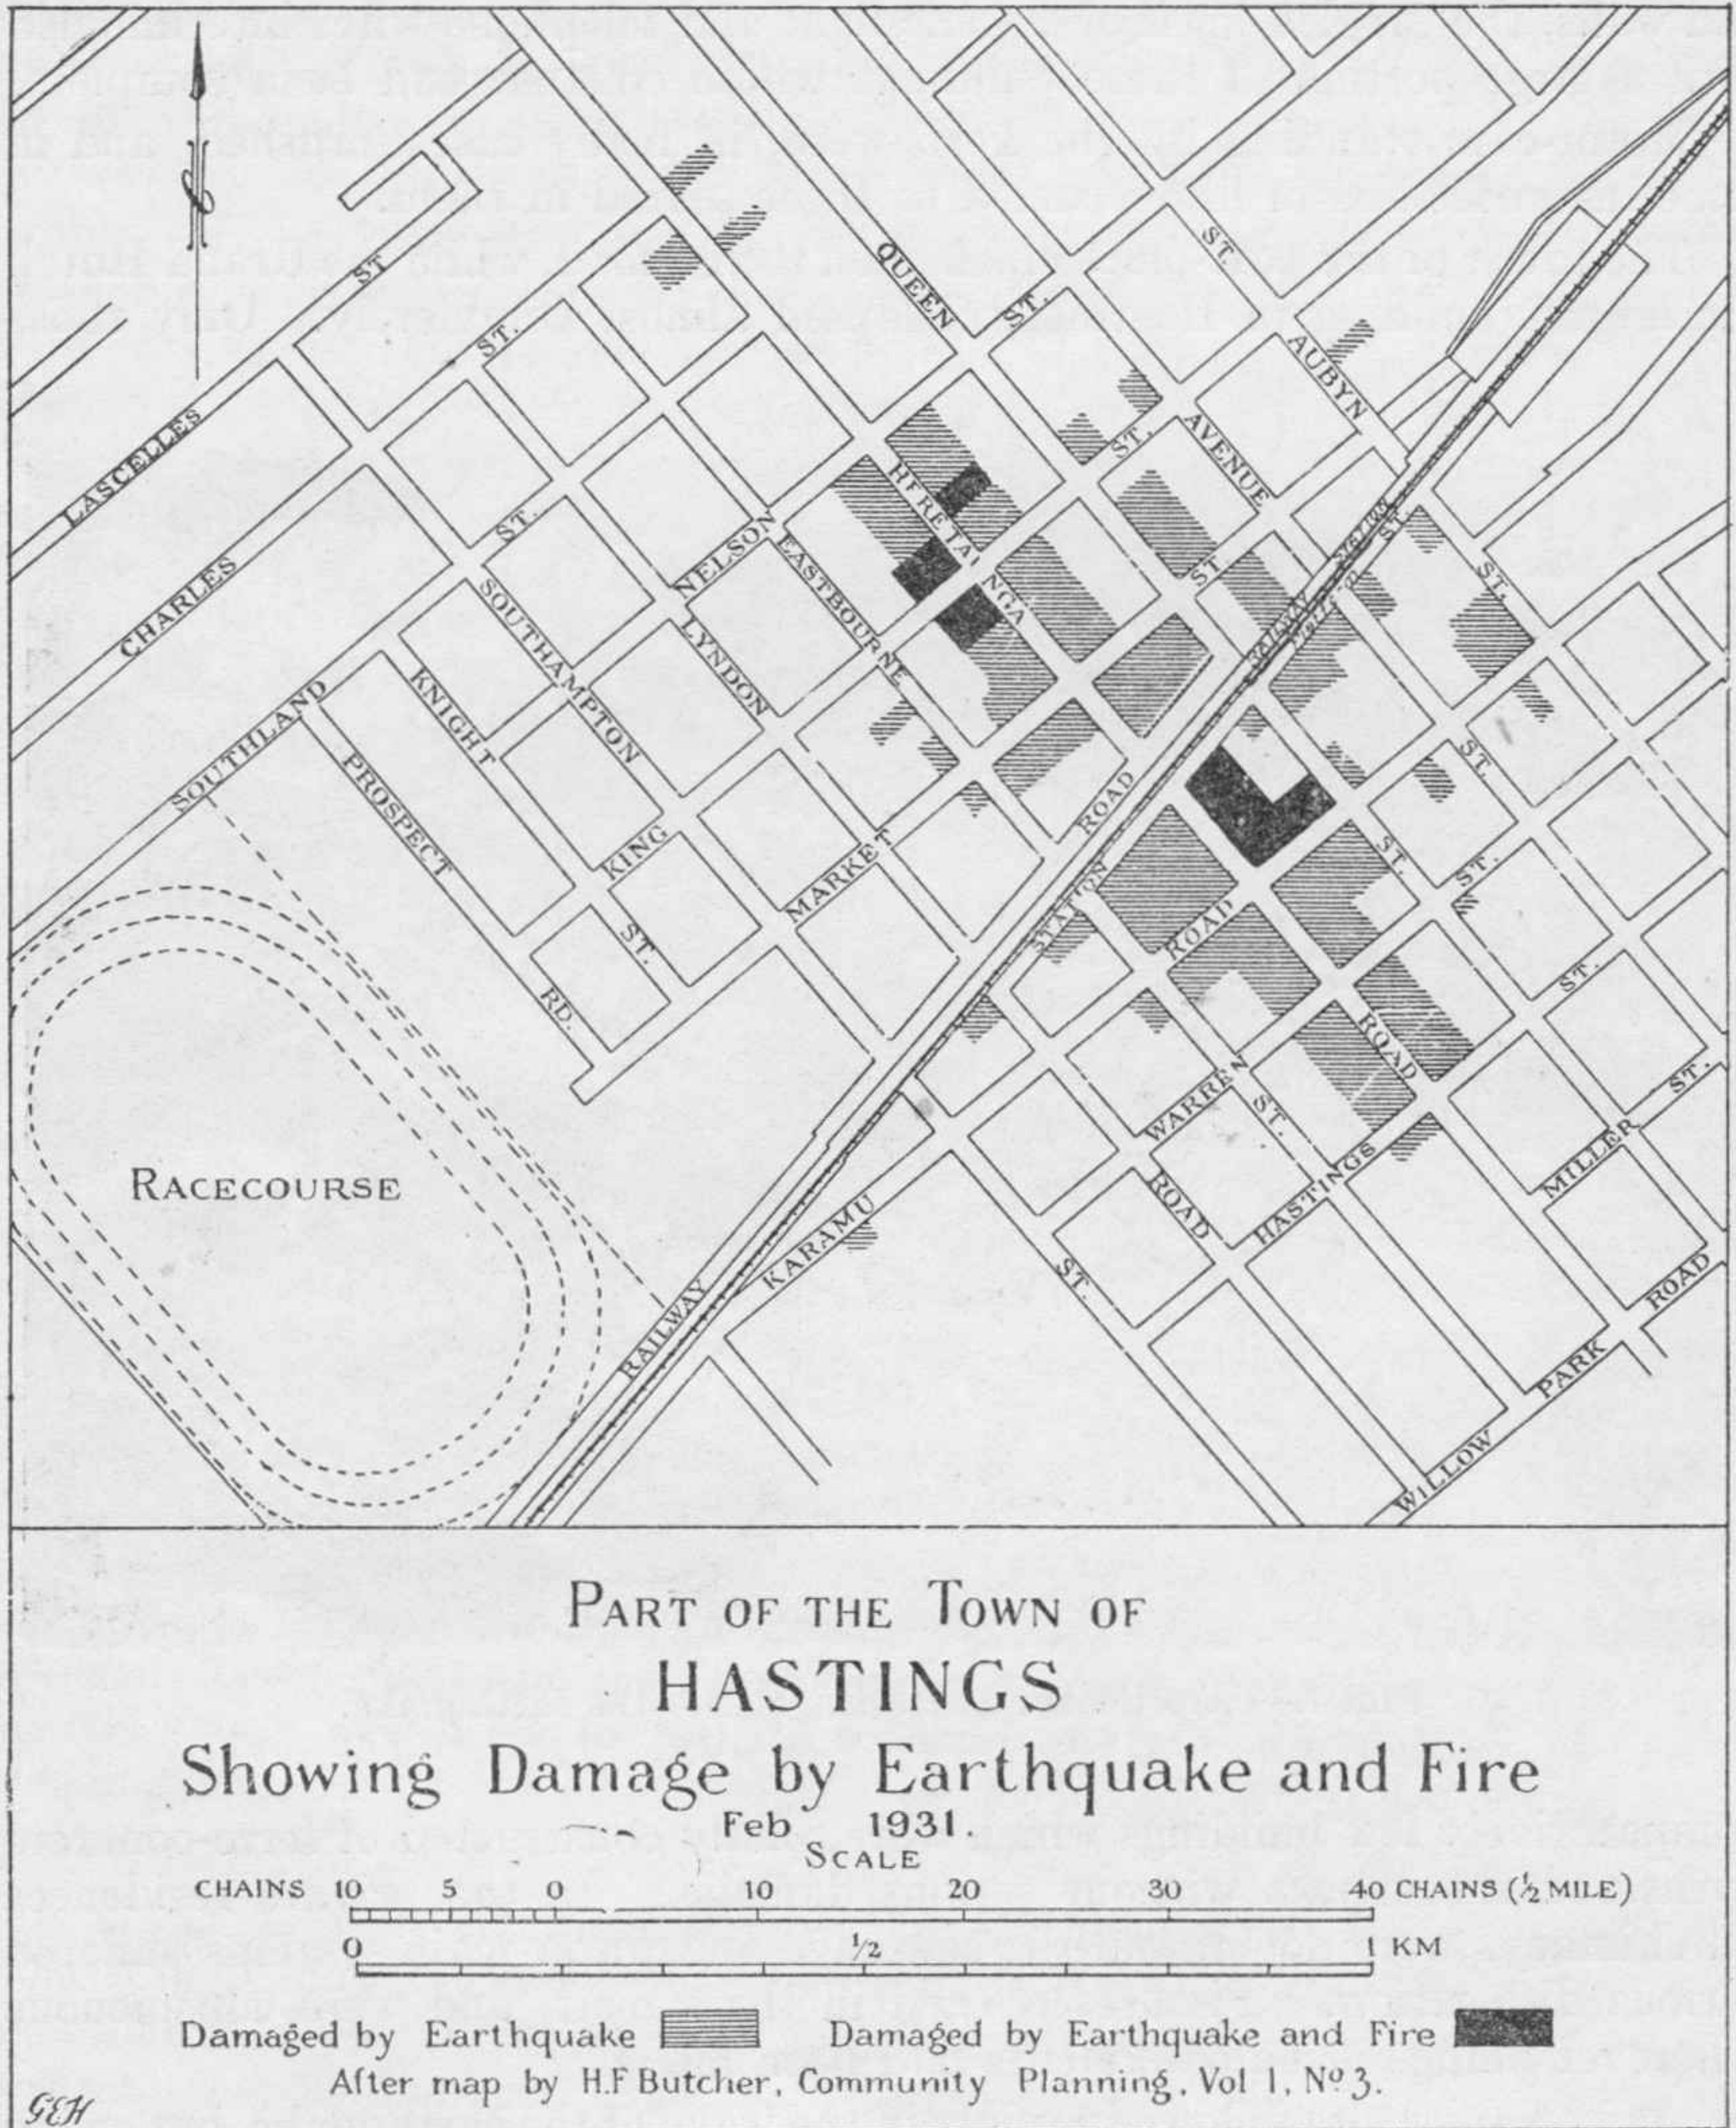
FIG. 8.

The accompanying map of Hastings indicates the business area which suffered destruction, and also the areas gutted by fire. (Fig. 8.)

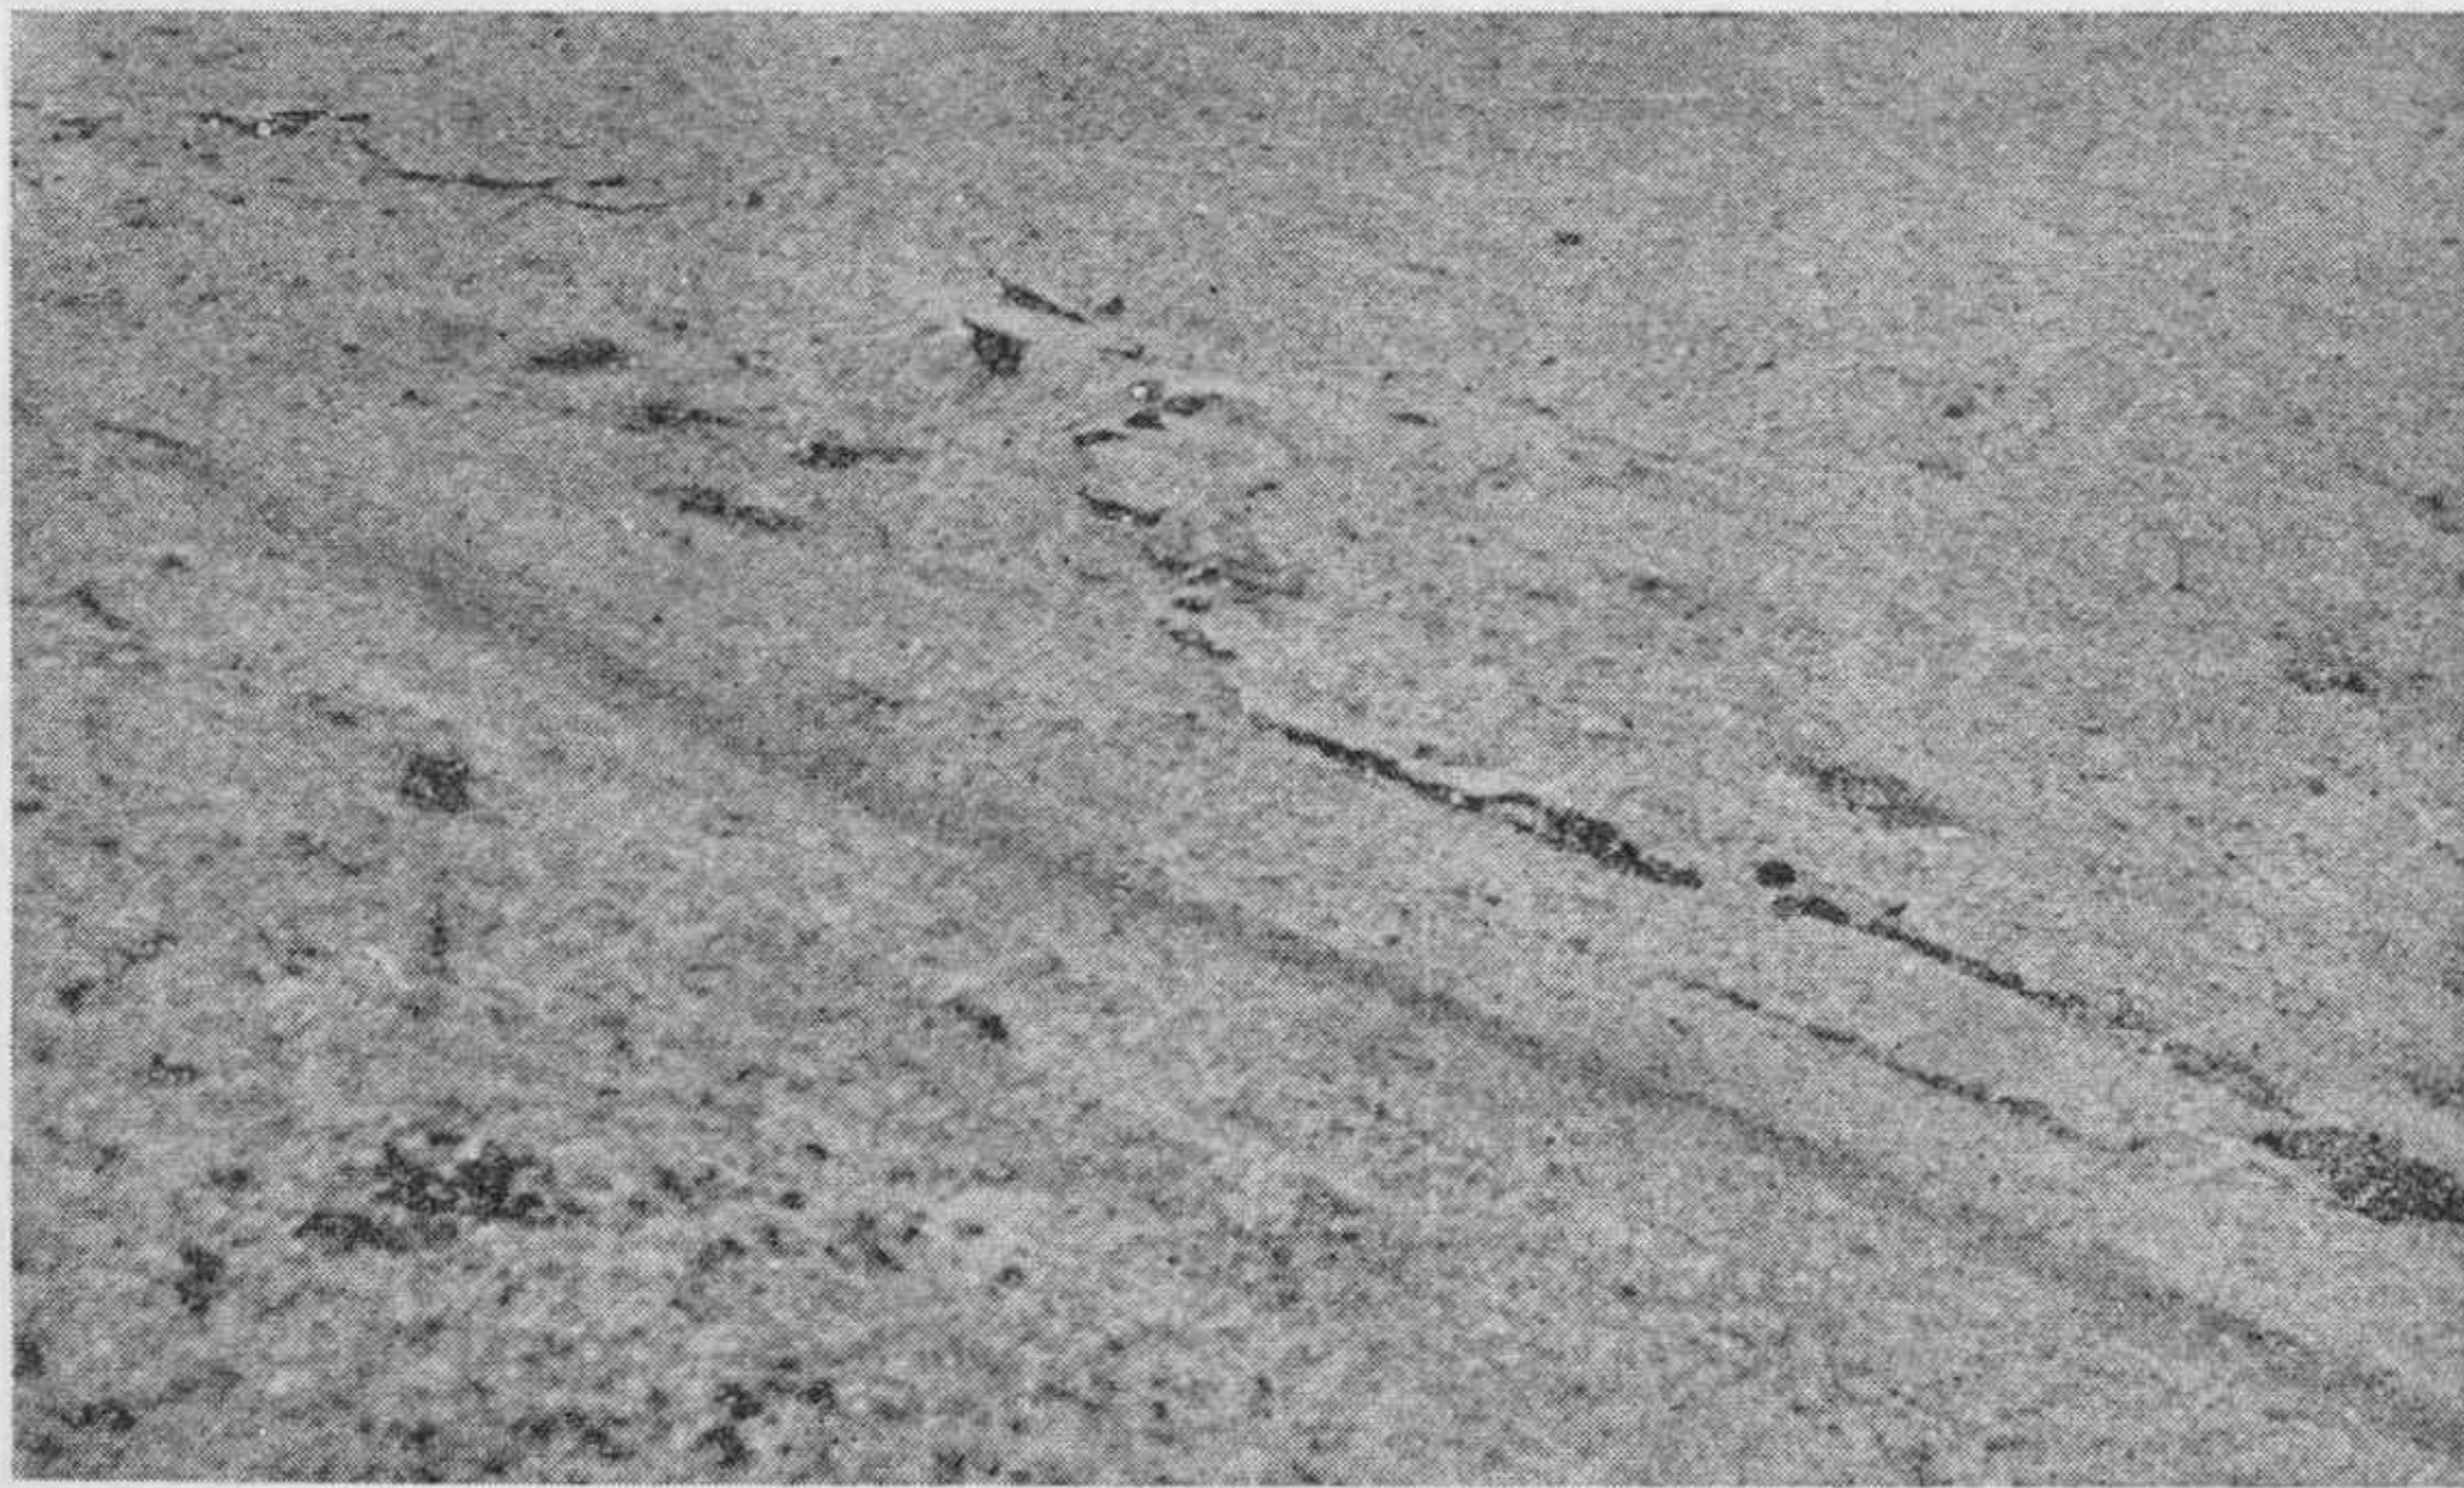
PLATE VI.—(a) Pressure ridge on flat ground a few chains east of main road 70 chains north-east from turn-off to Poukawa Railway-station. This small ridge shows an overthrust grading to a fold.

The ridges, rents, and cracks (Plate VI, *a*, *b*, and *c*) already referred to extend continuously along the Poukawa Valley for about six miles north-east from Lake Poukawa. The ridges are obviously due to the shortening of the surface, and resemble the pressure ridges formed at the toe of a surface slump. Like them also they usually occur at the foot of a slope, but their continuity in a general direction for miles, and the fact that in most places no gaping cracks occur higher up the slope, show that they are not mere

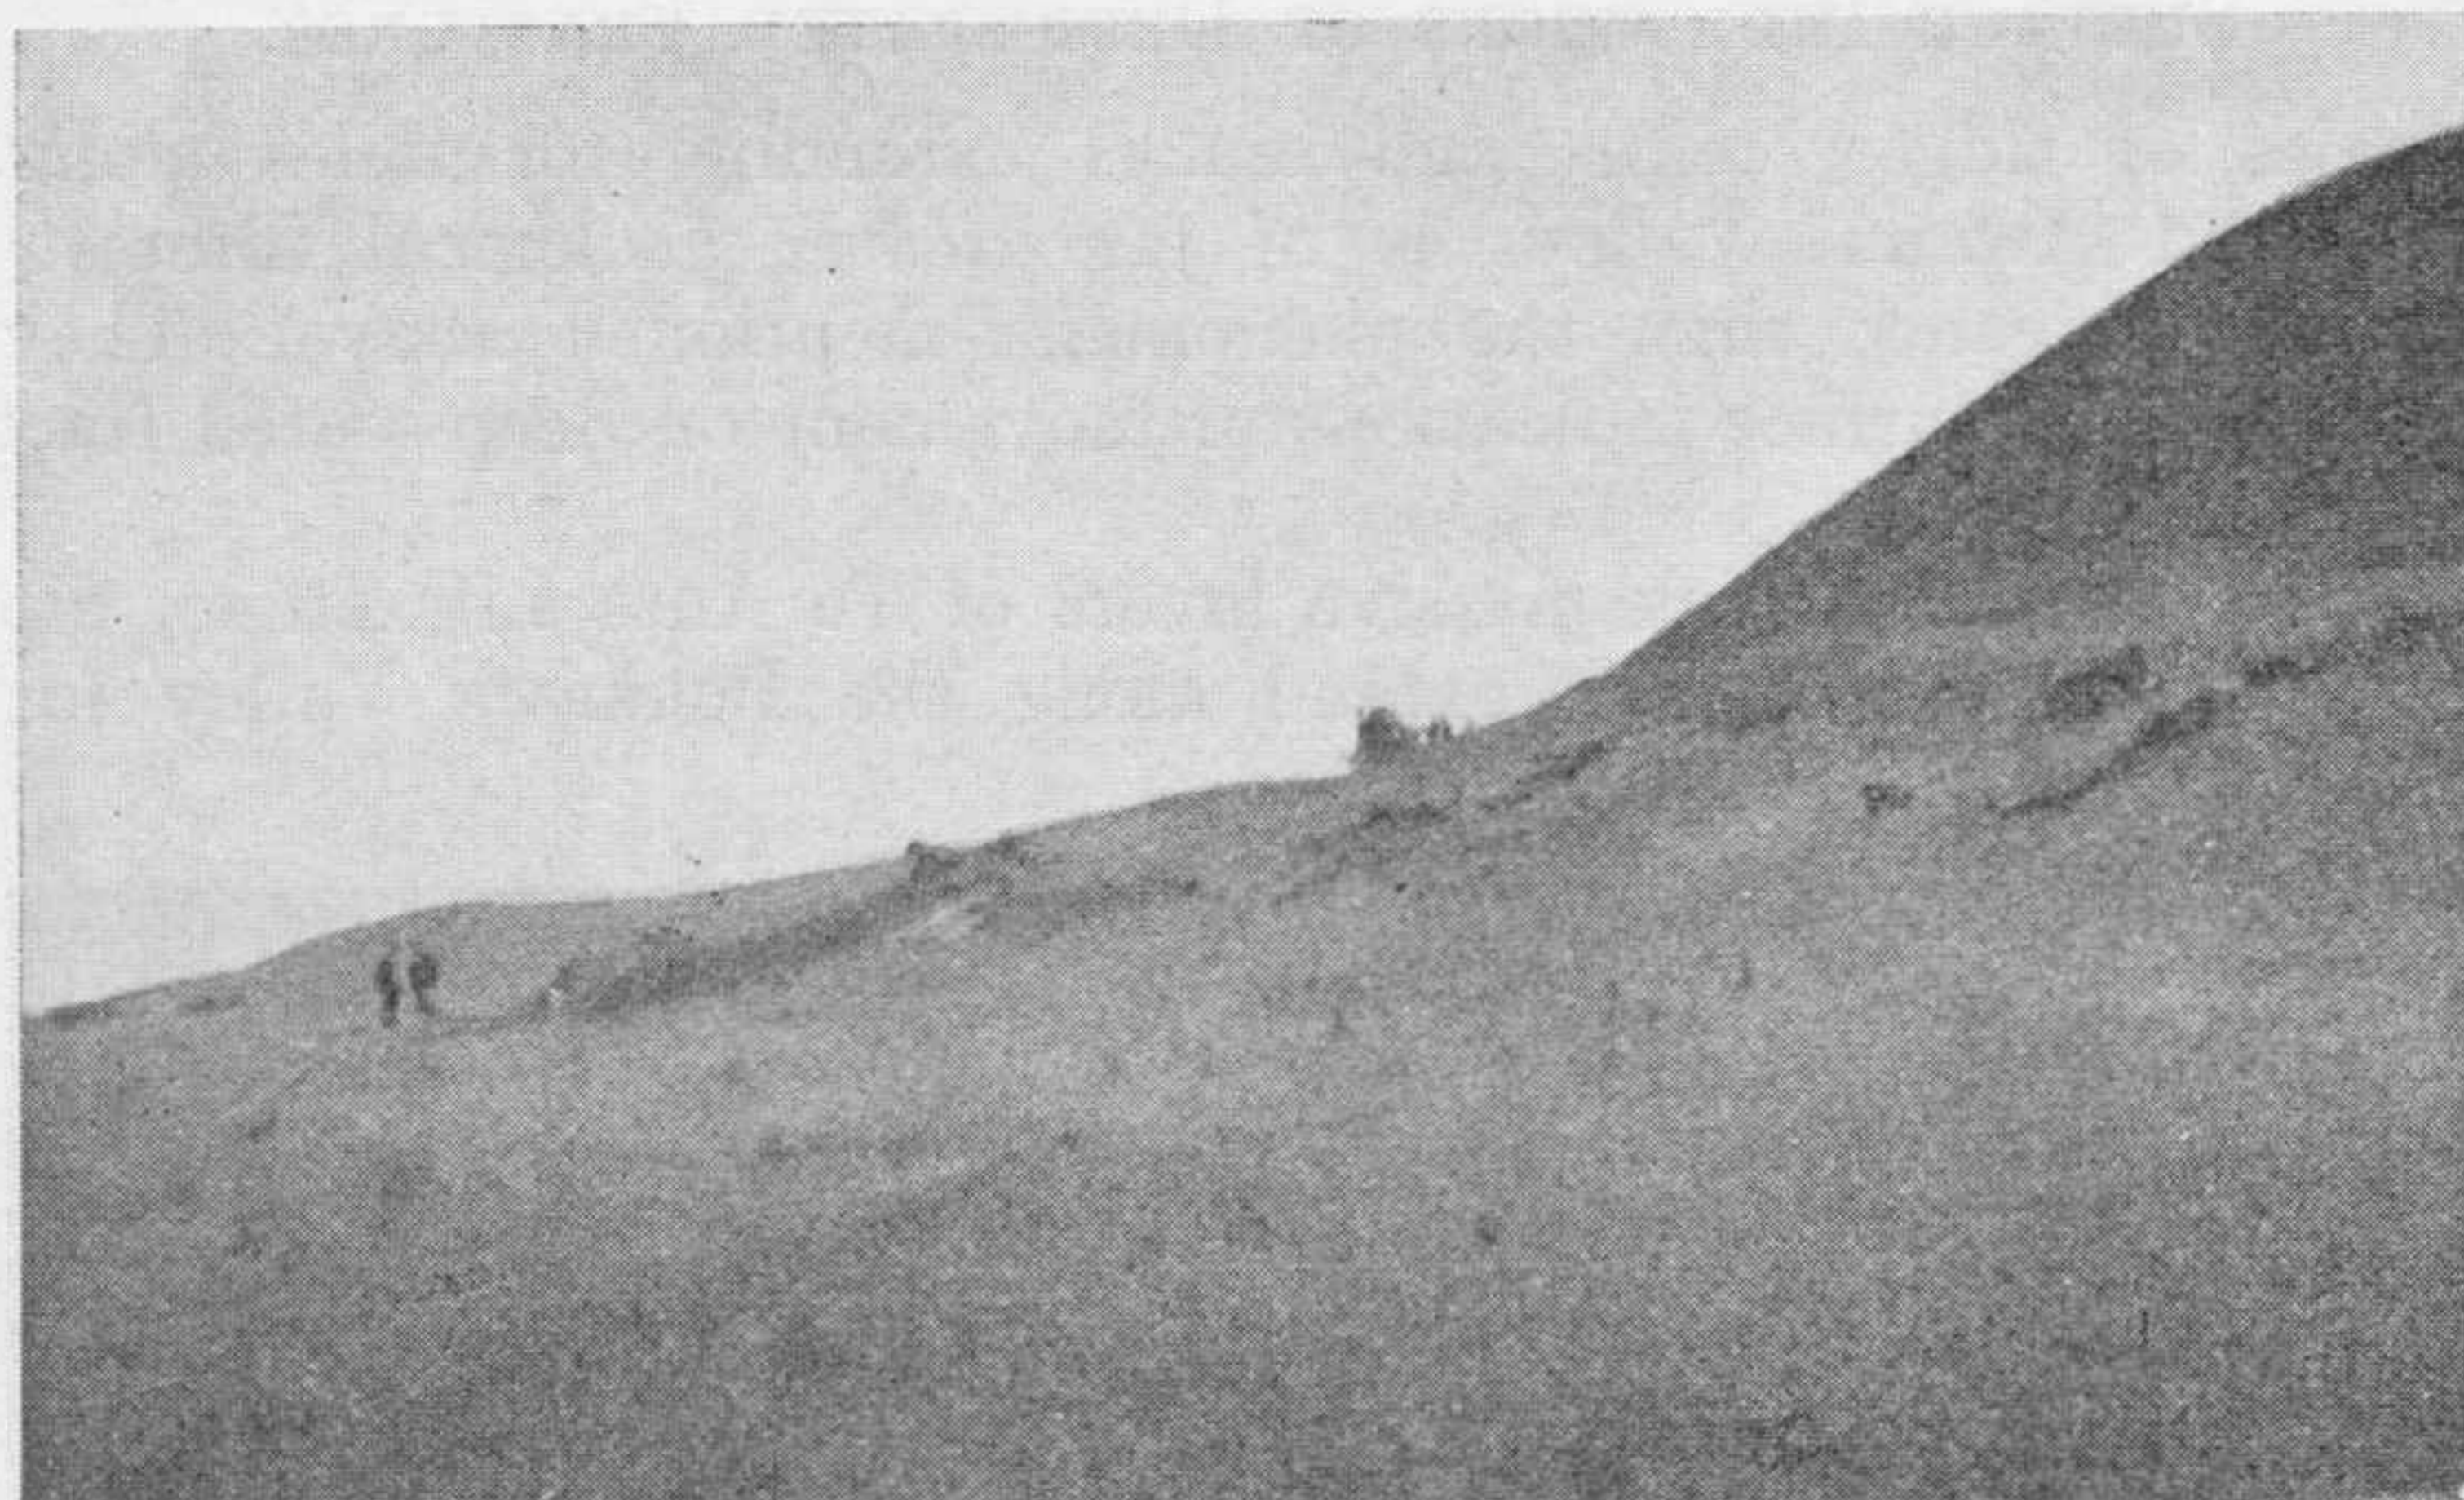
PLATE VI.—(b) Pressure ridge, Poukawa Valley, 60 chains north-east of Poukawa Railway-station.

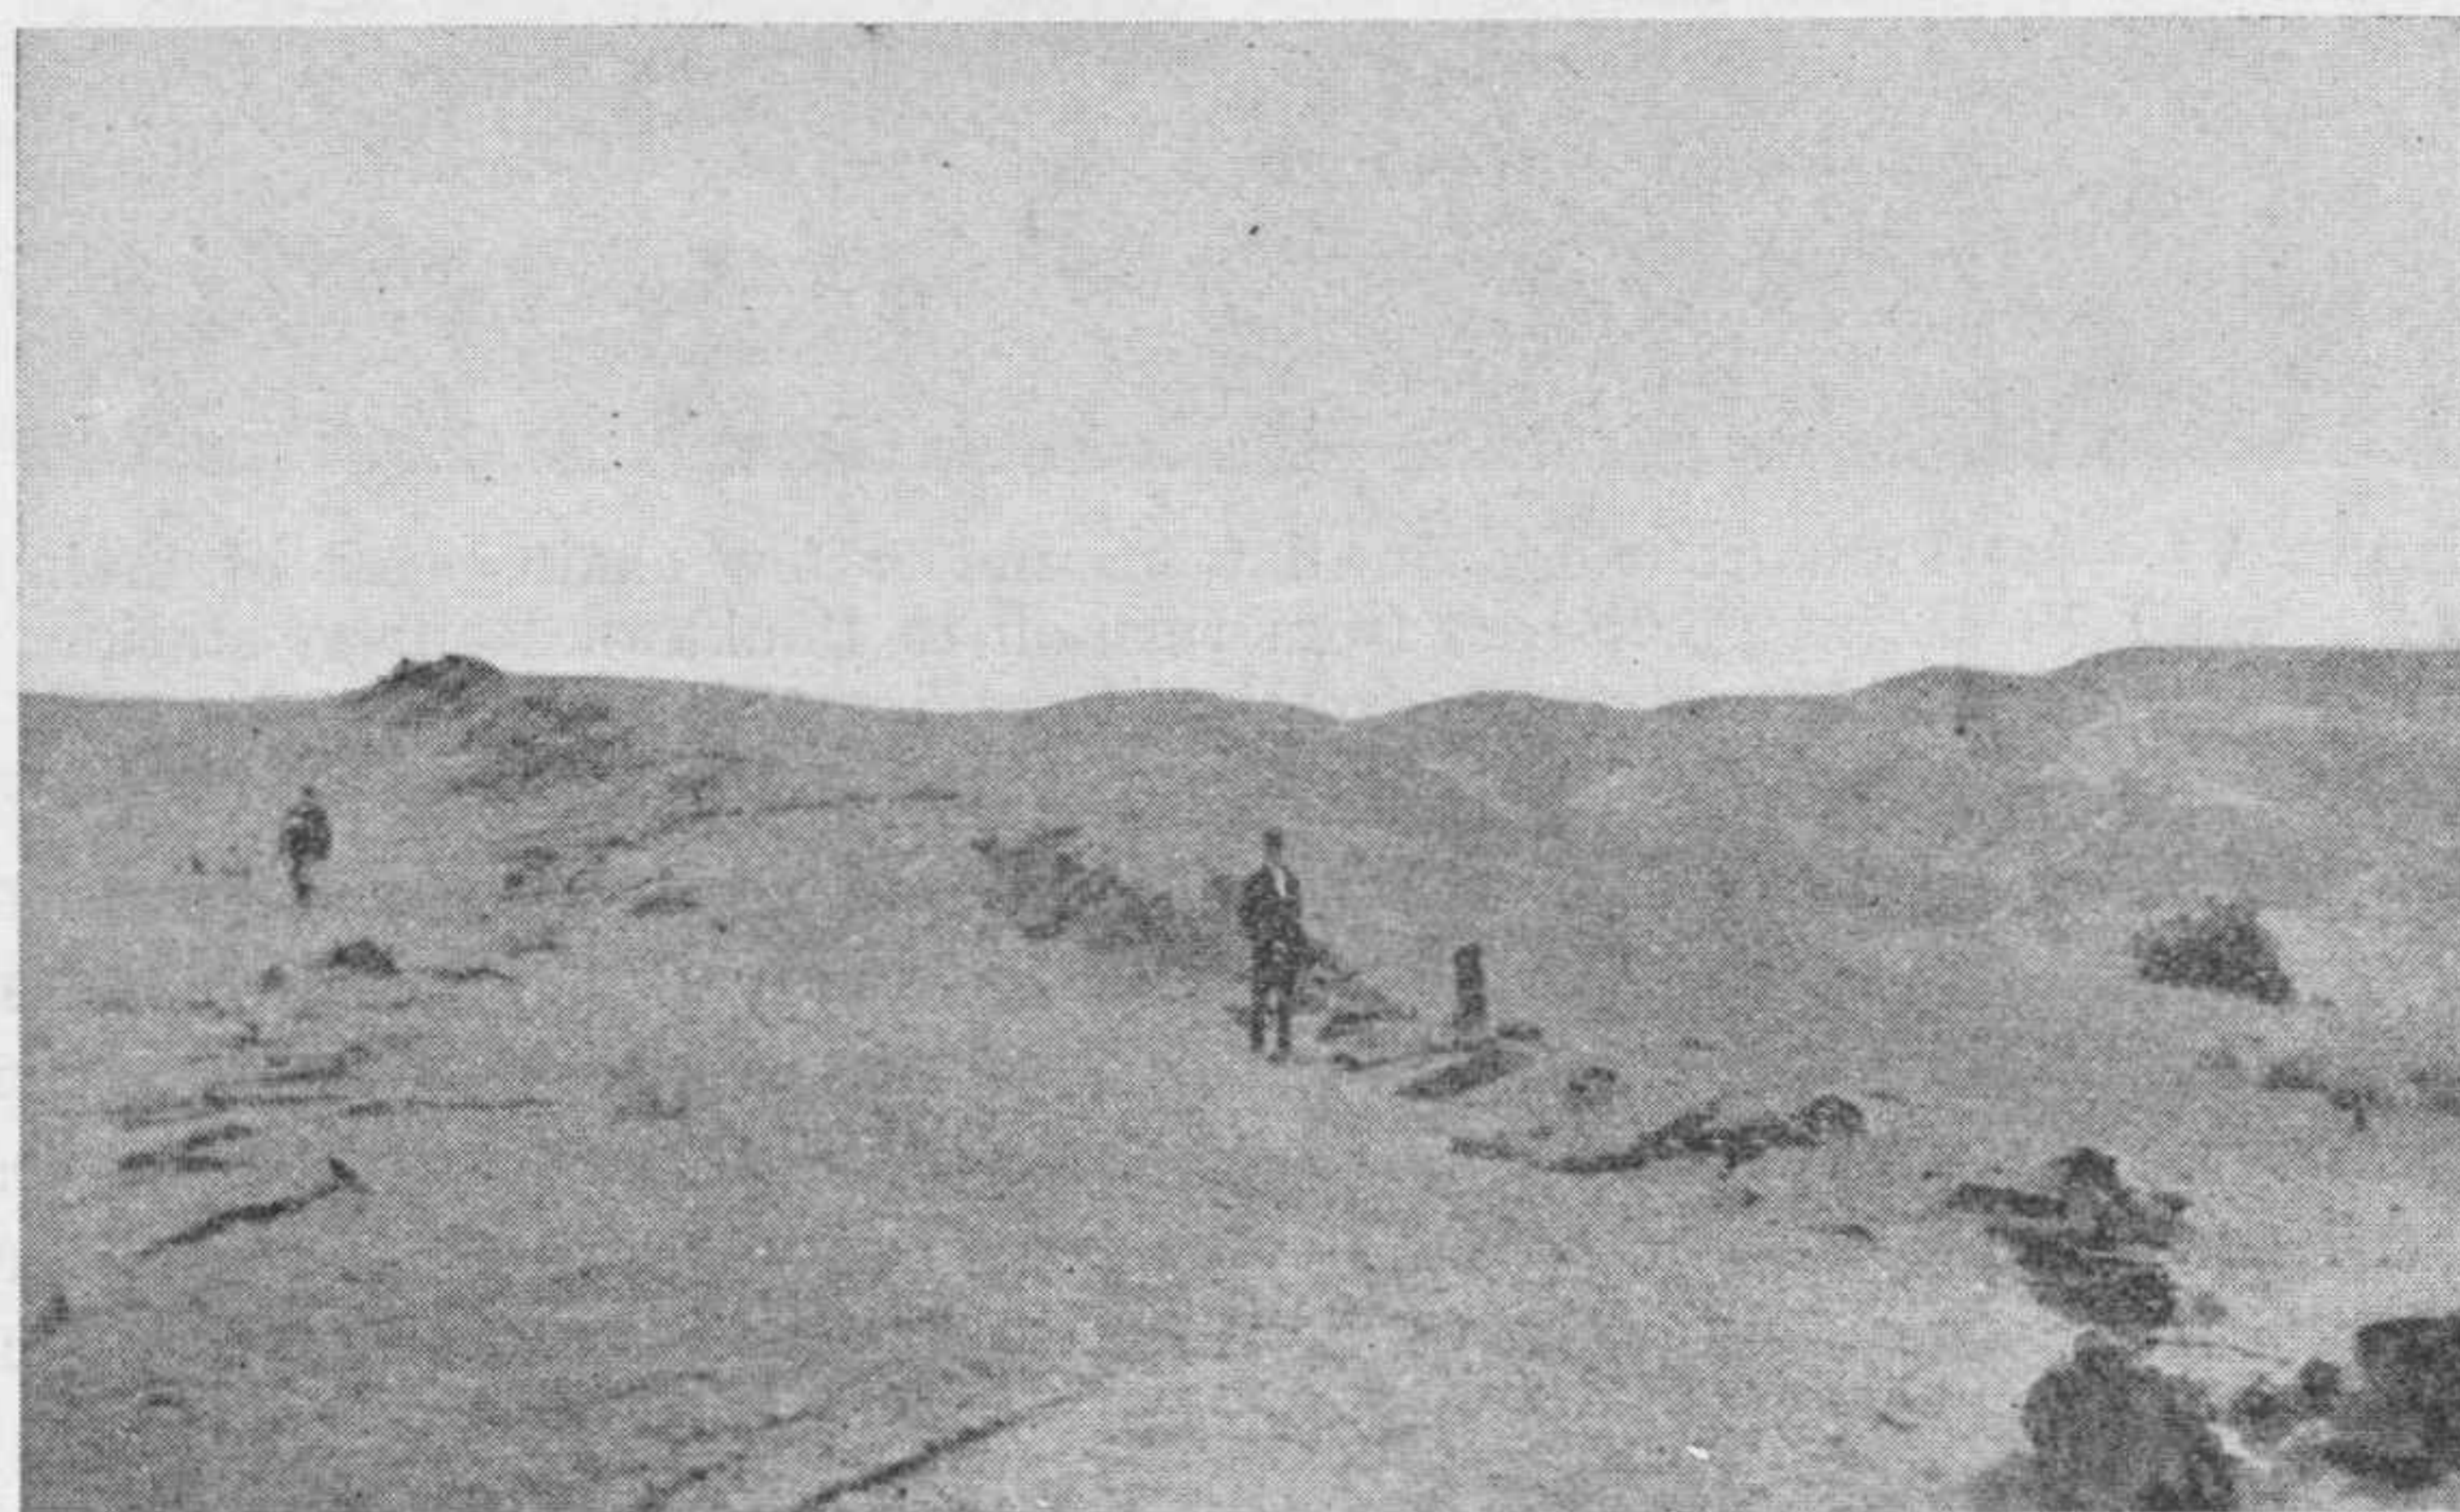
PLATE VI.—(c) East-west part of fracture, Poukawa Valley.

that, parallel among themselves, follow the fracture *en echelon* obliquely transverse to it. These fissures strike south-east, whereas the dislocation as a whole strikes east, and, as the ground on the north side has moved eastward relatively to that on the south, the fissures gape and the strips of turf between, compressed lengthwise by one component of the horizontal movement, are confusedly folded and overthrust (Plate VI, c).

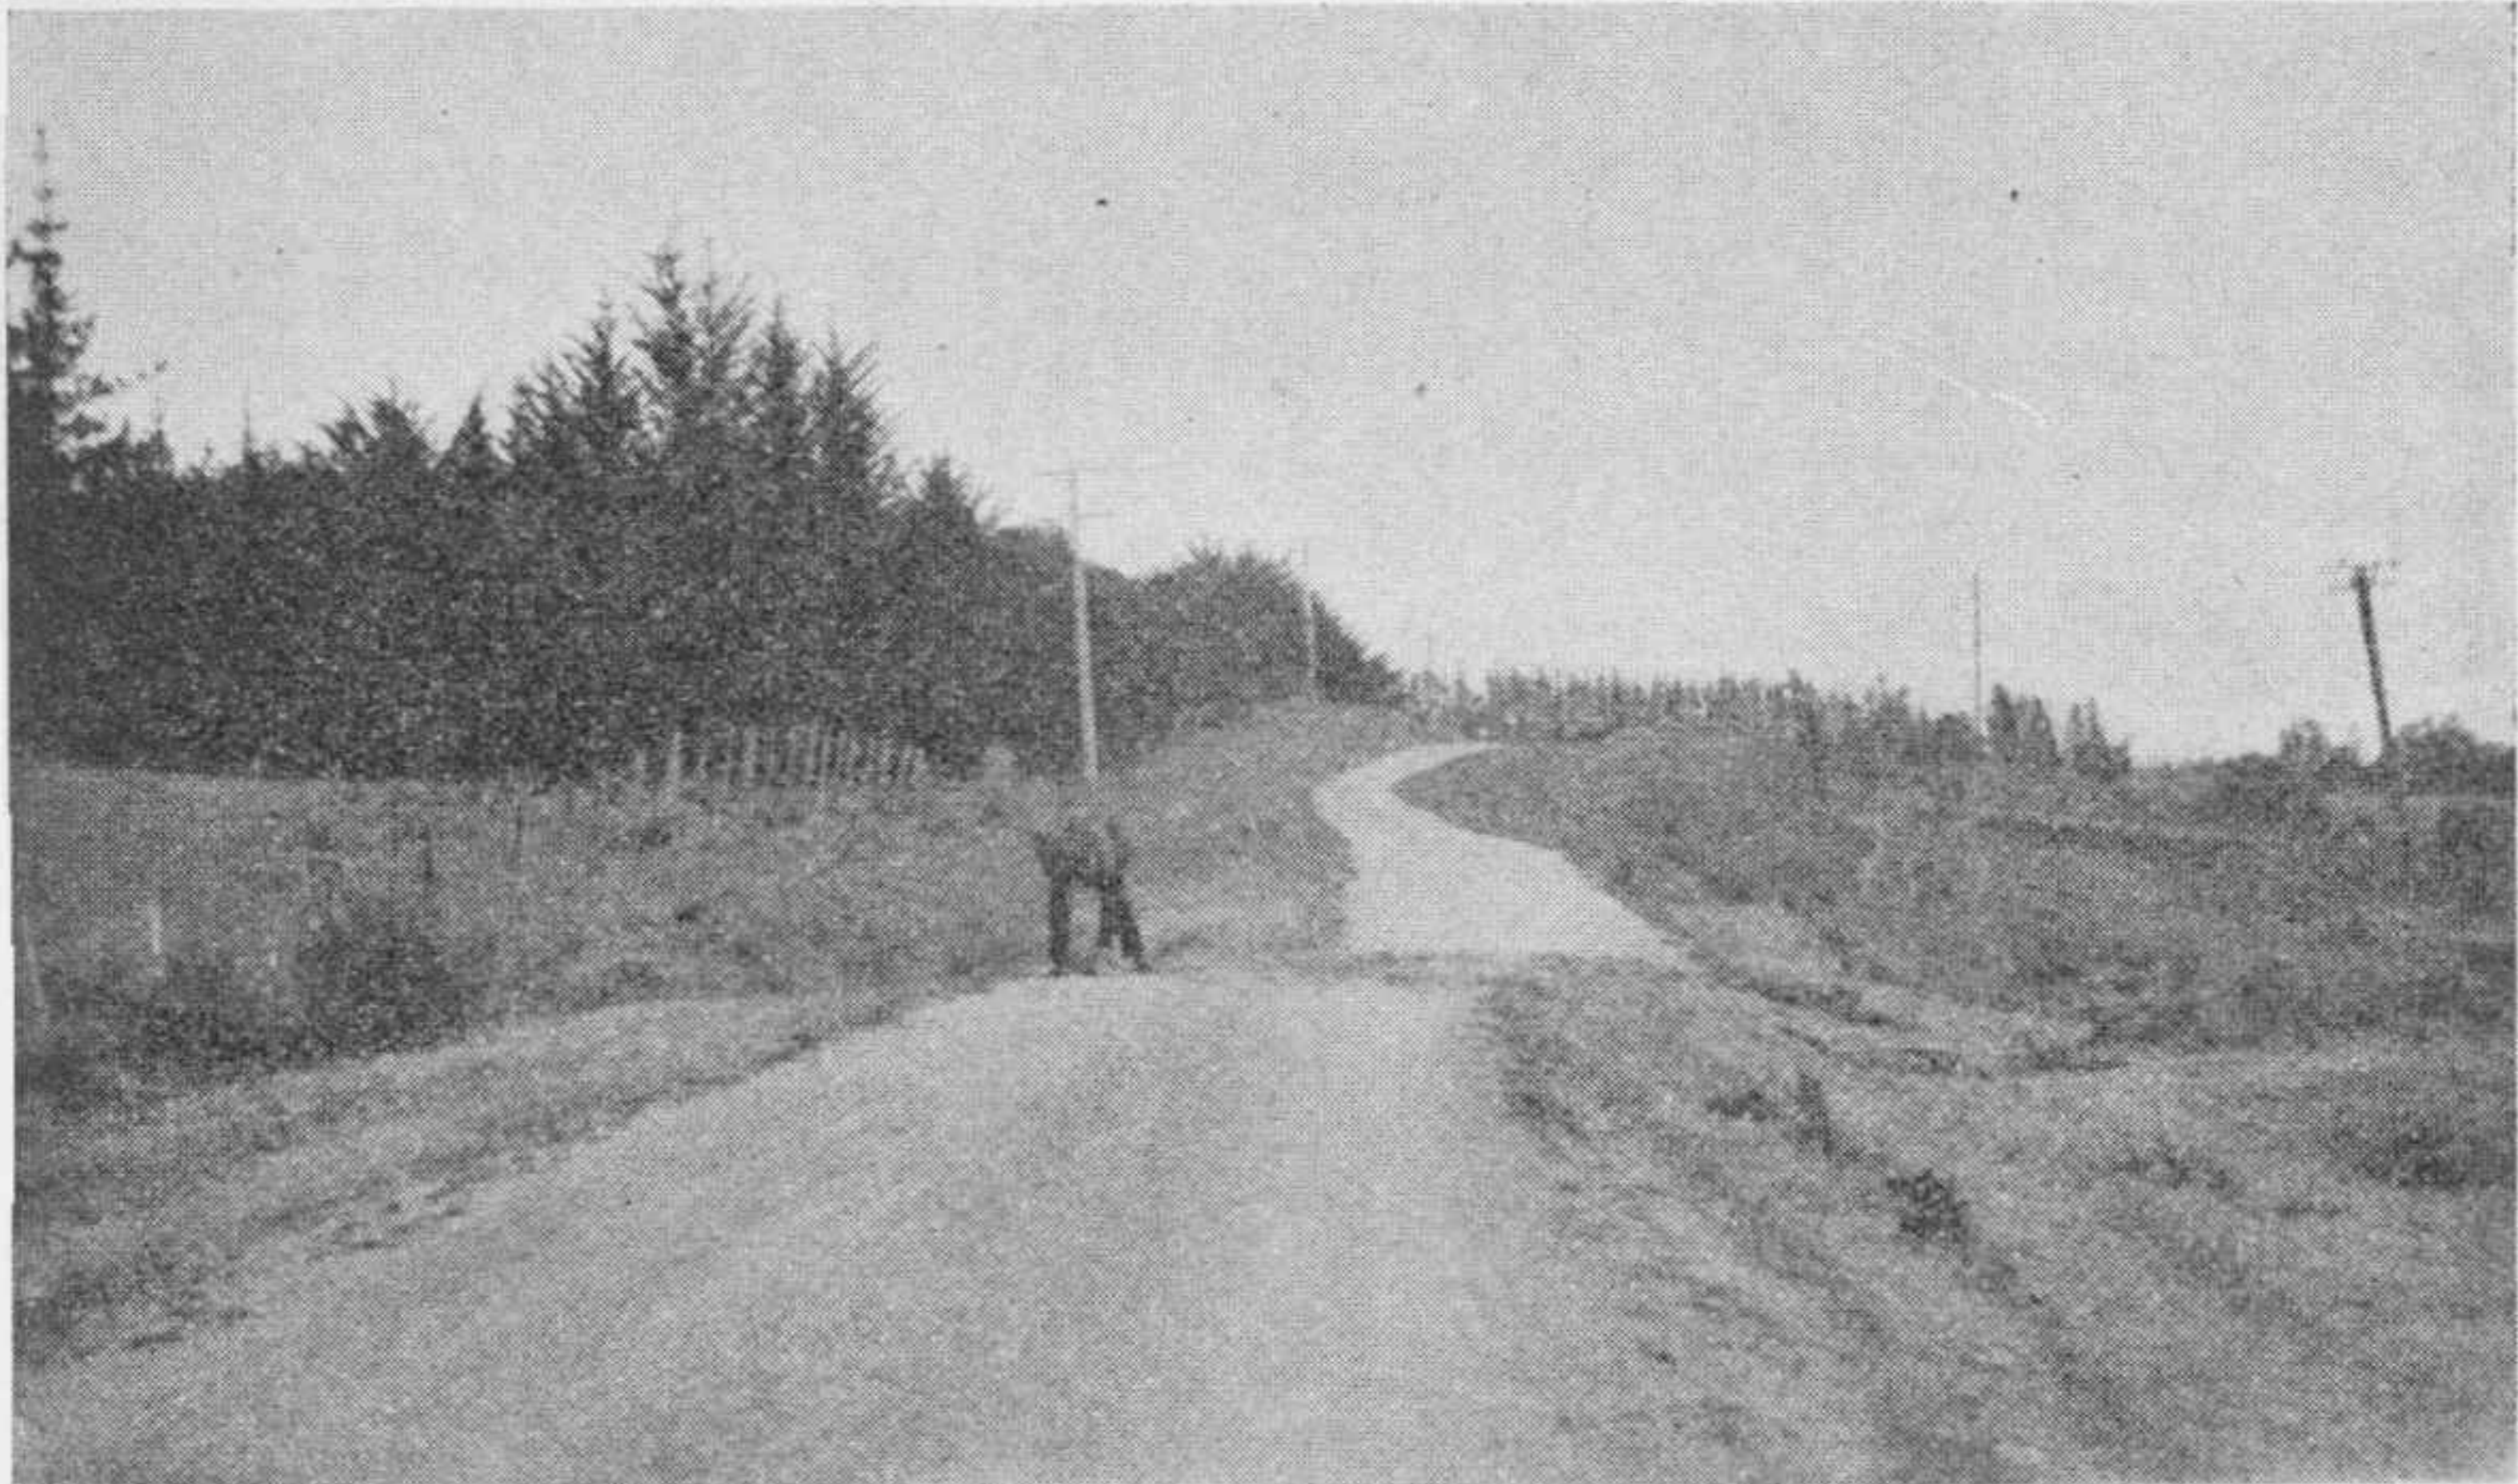
PLATE VII.—(*a*) Road east side of railway, two and a half miles north-east of Poukawa Railway-station. The displacement is between 6 ft. and 7 ft.

bordering the lake. It then turns nearly due east, the surface over several square chains at this locality being strongly and irregularly ridged and broken. It maintains an east-west course for about a mile, crosses the stream, displaces the railway and road horizontally between 6 ft. and 7 ft.

(Plate VII, a), and passes over the low hills of the dip-slope to the strike valley of Sutro Creek, a small tributary of the Poukawa. Here it again resumes a north-east course, and follows the base of the limestone scarp on the west side of the valley, dying out in about a mile in the valley of the next small stream to the north. In the valley of Sutro Creek, as in
