N.Z. DEPARTMENT OF SCIENTIFIC AND INDUSTRIAL RESEARCH.

BULLETIN No. 43.

REPORT
OF THE
HAWKE'S BAY EARTHQUAKE
(3rd FEBRUARY, 1931).

**THE HAWKE'S BAY EARTHQUAKE OF
3rd FEBRUARY, 1931.**

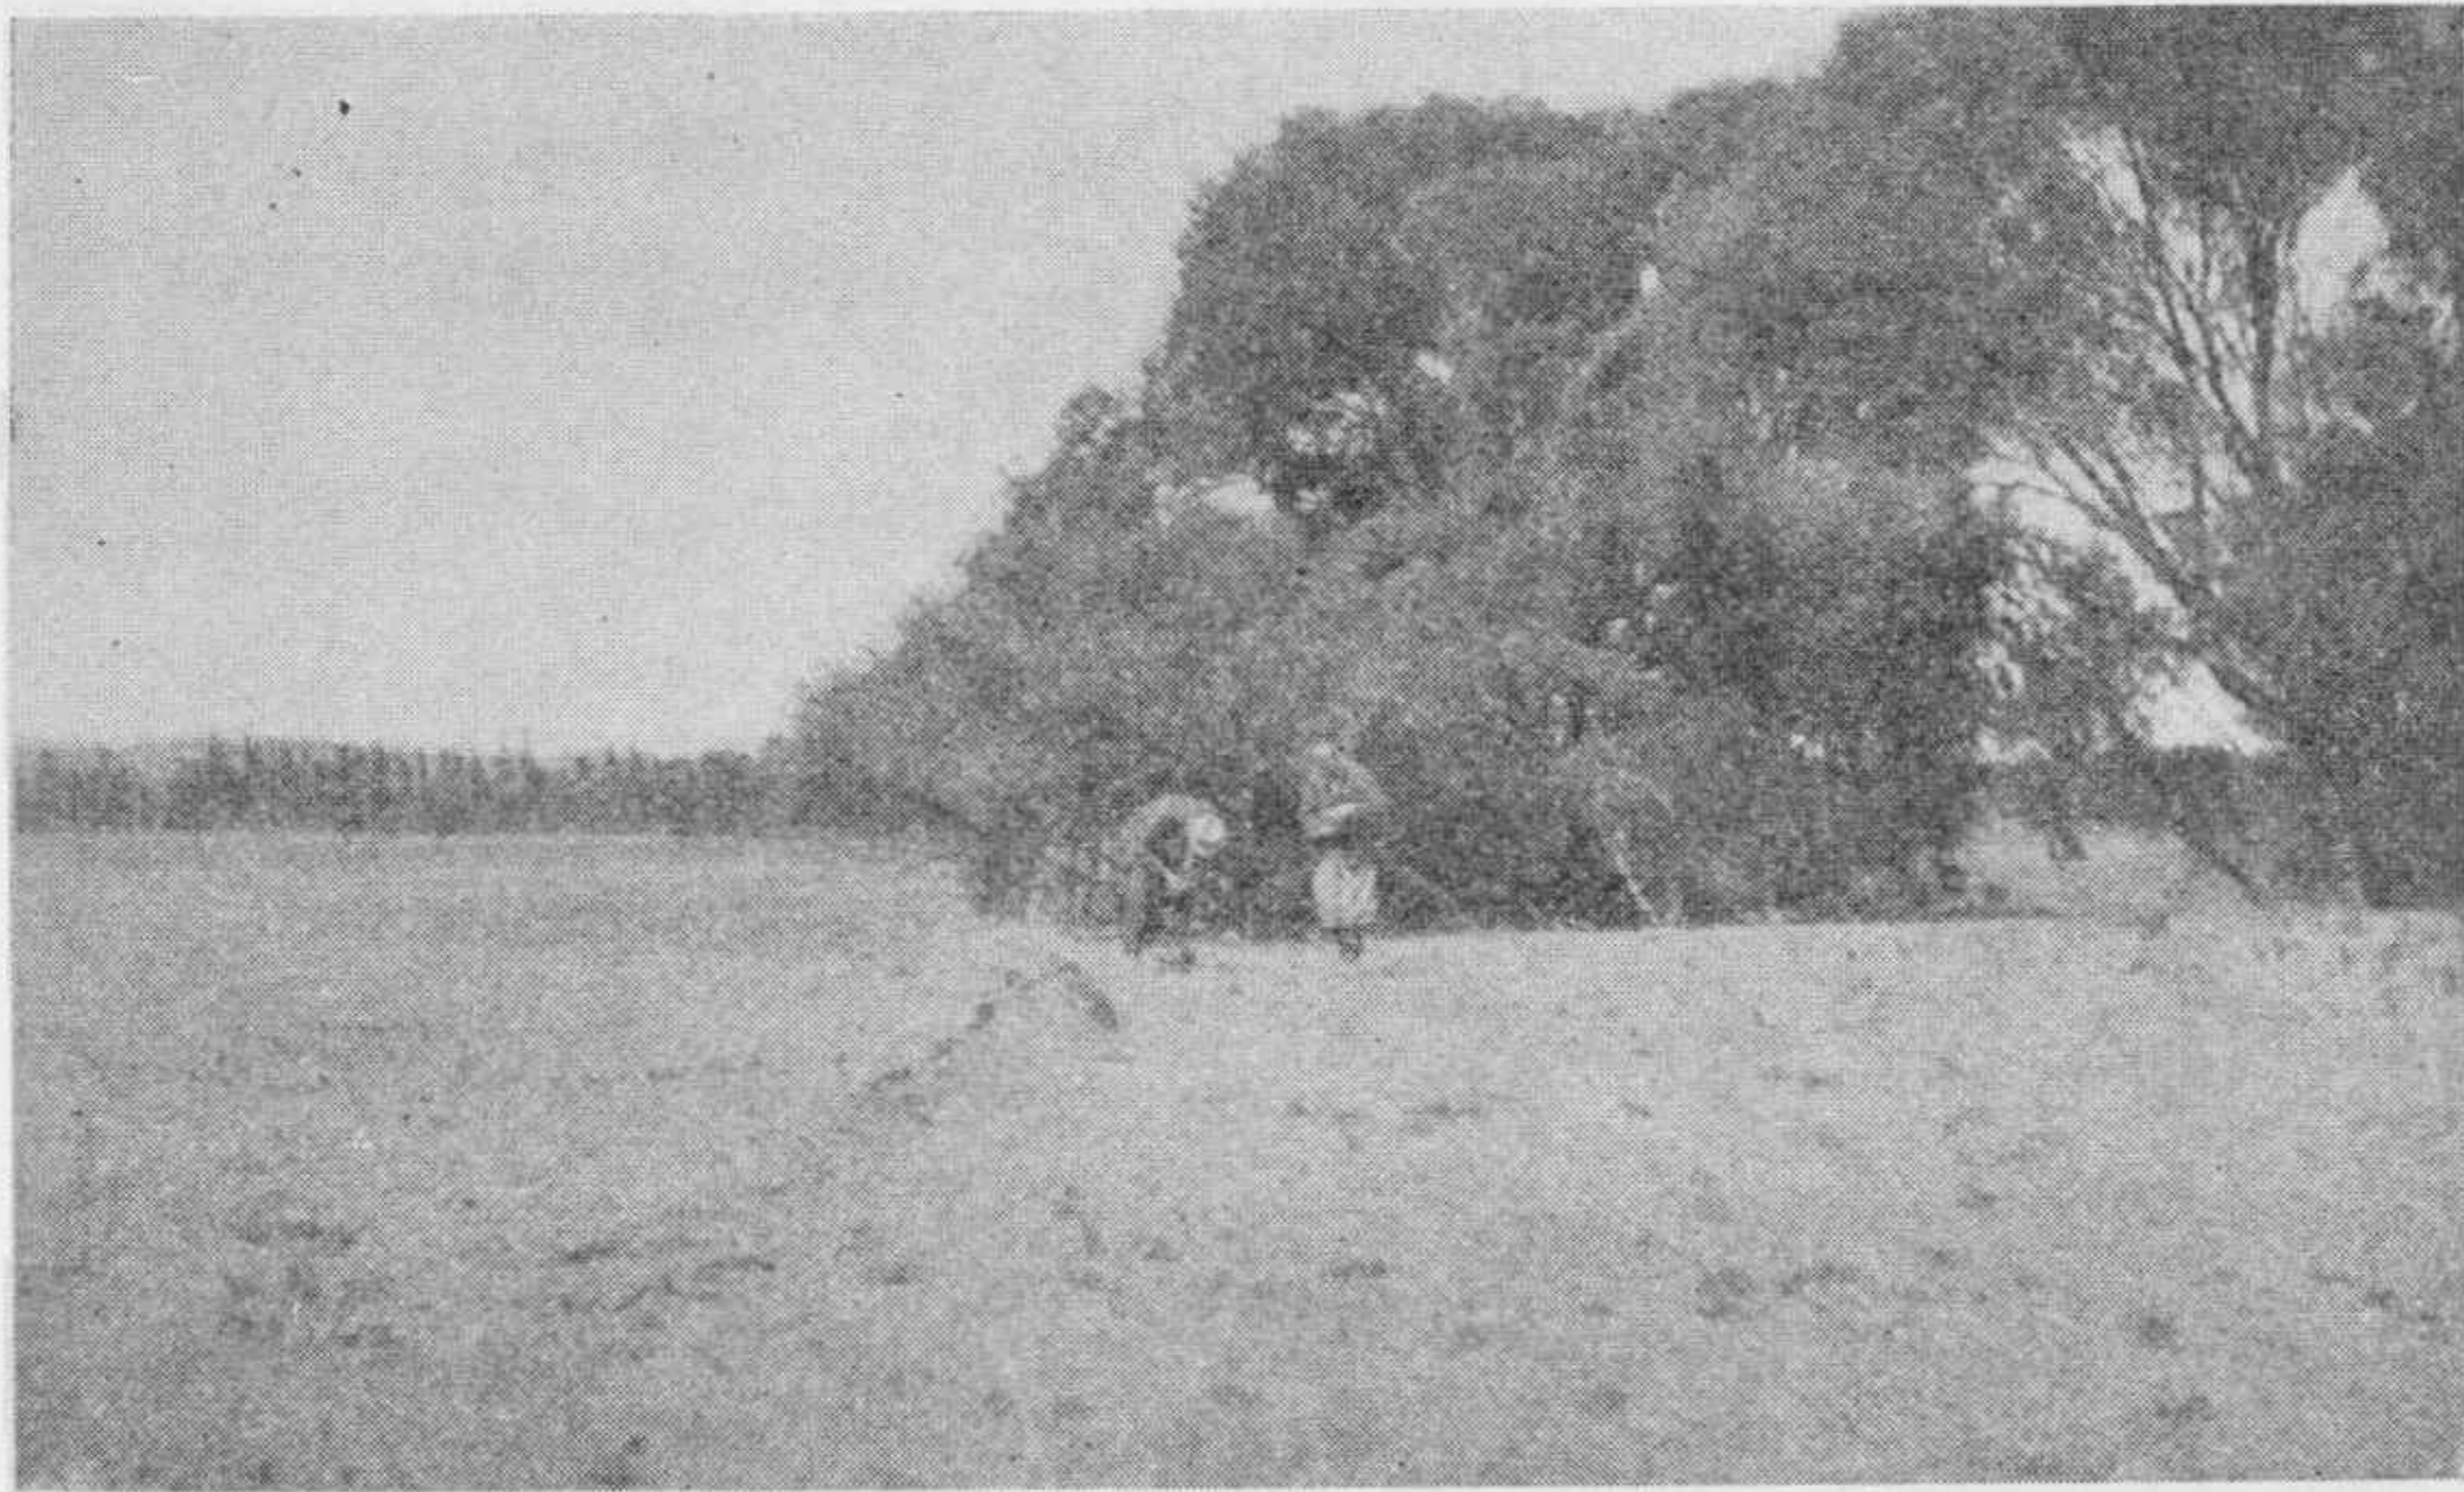
PLATE VII.—(*b*) Flood plain, Poukawa Stream, 120 chains north-east of Poukawa Railway-station. The area to the right of the pressure ridge is 18 in. higher than that to the left.

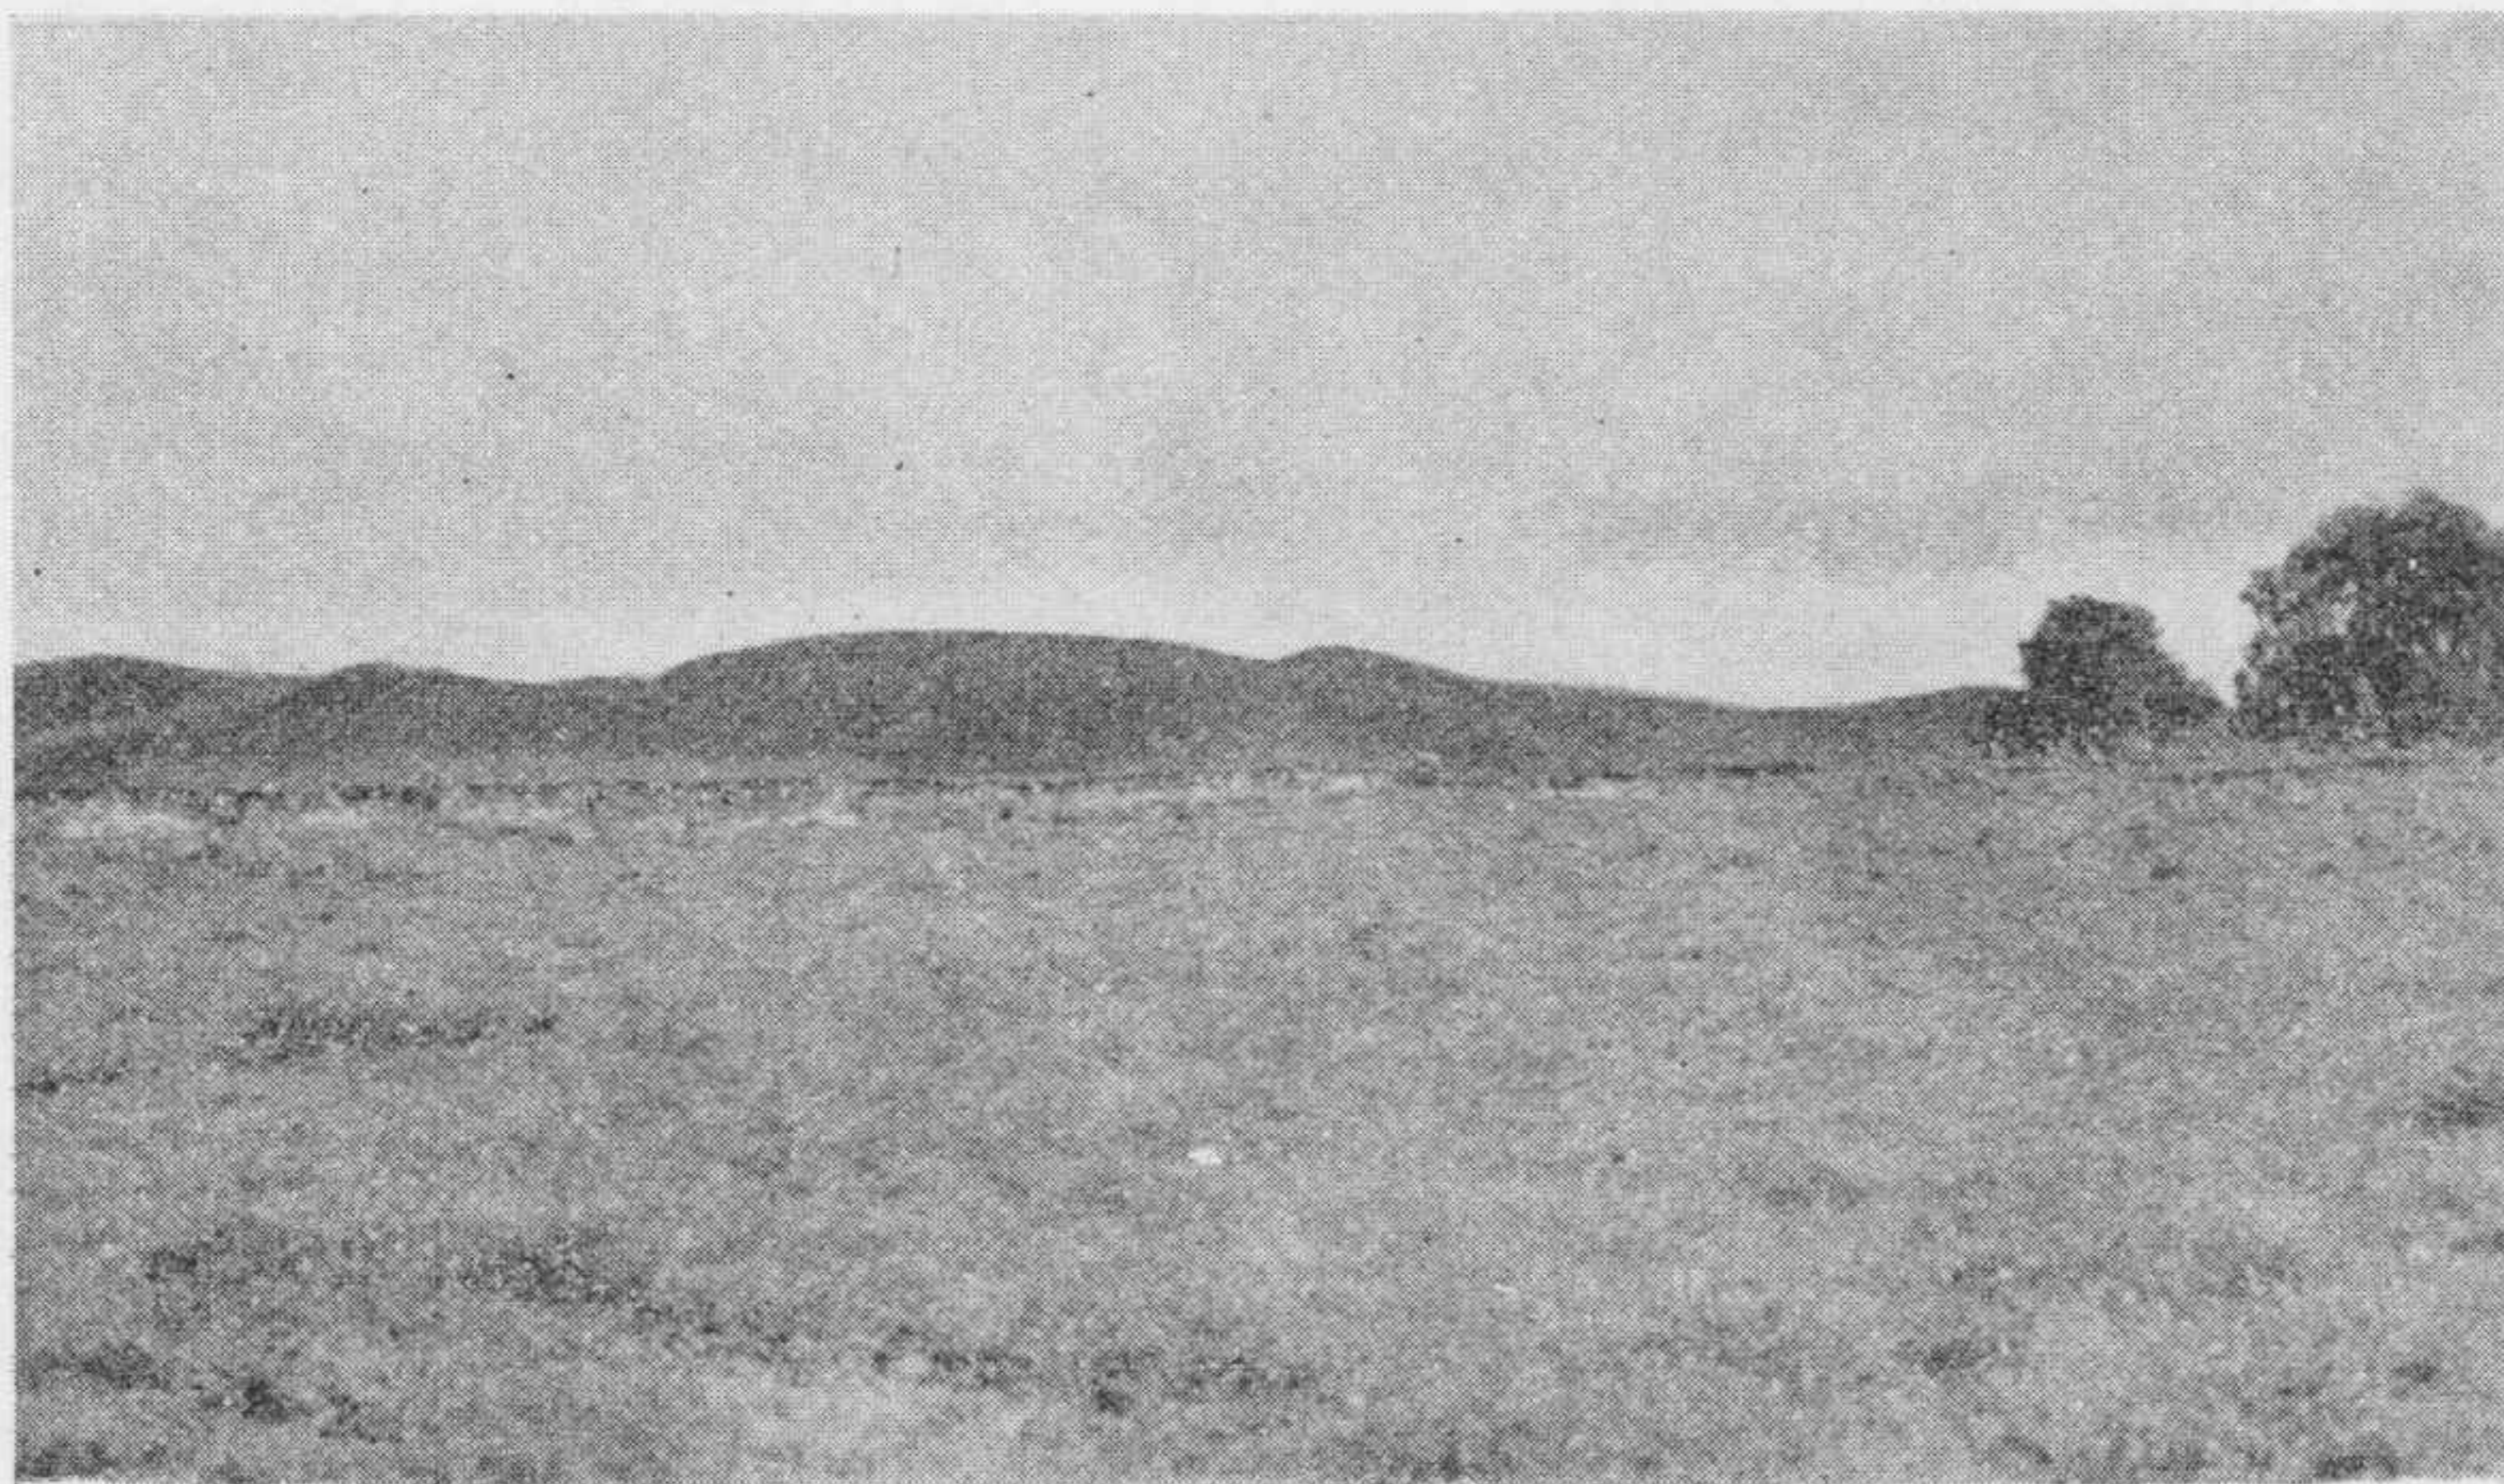
PLATE VII.—(c) Awanui fracture, 120 chains west of Pakipaki. The step-up or "terrace" is 15 ft.; to the right two steps are shown; to the left the step-up grades to a warp (see Plate VIII (a)).

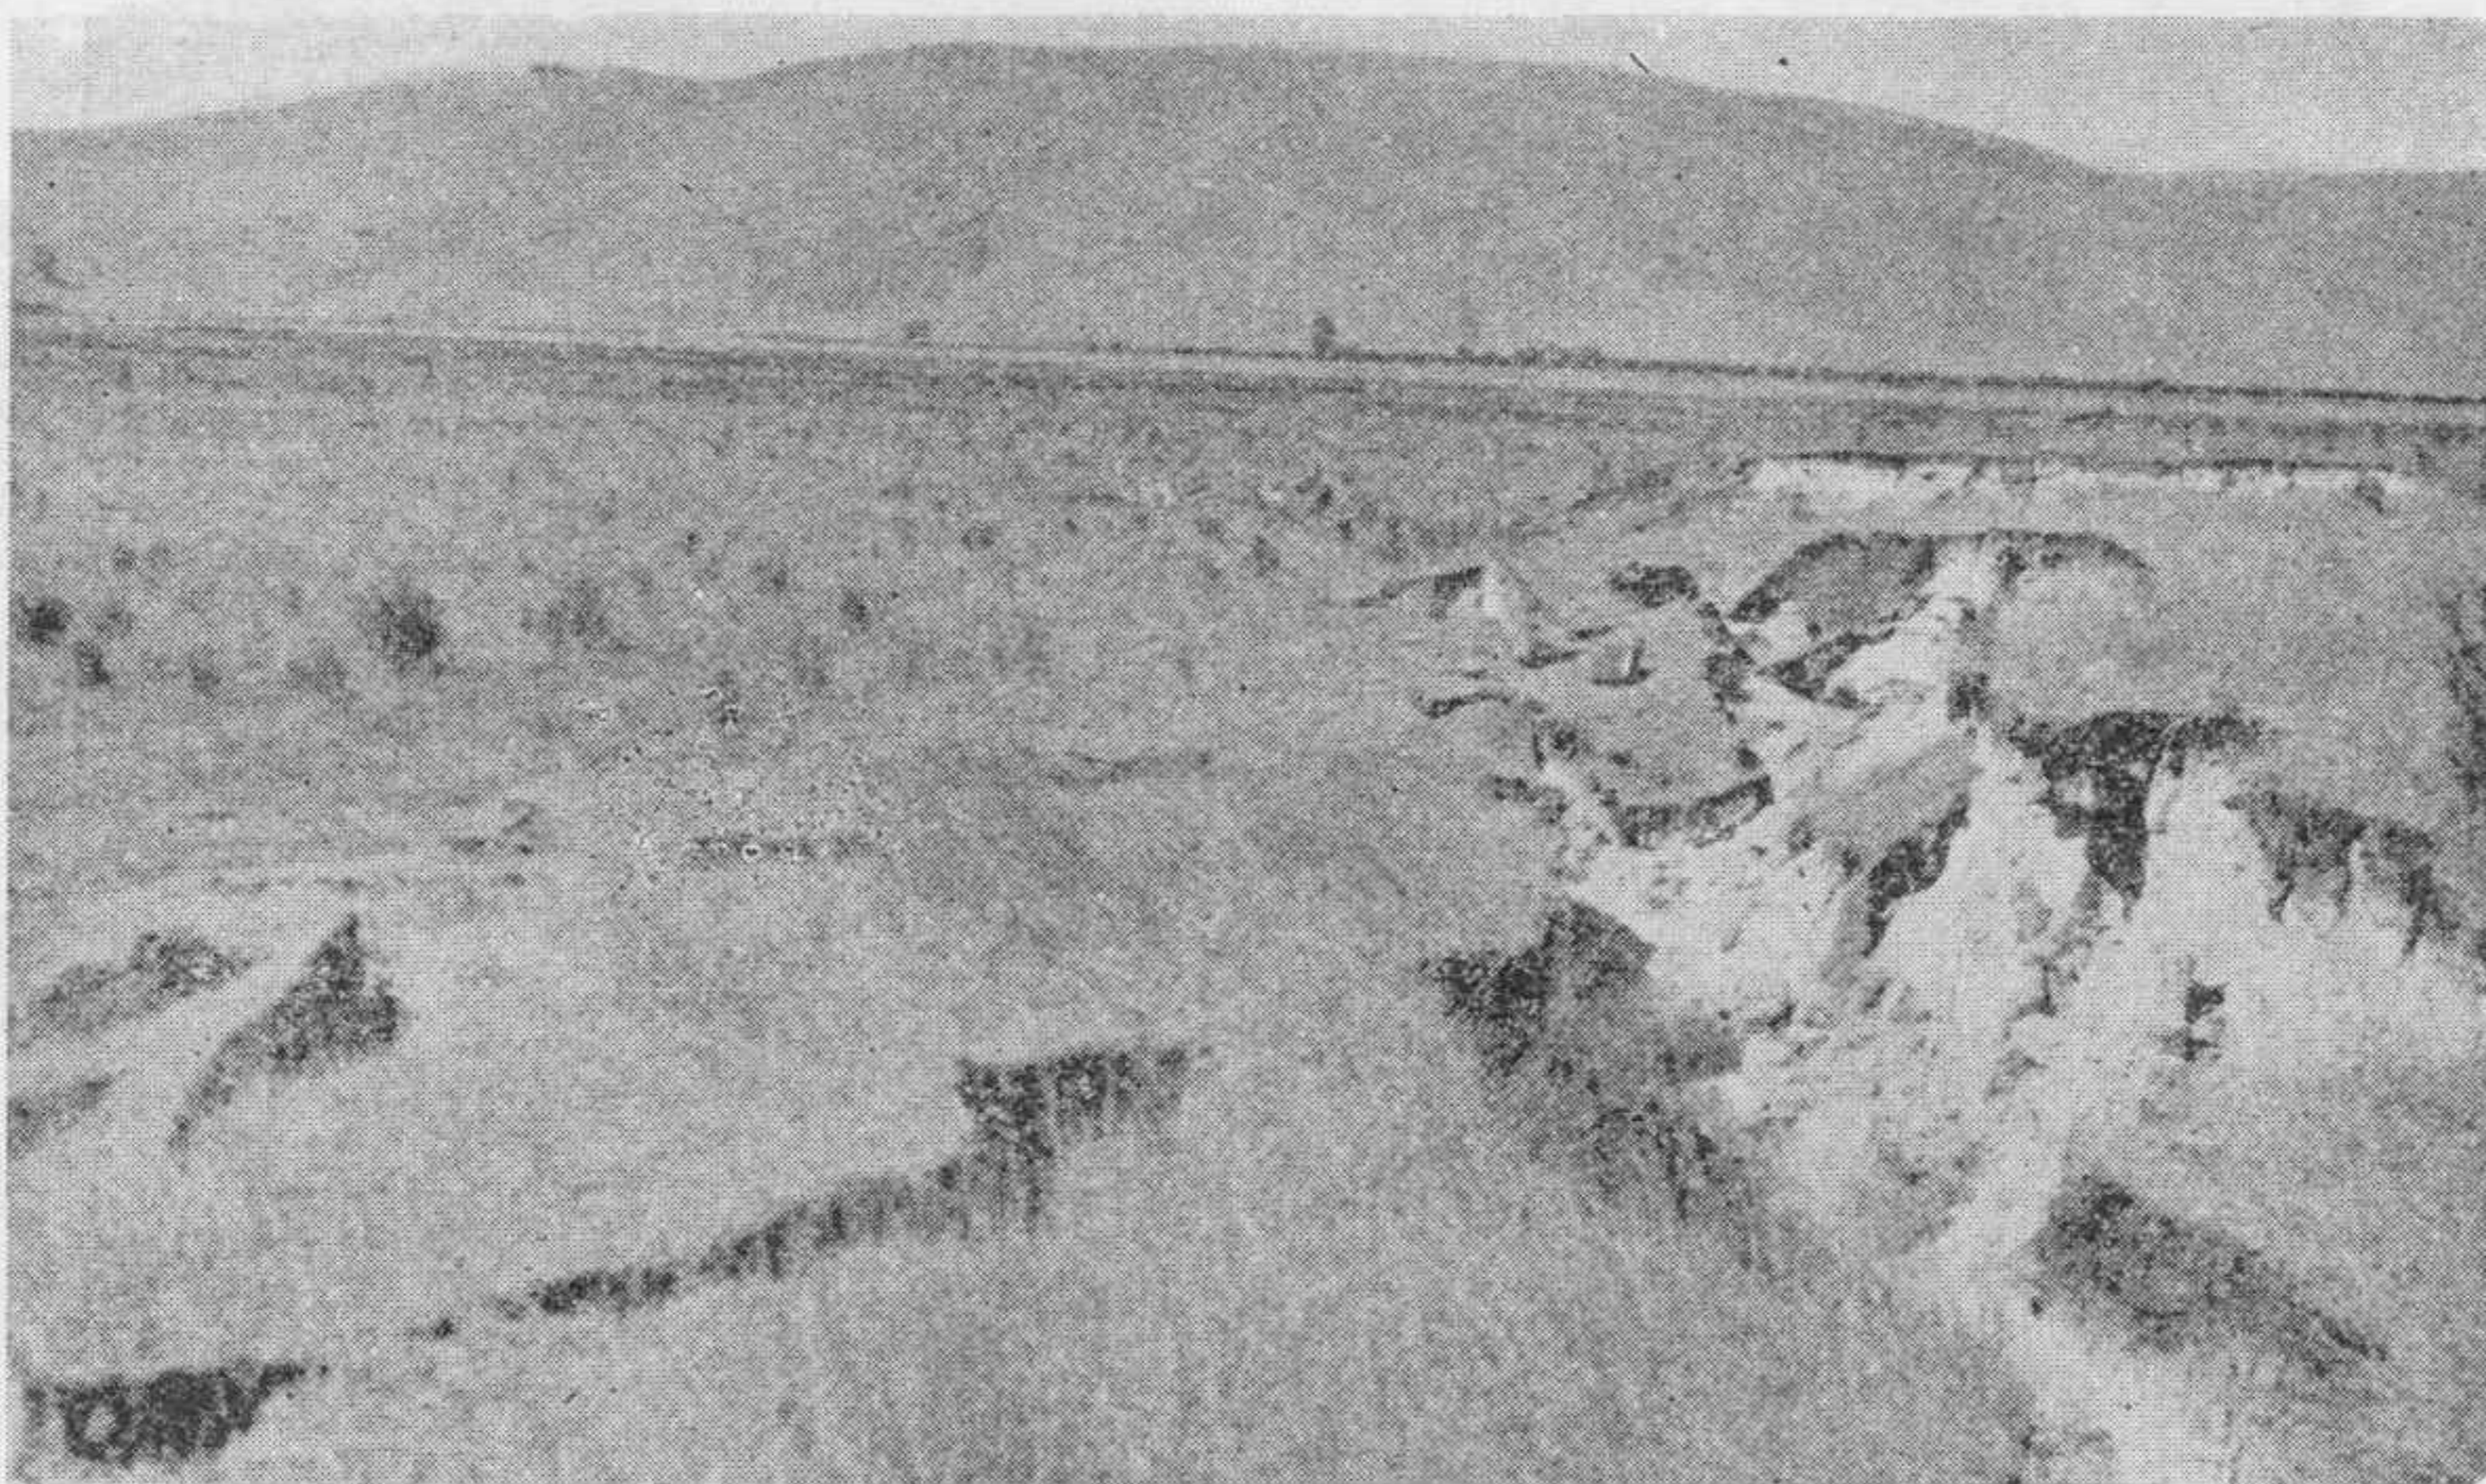
PLATE VIII.—(a) Awanui fracture, 120 chains west of Pakipaki. The step-up grades to a warp.

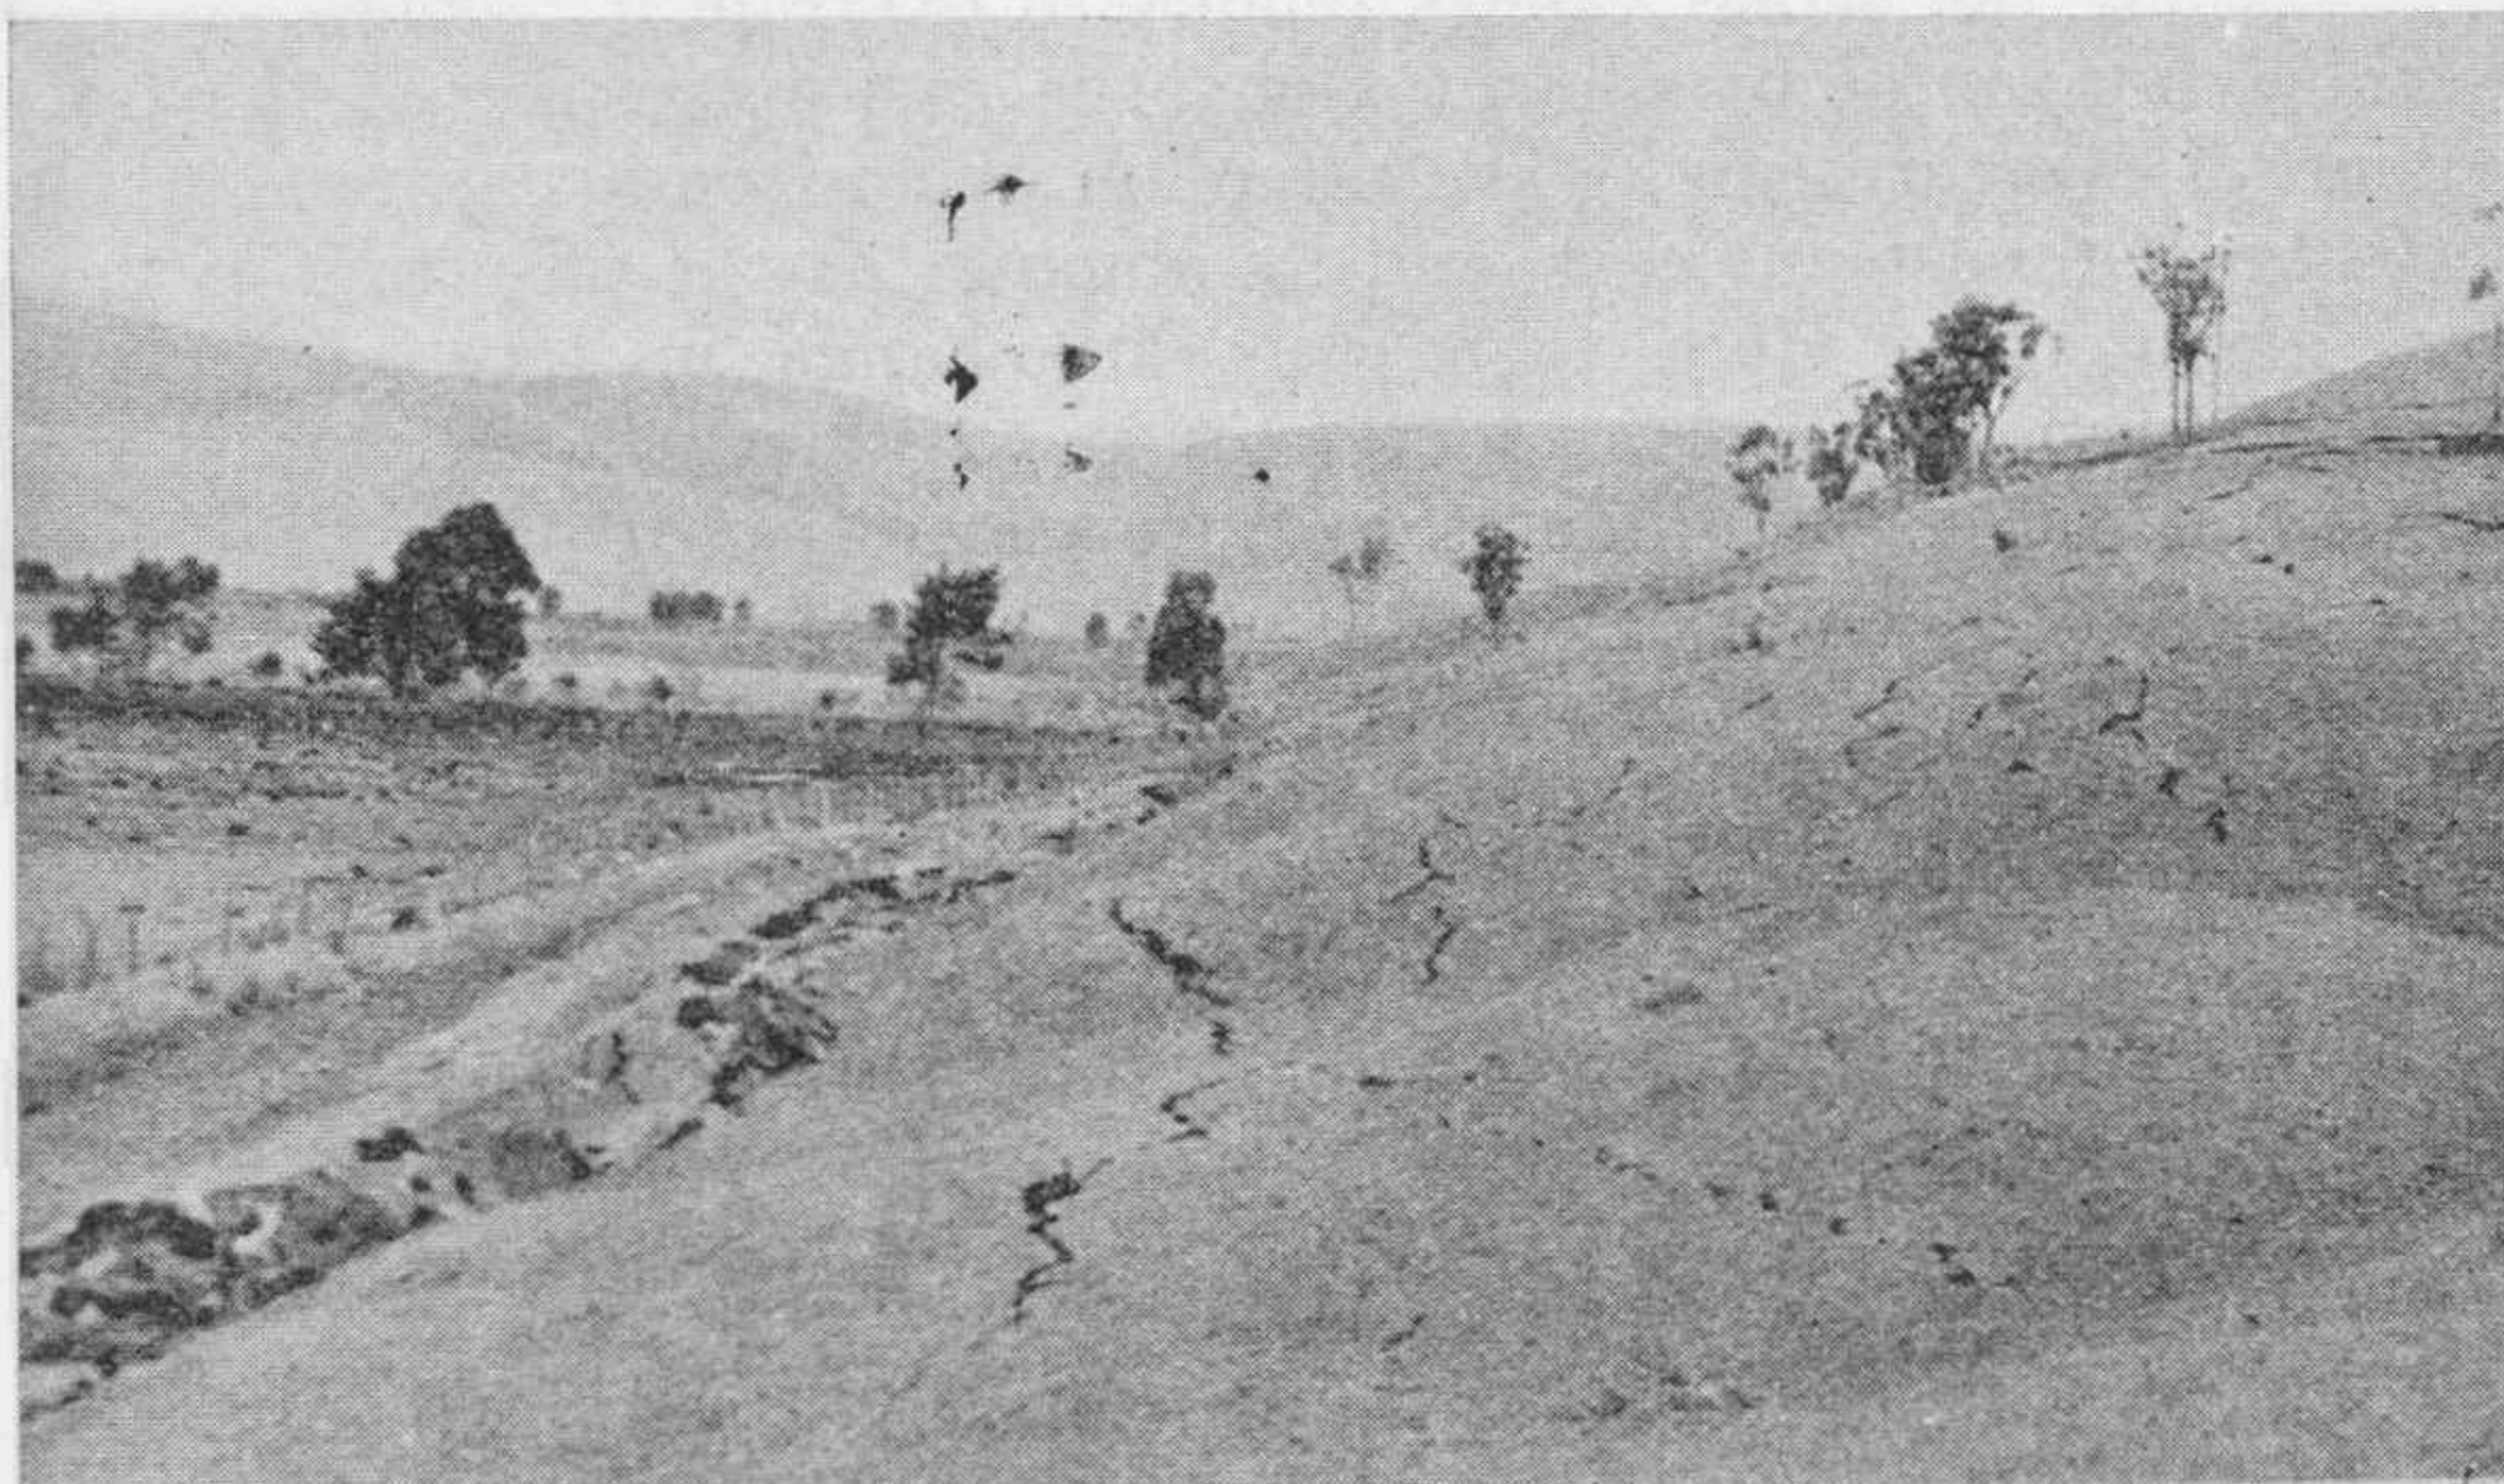
as if the ground beneath had swollen and stretched the turf (Plate VIII, *b*), facts suggesting that the substrata are fragmented and occupy more space than formerly. In some localities the swelling seems much greater and extends back for several chains, the surface being strongly ridged and

PLATE VIII.—(b) Pressure ridge, Awanui Valley, 20 chains south of Mr. N. Campbell's house. The hill-slope beside the ridge is swollen and shows tension cracks.

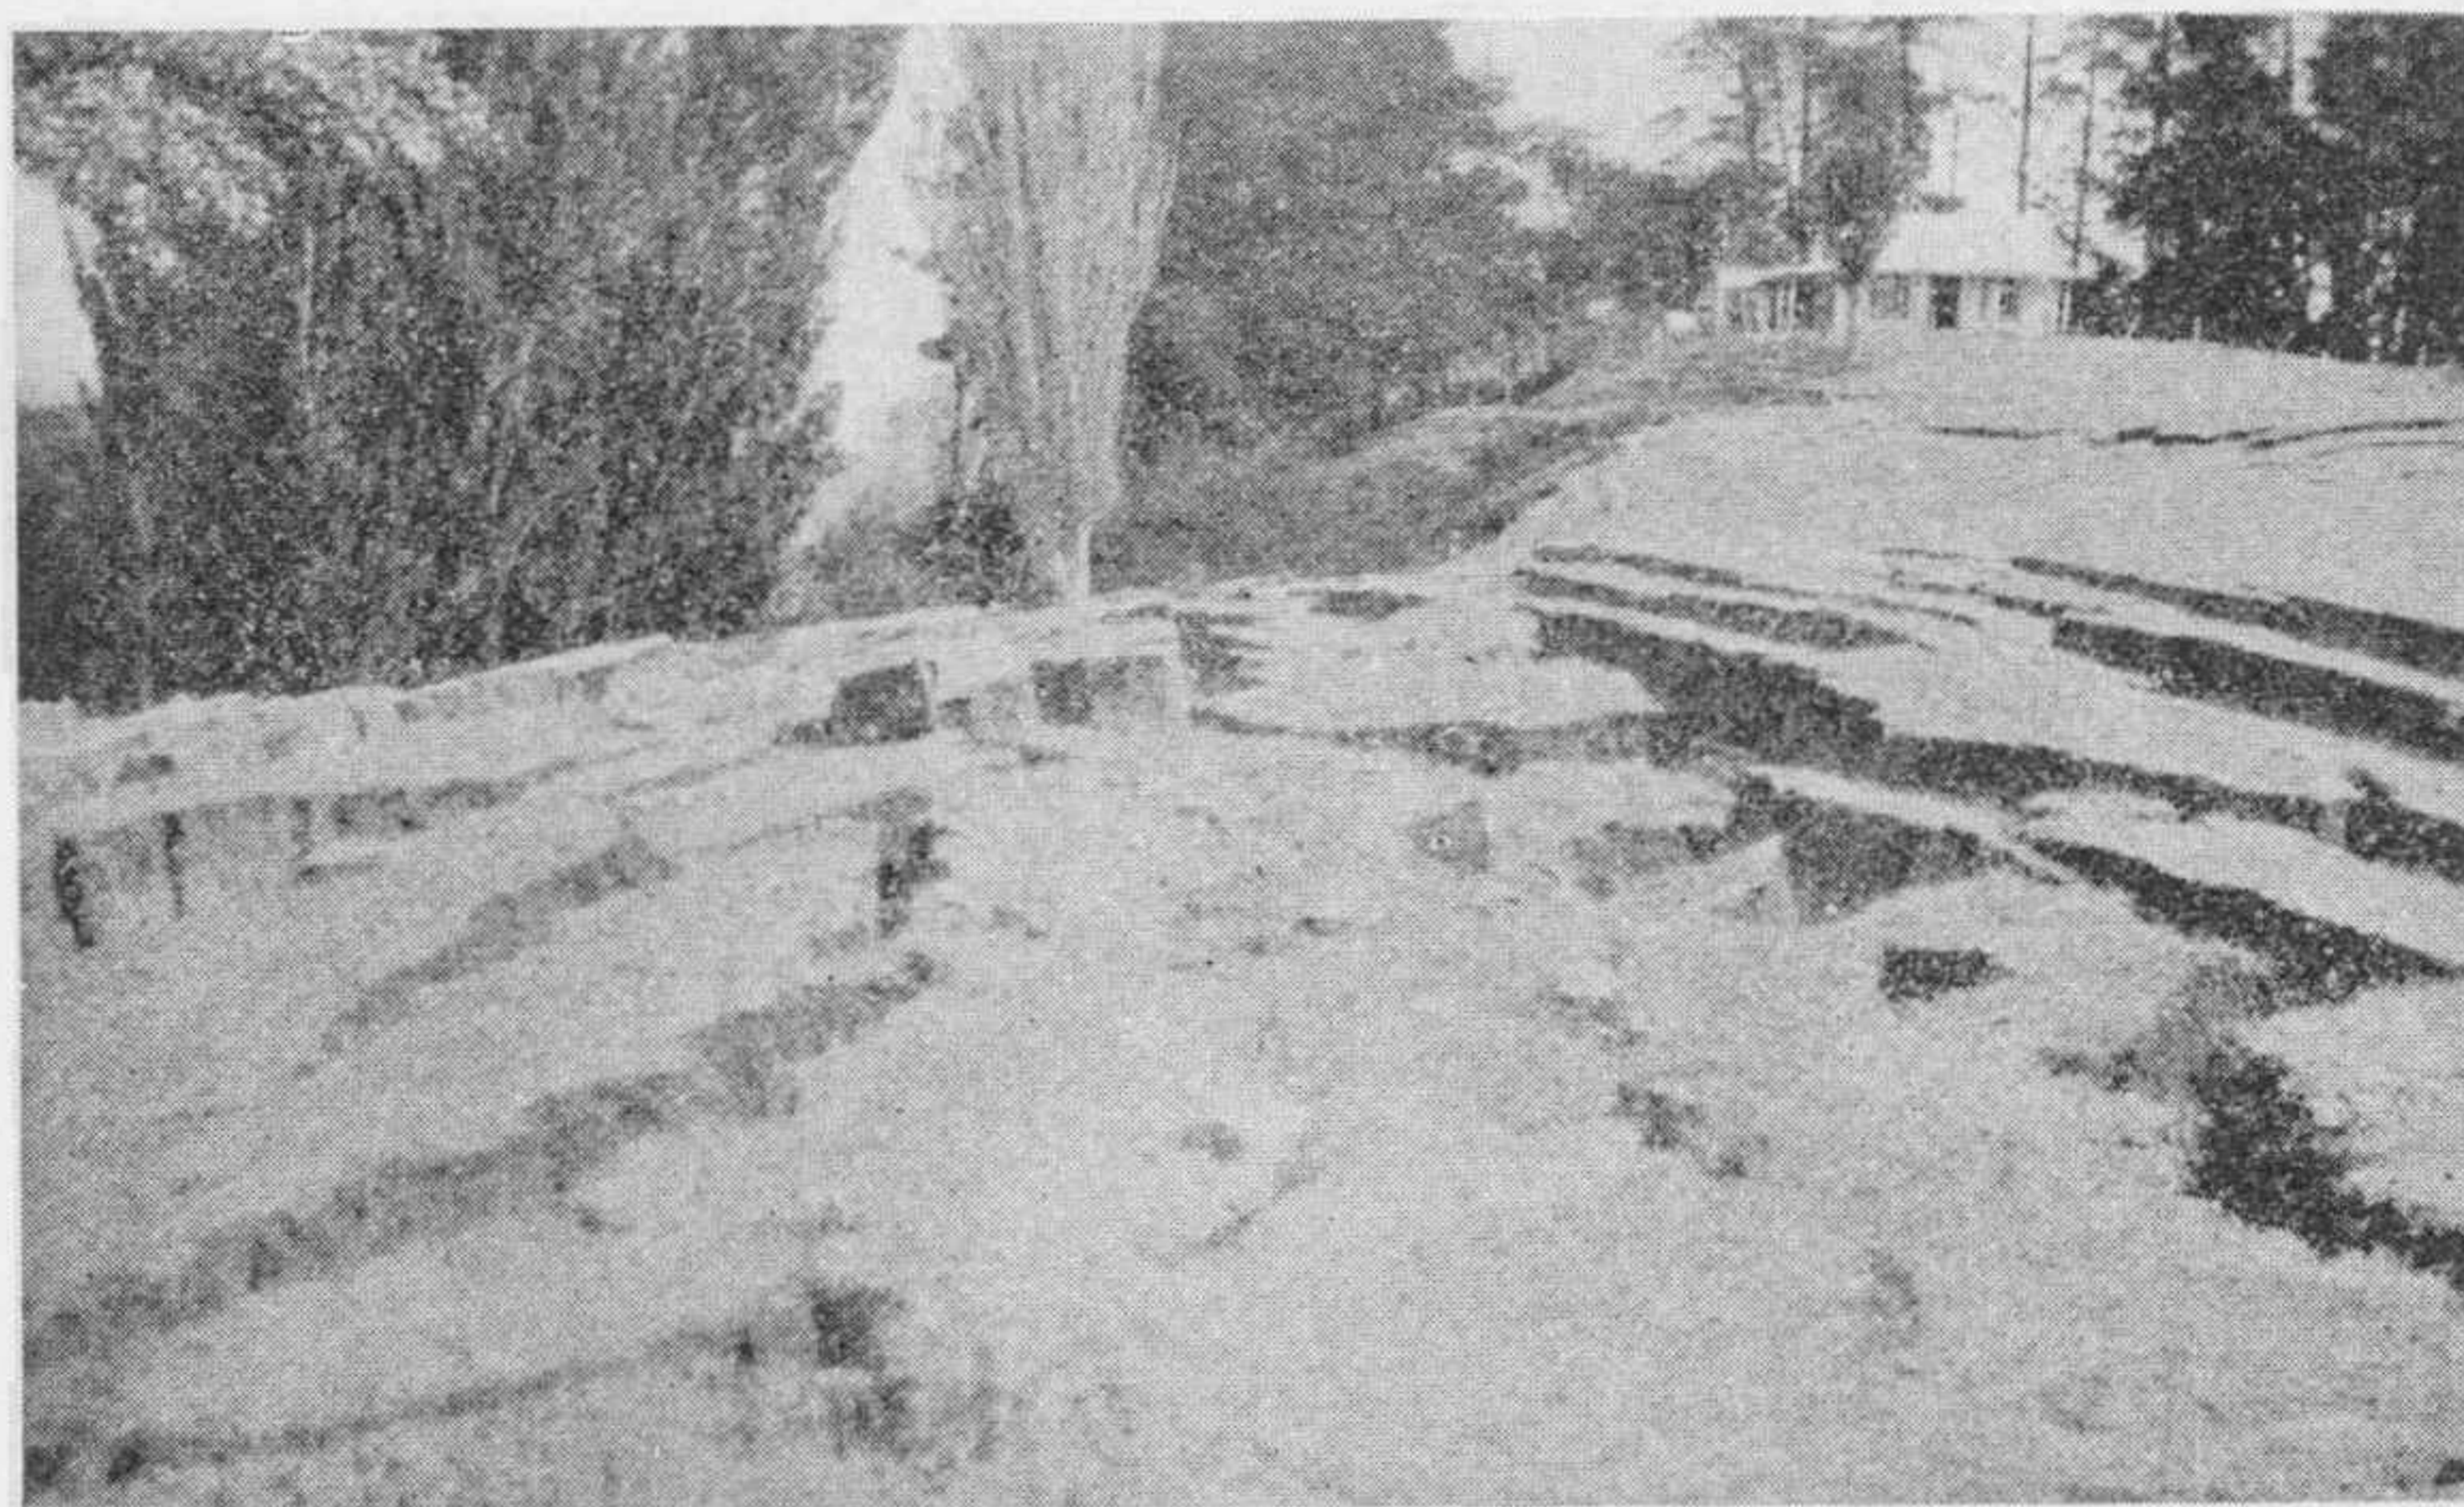
stepped (Plate VIII, *c*). At one point this swelling seems to go back for 20 chains, the wires of a fence across this area being very tight though the surface cracks observed were few and small.

PLATE VIII.—(c) Swollen and subsided ground west of pressure ridge, Poukawa Valley, 140 chains north-east of Poukawa Railway-station.

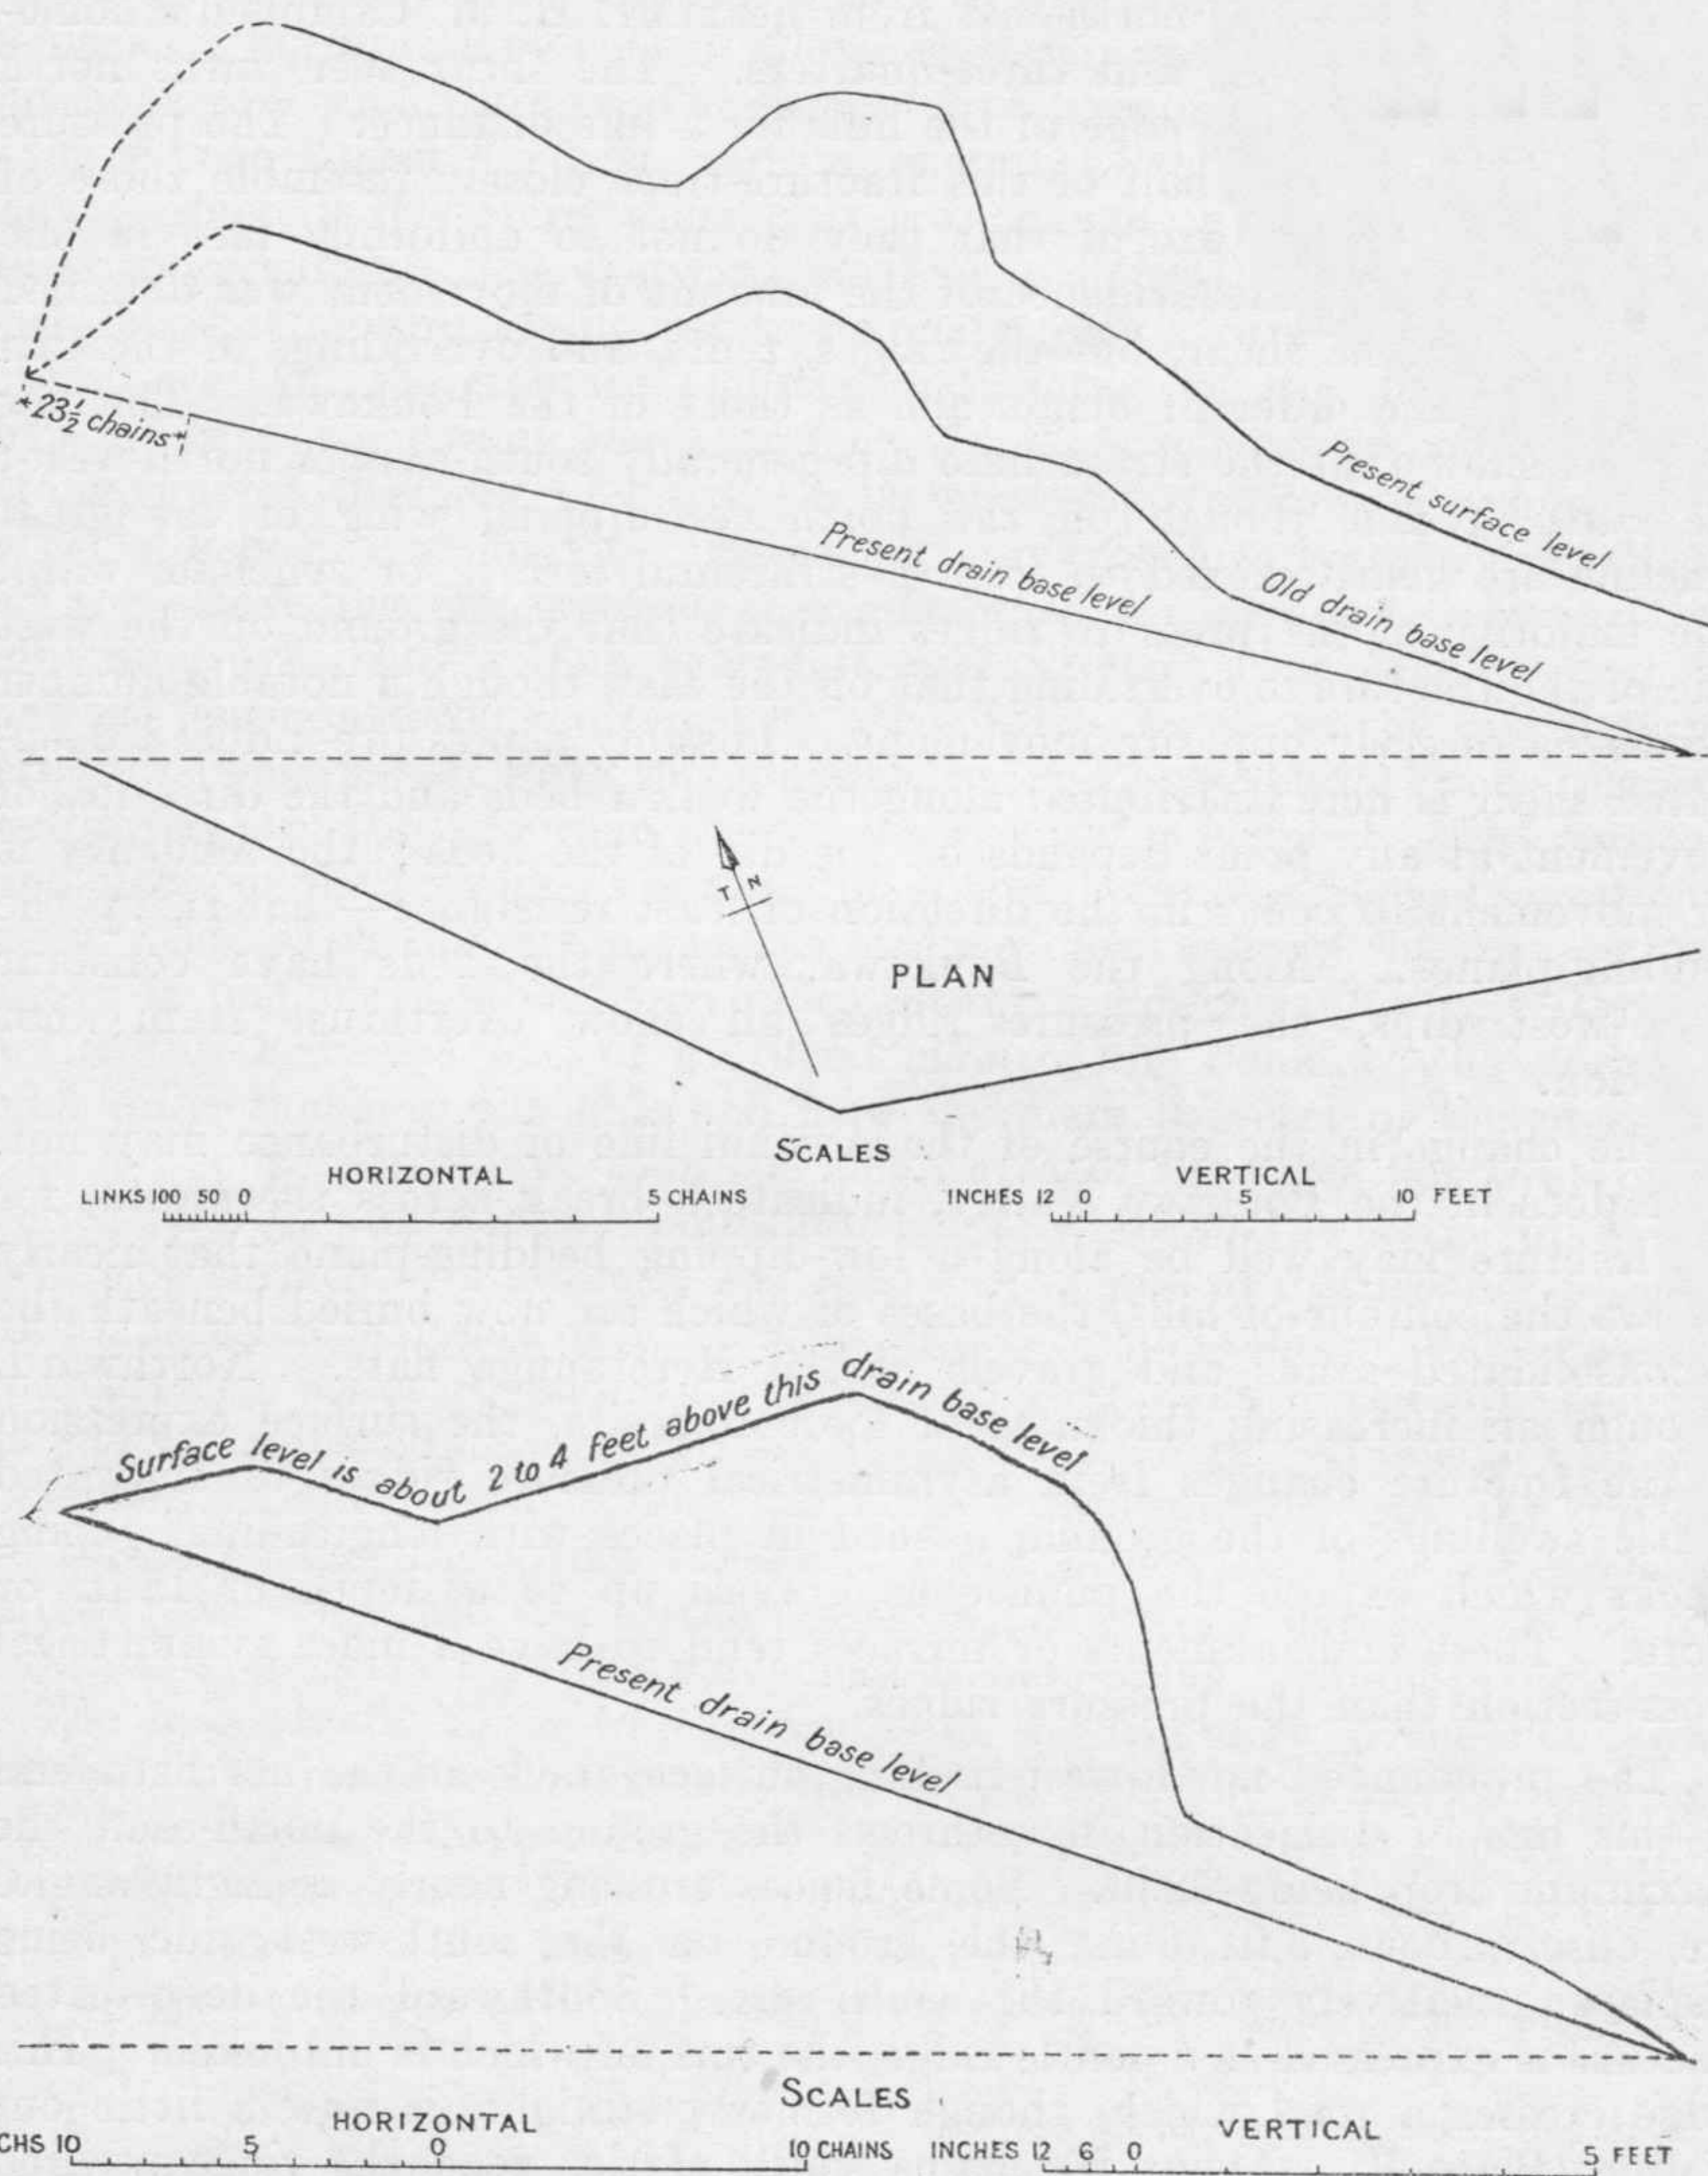
Sections along drains across abrupt warp in surface, 60 chains north-north-east from Mr. N. Campbell's house.

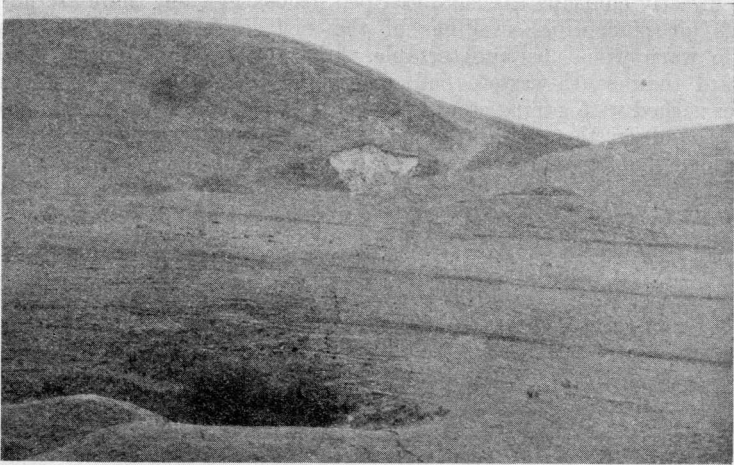
north from Lake Poukawa about a chain of the road sank between steps from 4 in. to 8 in. high (Plate IX, *a*). These cracks extend half a mile southward, in which direction there are in places numerous subparallel fissures. Northward the cracks have rather irregular courses, though for nearly a mile

PLATE IX.—(*b*) The same tension crack on the other side of the road. The crack was traced beyond the quarry.
