N.Z. DEPARTMENT OF SCIENTIFIC AND INDUSTRIAL RESEARCH.

BULLETIN No. 43.

REPORT
OF THE
HAWKE'S BAY EARTHQUAKE
(3rd FEBRUARY, 1931).

**THE HAWKE'S BAY EARTHQUAKE OF
3rd FEBRUARY, 1931.**

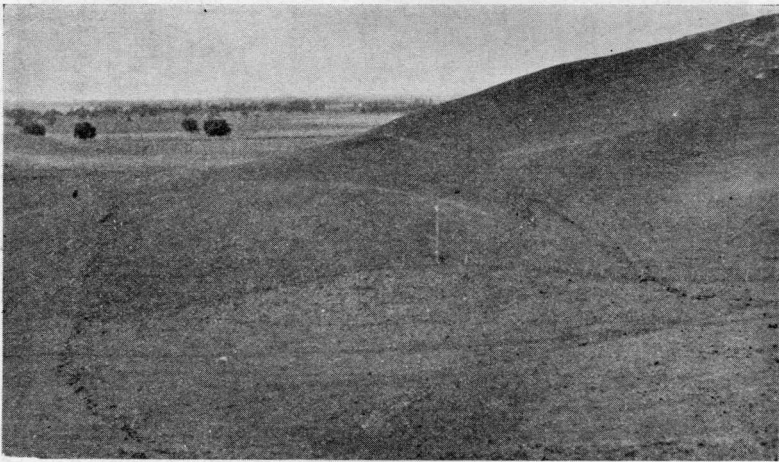
PLATE IX.—(*c*) Tension cracks 60 chains west of Mr. N. Campbell's house, Awanui Valley. The area between the cracks is depressed 12 in. to 18 in.

Similar irregular tension fissures extend half a mile or more along a small branch that enters the Awanui from the west near the southern end of the shear along the head of that stream. These are possibly due to incipient slumping of the hillside, but northward, though not continuous with them, are two groups of tension cracks which cannot be so explained. The first and less important lie a little to the right of the general line, and the second, though on the line, have courses oblique to it. The first group consists of small open fissures in the limestone of a quarry about half a mile south of Mr. N. Campbell's house (Plate XI, *a*). These cracks strike a little west of north. The second group consists of three strong sub-parallel fissures some 30 chains west and north-west of Mr. Campbell's house. Their general course is north-north-east, but at the northern end of each the strike swings to the north. The most westerly, which is fully 60 chains long, downthrows the ground to the east of it from 12 in. to 20 in. The others, each about half as long as the main fissure, and east of its southern half, downthrow the ground to their west from 8 in. to 12 in. (Plate IX, *c*).

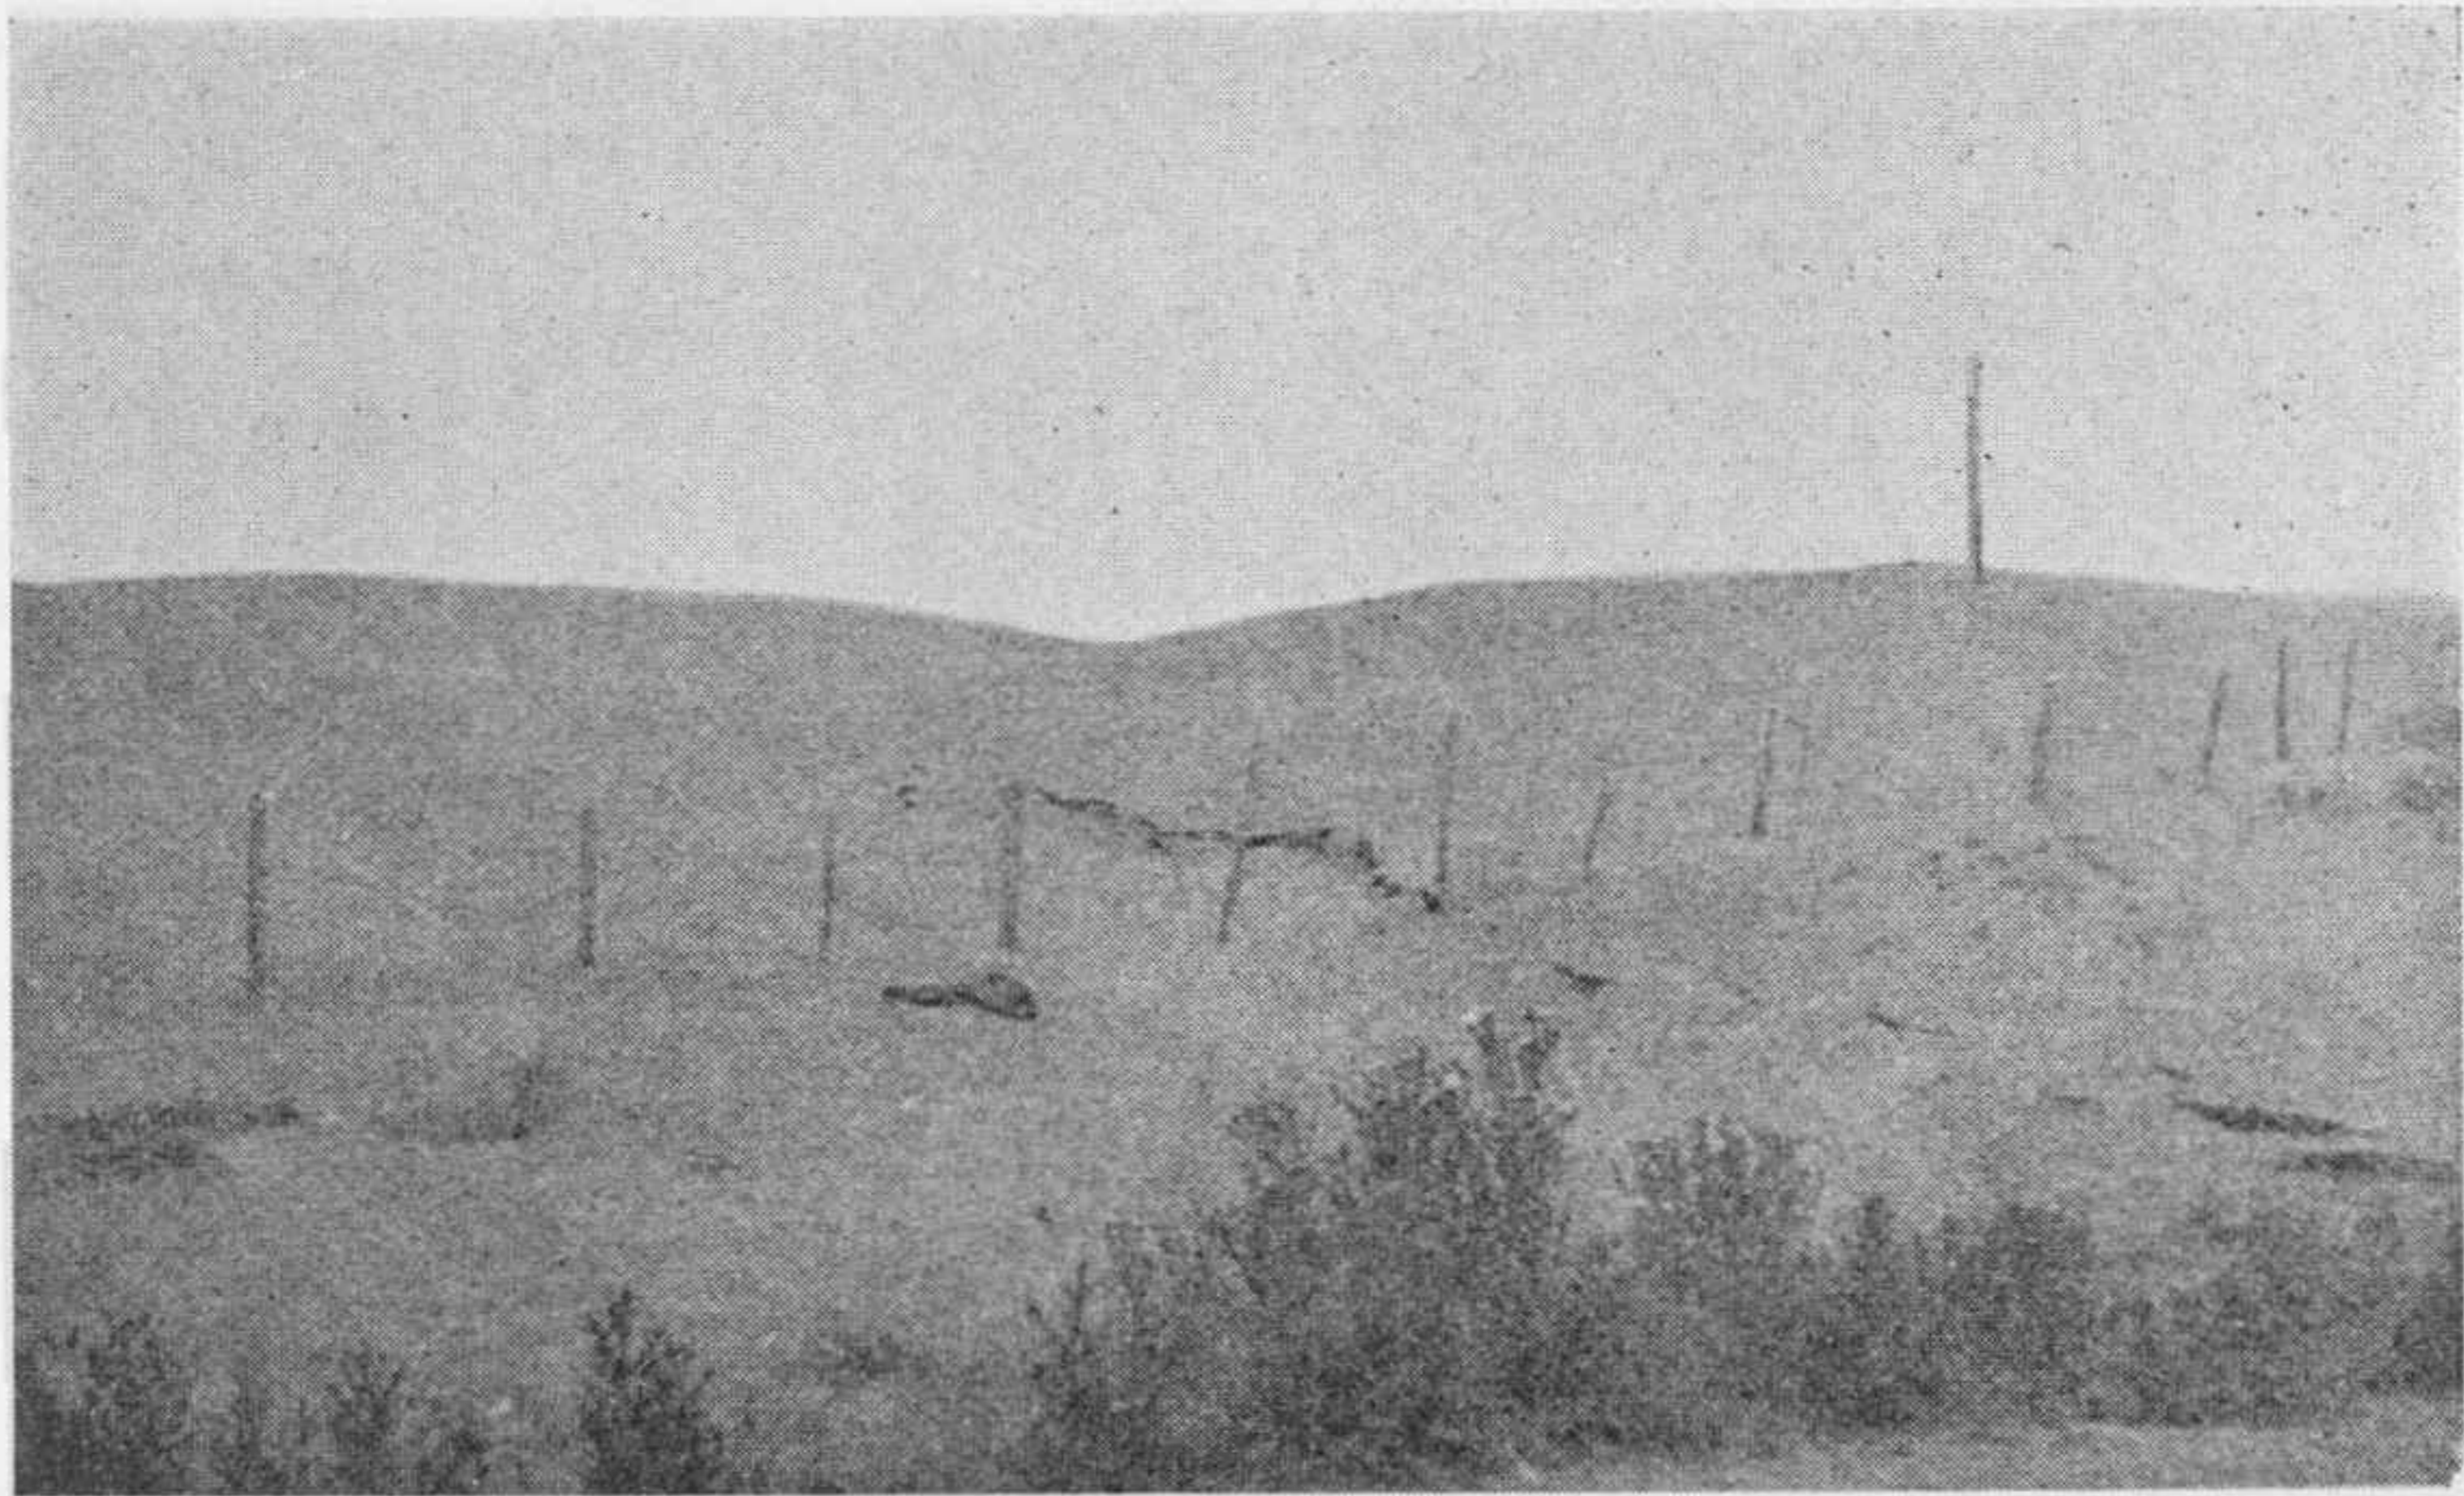
PLATE IX.—(a) Tension crack, east side of main road, 120 chains north-east of turn-off to Poukawa Railway-station. The step is 6 in.

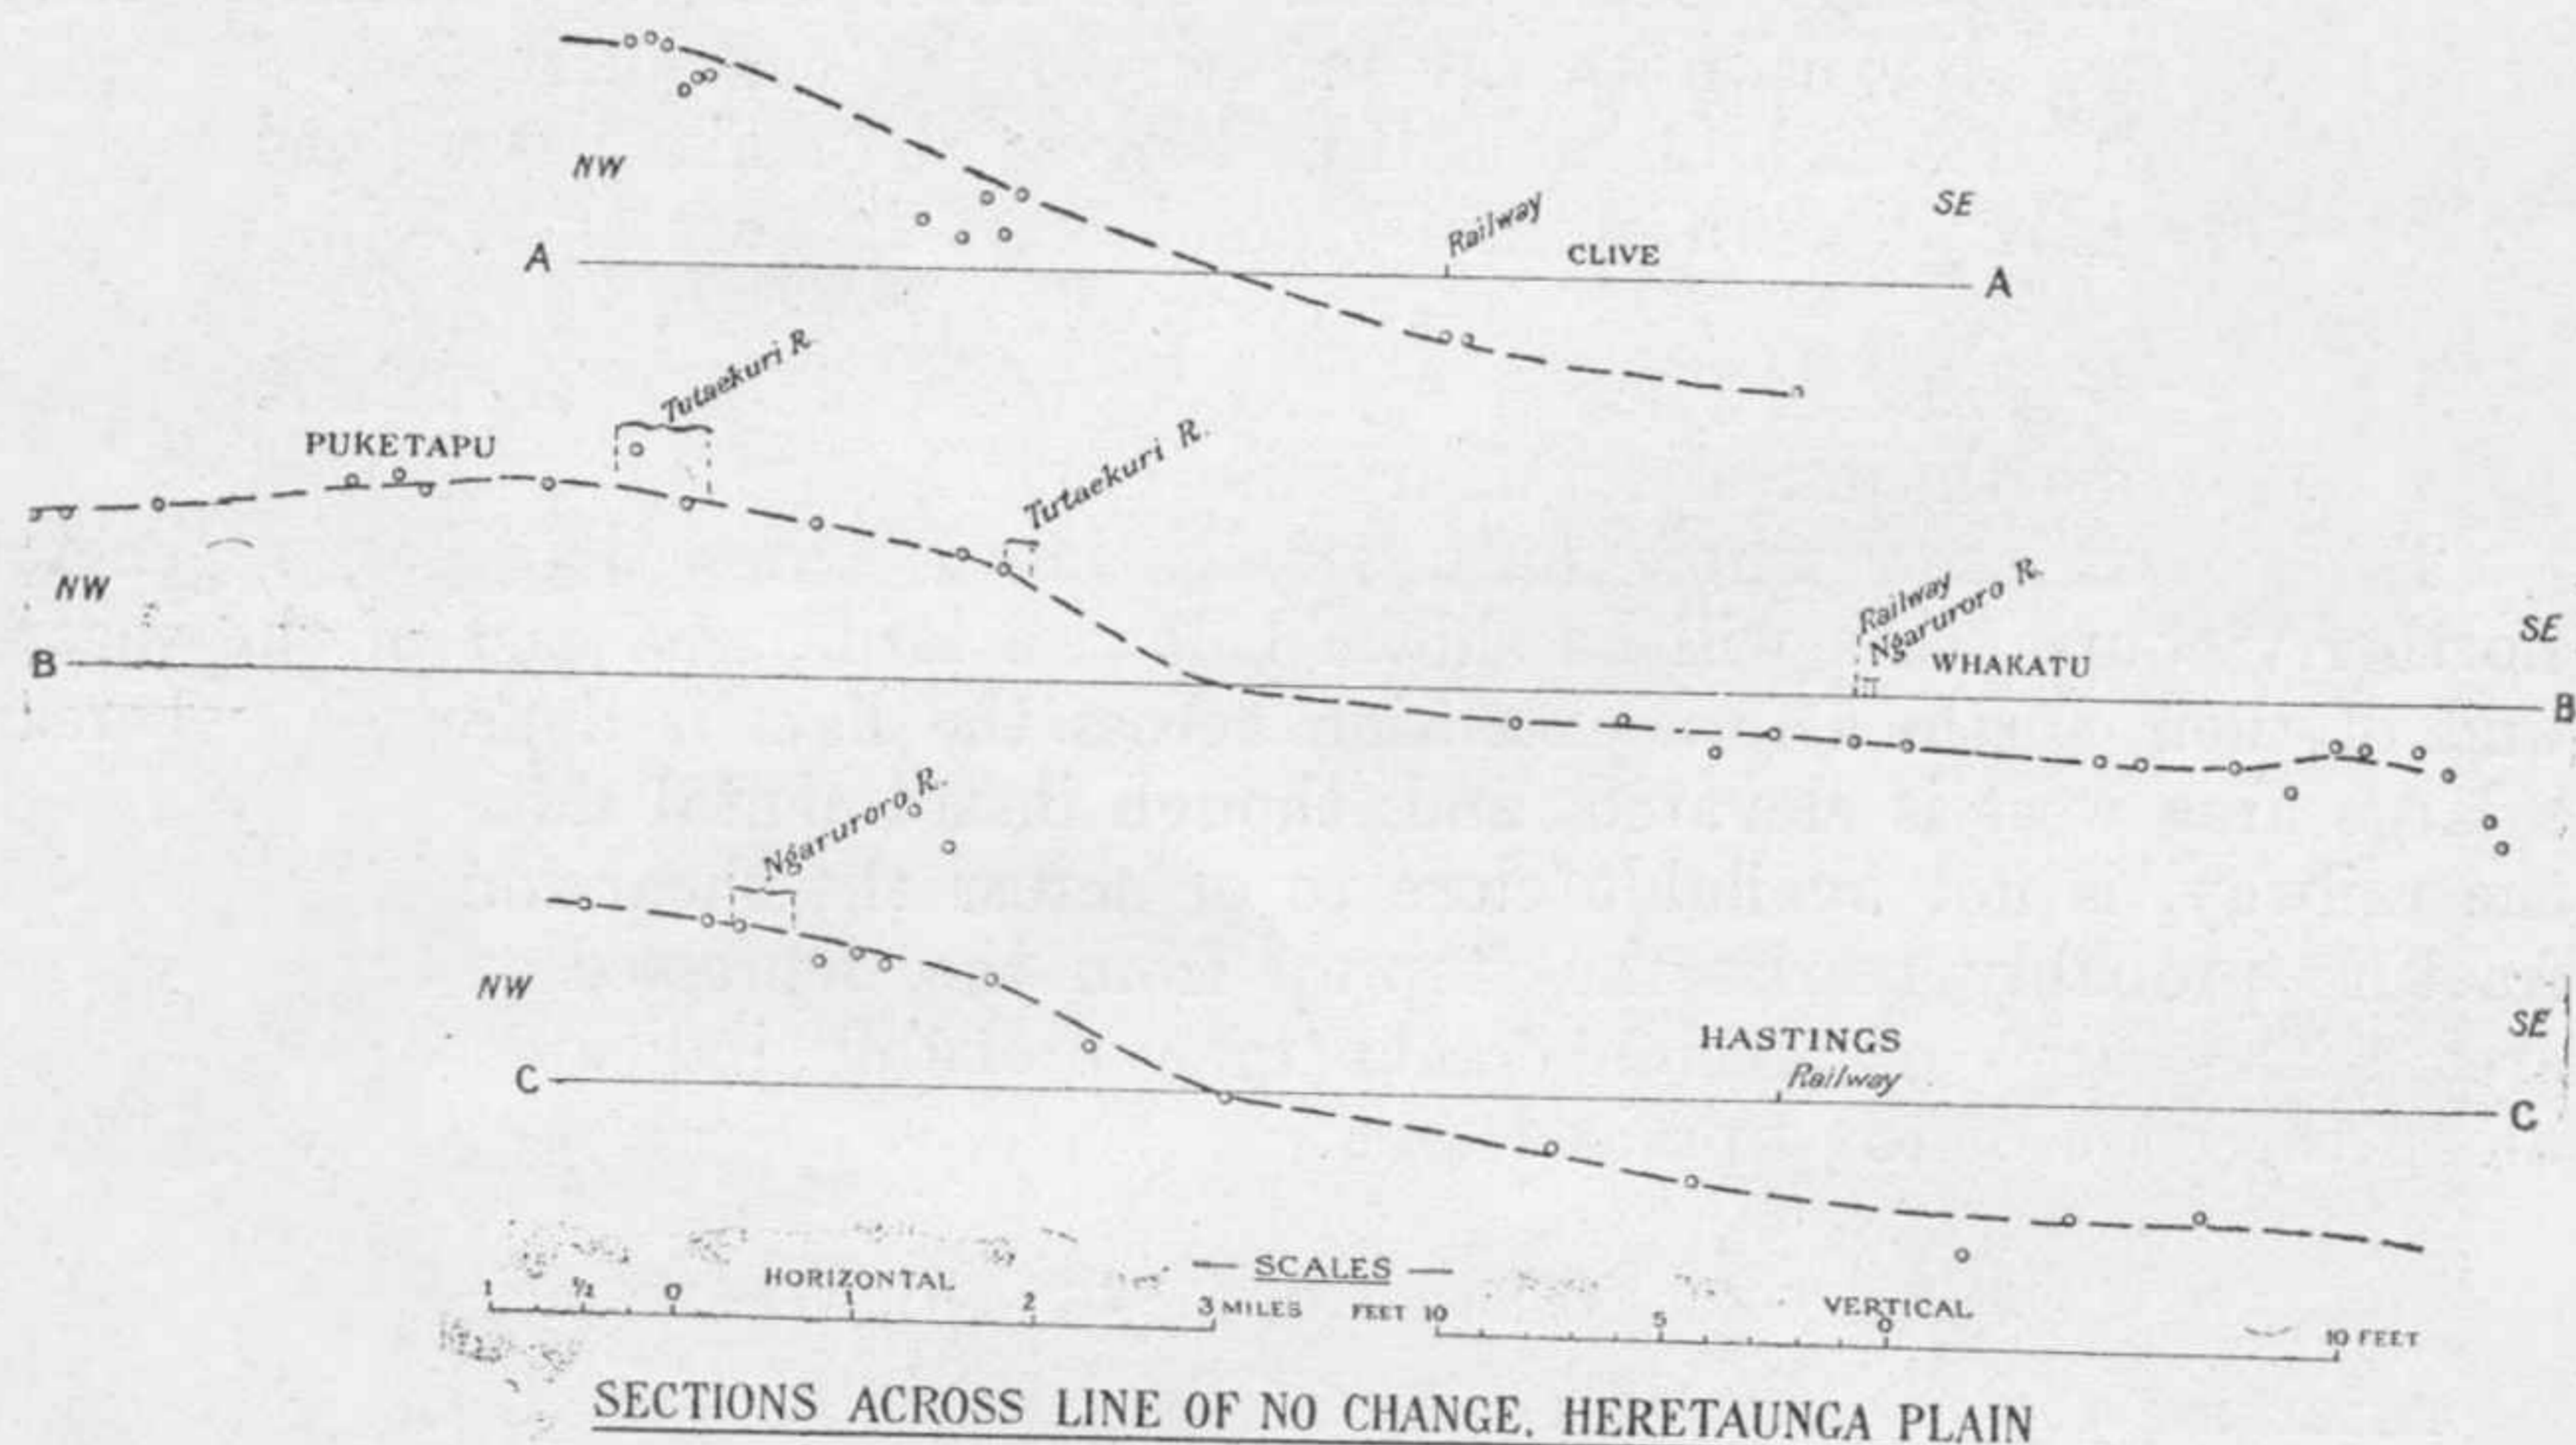
SECTIONS ACROSS LINE OF NO CHANGE, HERETAUNGA PLAIN

least nine miles. It should be noted that no change of level is perceptible on the ground, the pronounced irregularity of the sections being due to the great exaggeration of the vertical scale. There are enough bench-marks to allow of the second section being extended north-west along the Tutaekuri for seven miles from the line of no change and south-east across the flats to the lower Tukituki for a like distance. This section indicates that the country north-west of the neutral line was elevated as a whole and that south-east of it depressed as a whole.

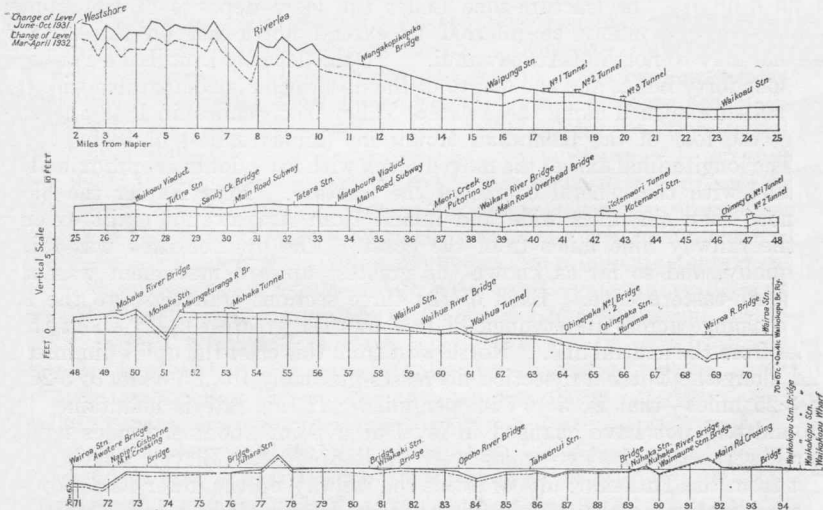
PLATE X.—Results of relevellings along Napier-Wairoa-Waikokopu Railway. From graphs supplied by the Public Works Department.

per mile. This gentle change in grade may be interpreted as the longitudinal down-warp of the northern end of the raised block to the country of unchanged level lying to the north.

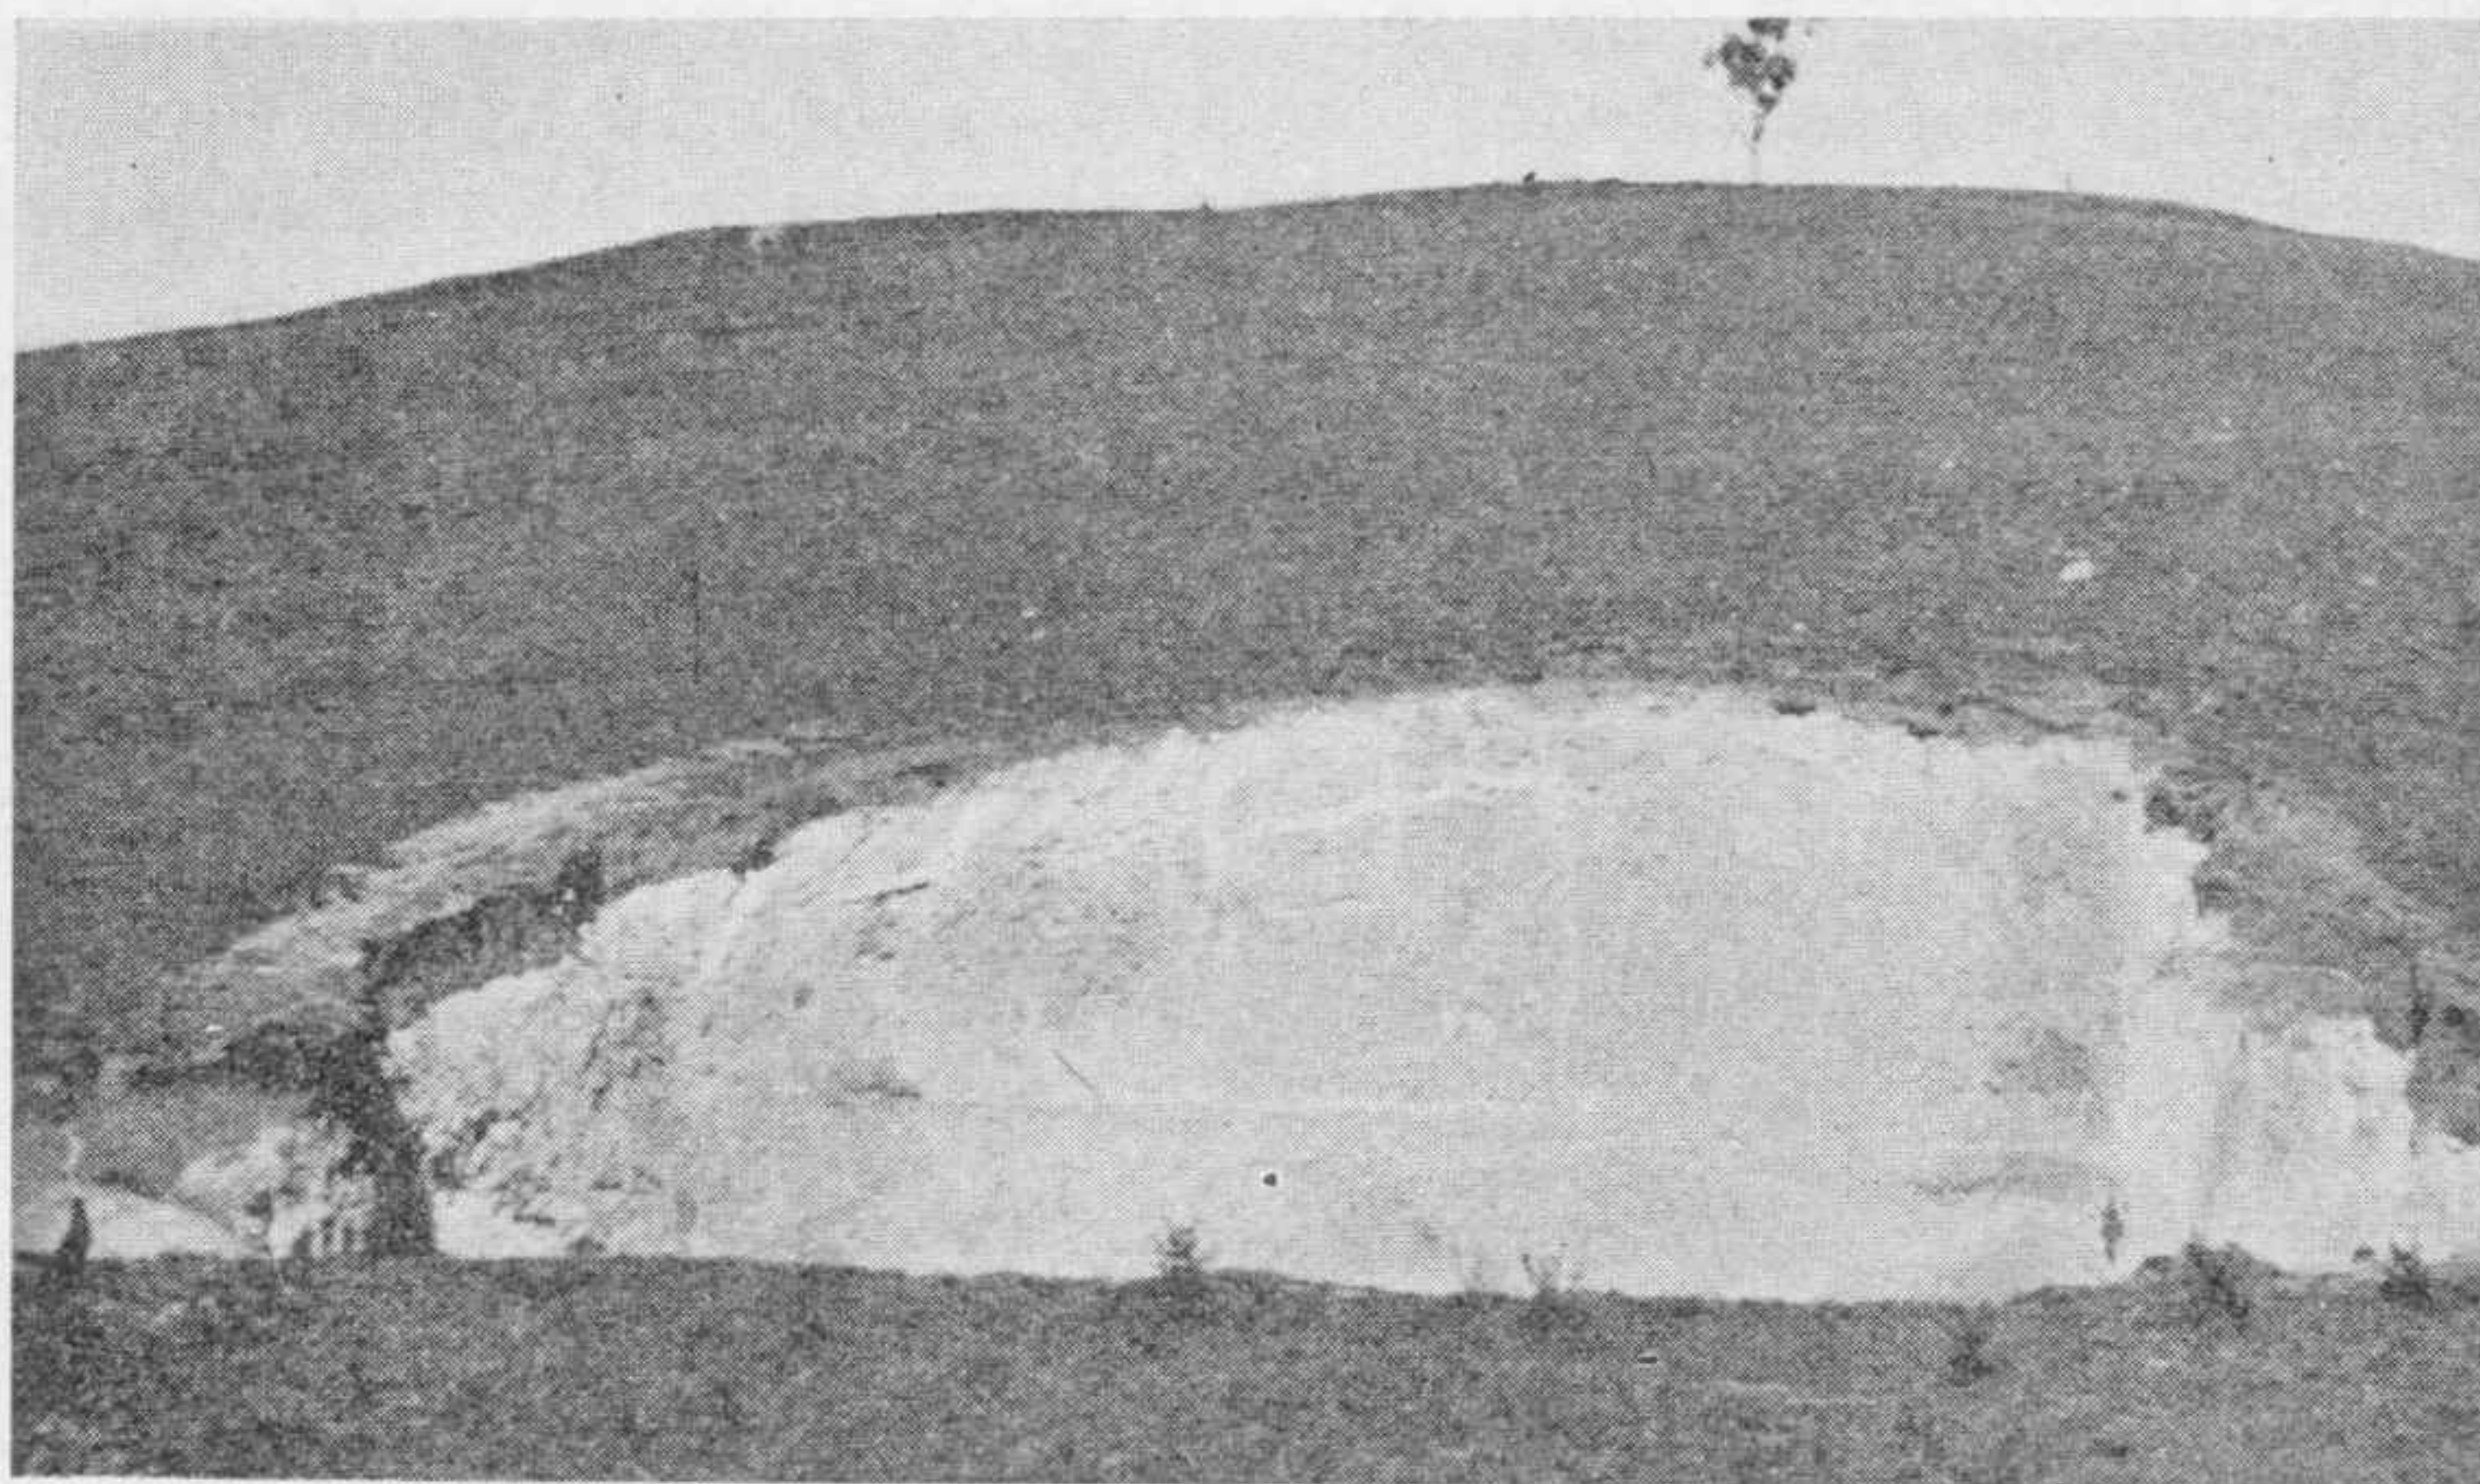
PLATE XI.—(a) Quarry in limestone, 20 chains south of Mr. N. Campbell's House, Awanui Valley. The open cracks at the right edge of the view are not so prominent as the calcite-filled old cracks.

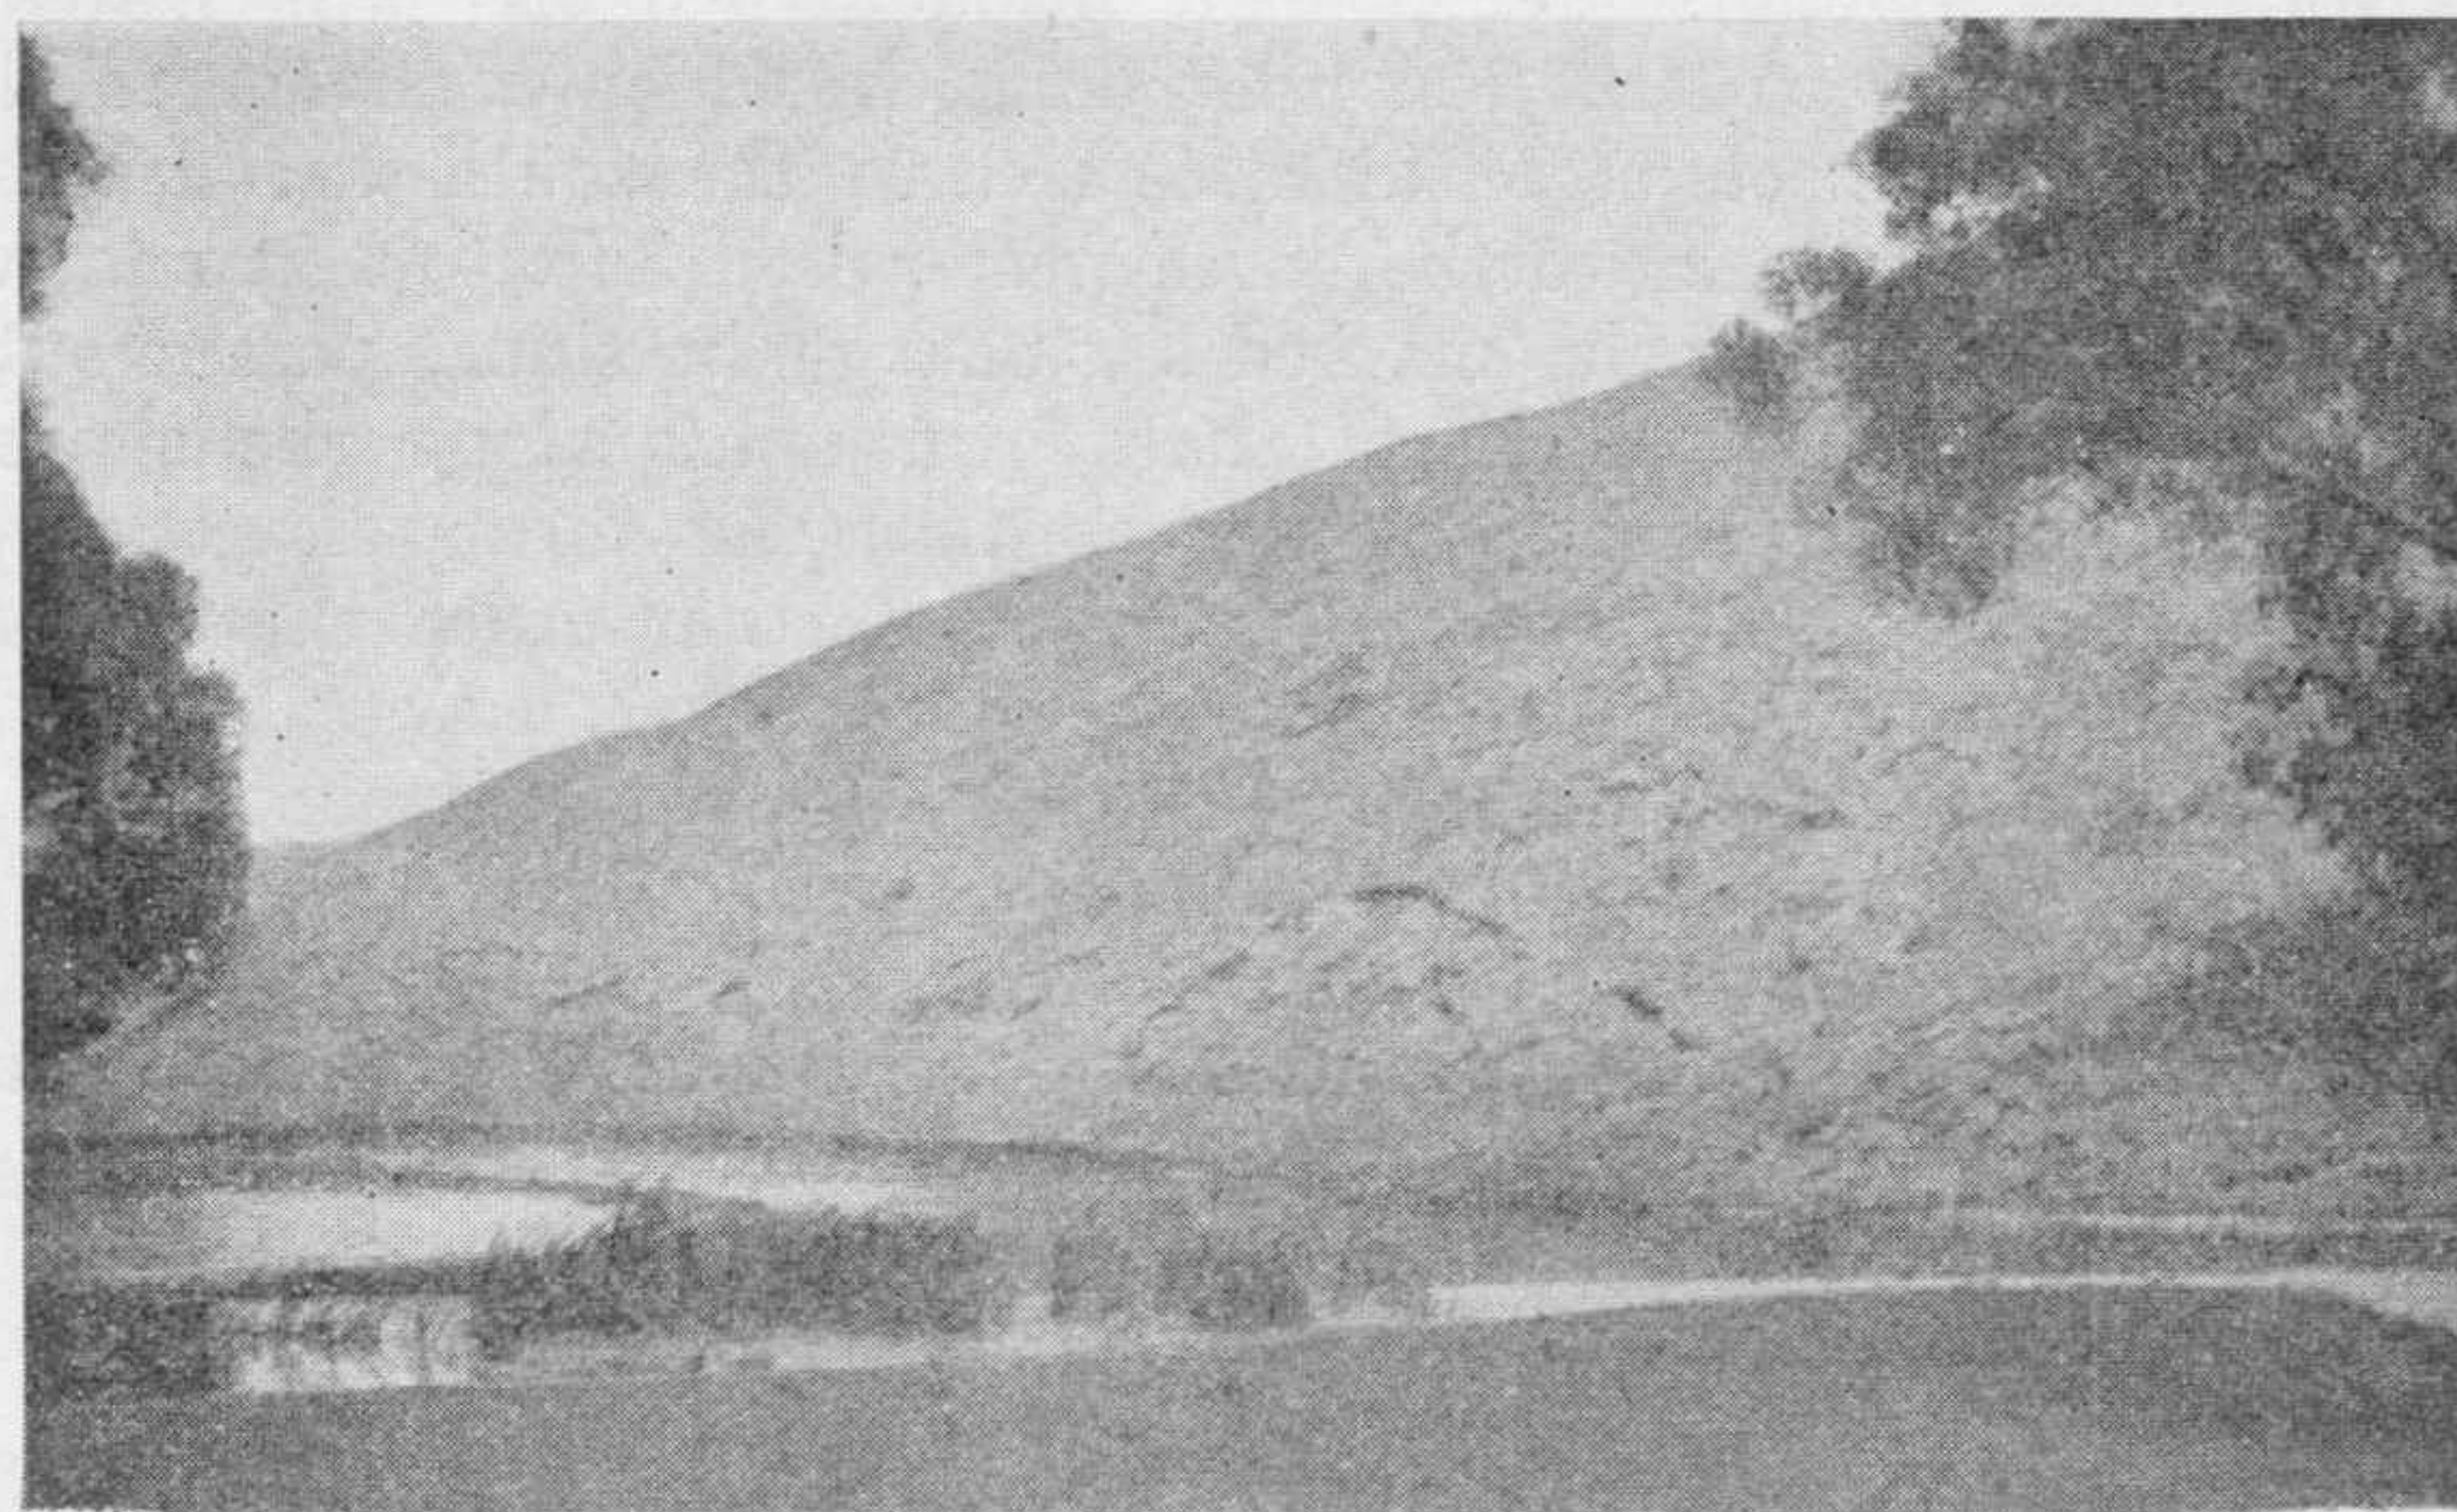
PLATE XI.—(b) Ponding of the Poukawa Stream, 120 chains north-east of Poukawa Railway-station. Pressure ridge shows across the pond.

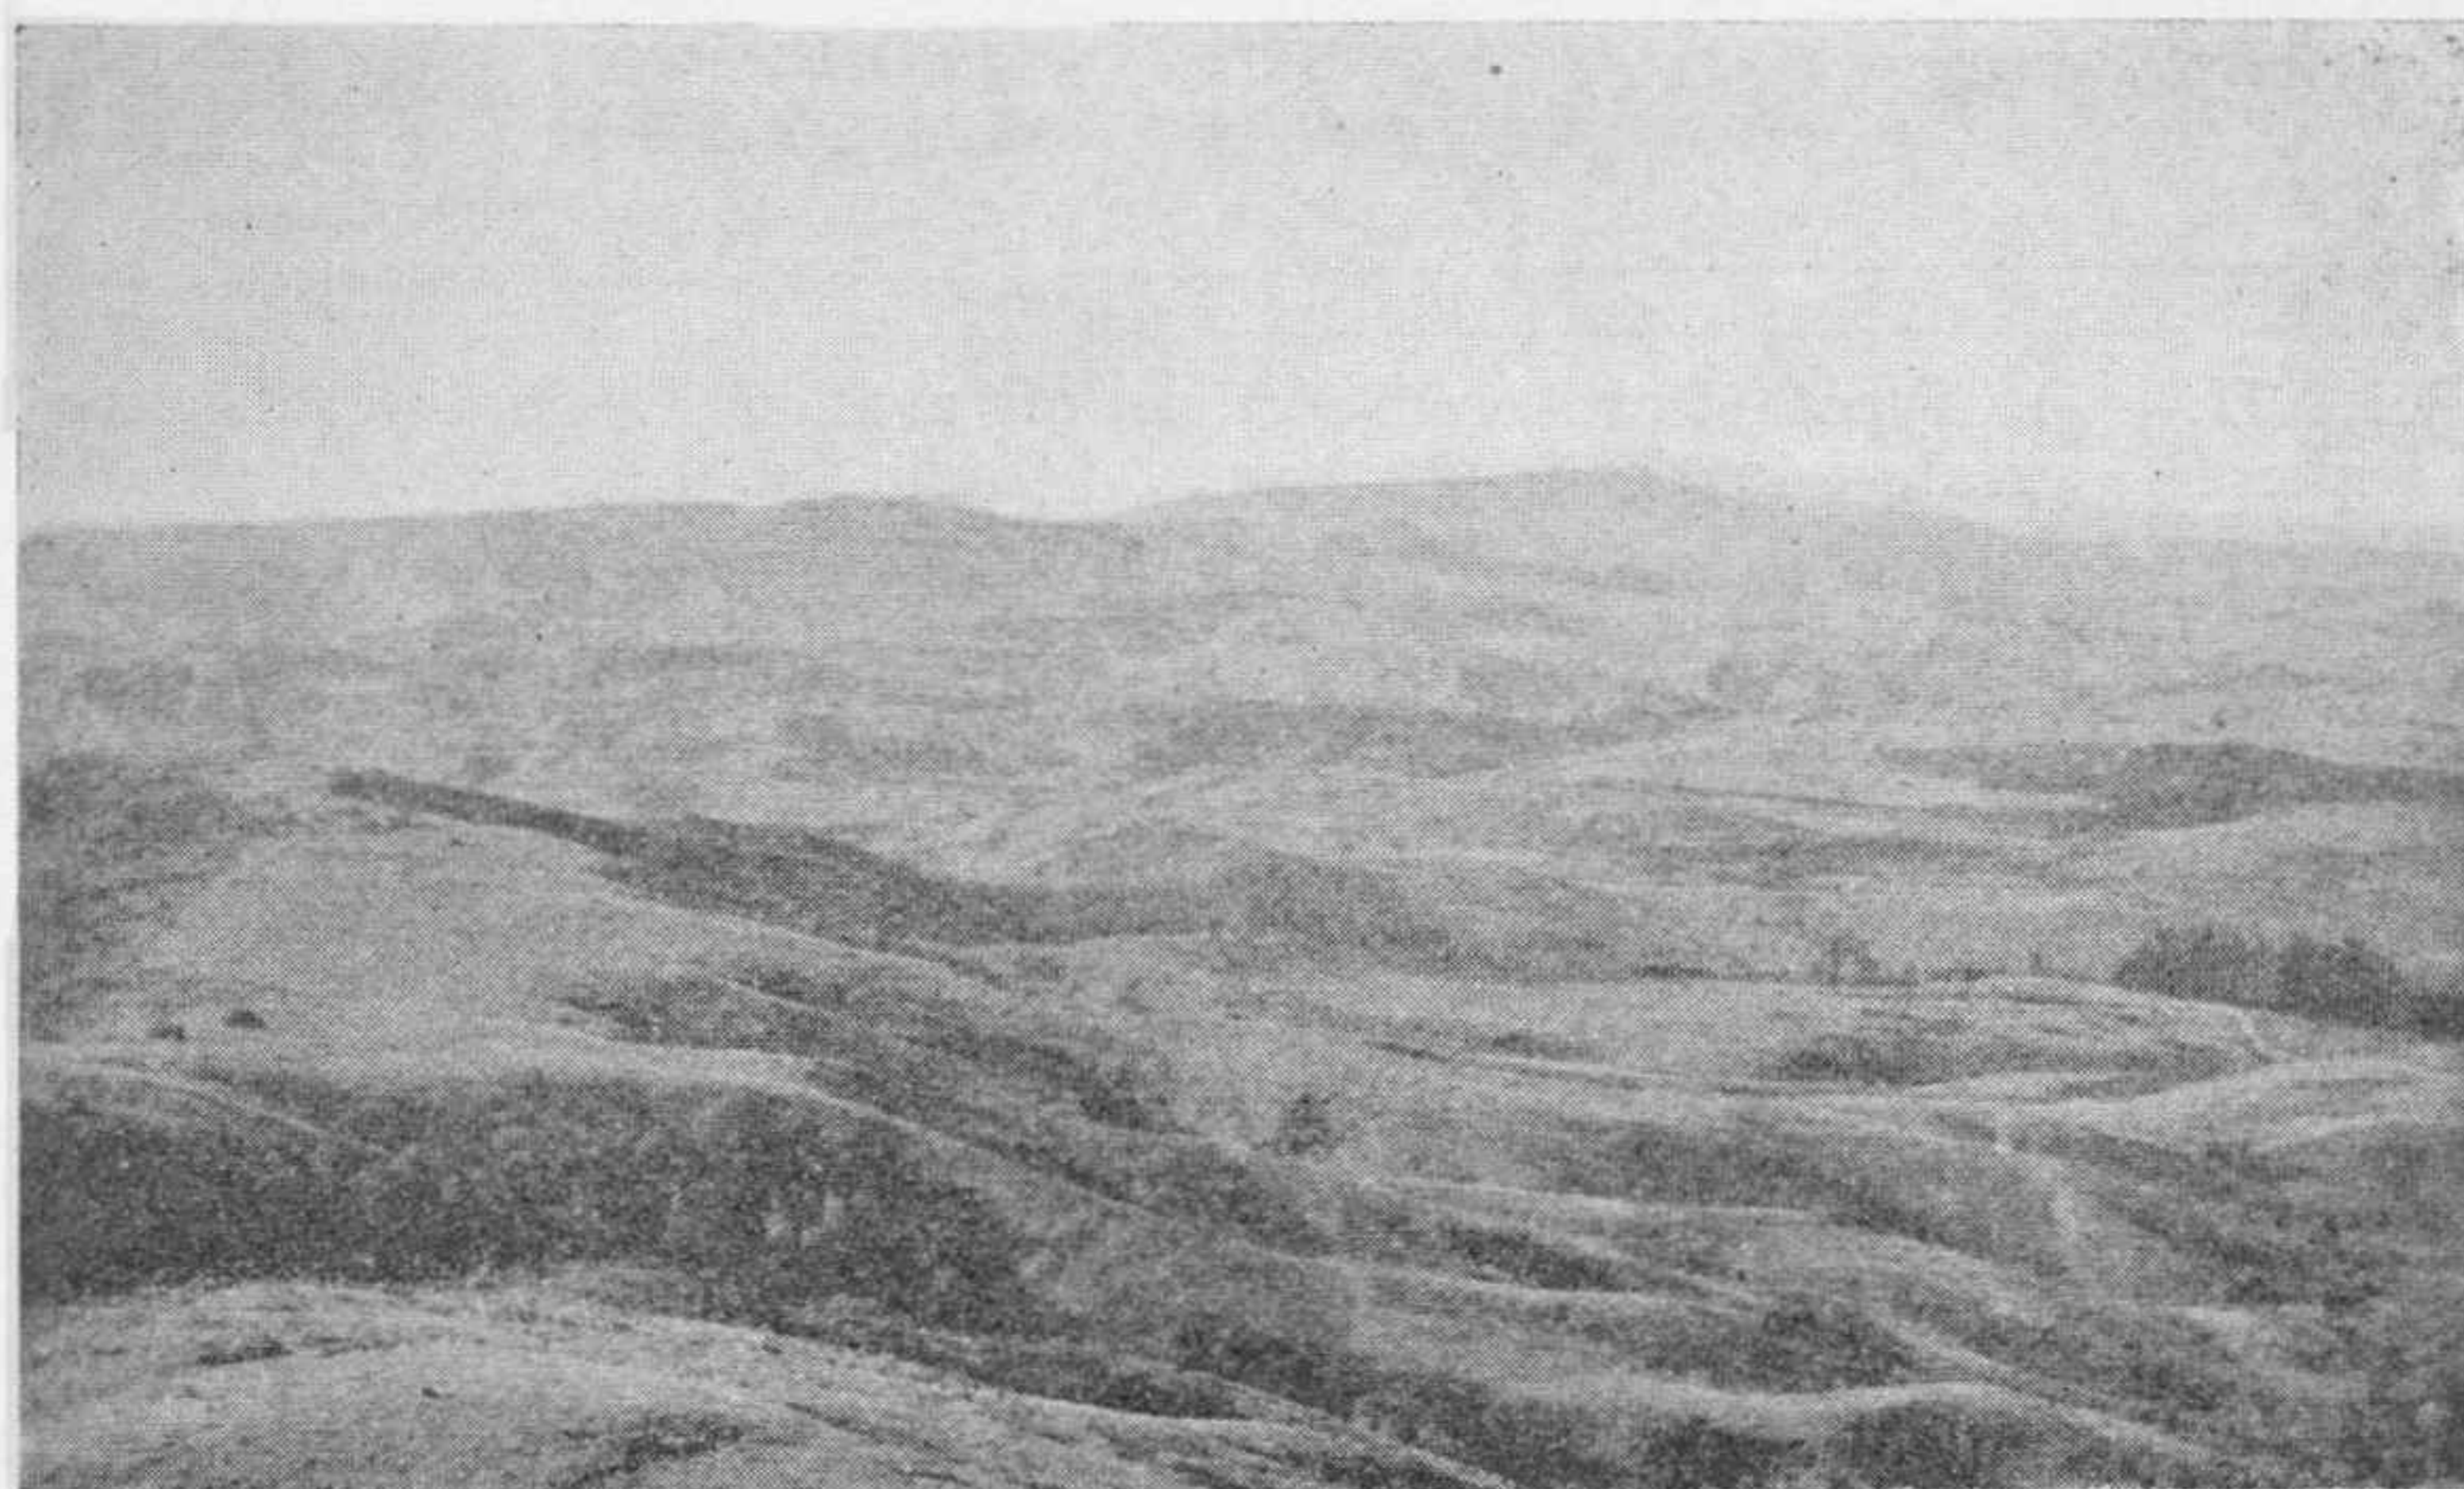
PLATE XI.—(c) View looking north from Patoka Hill. A fault passes the east base of the hill in the left foreground and another with a step-up to the east shows near the right edge of the view.

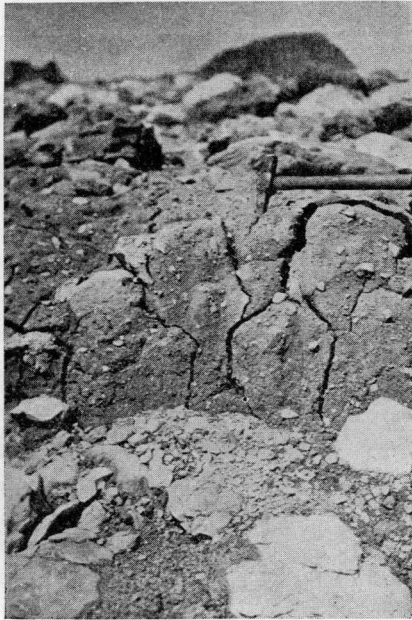
FIG. 2.—Fault breccia matrix of the Sponge Bay uplift.

The writer had made a study of this area and the neighbouring locality some two months previously, and about 1 ft. to 2 ft. of water had covered the "reef" at low tide. The new "reef" has a flat dome-shaped profile and is covered with large boulders of Lower Tertiary and Upper Mangatu (Cretaceous) age (see fig. 1). The underlying matrix consists of bluish-grey fine-grained fault pug with a high percentage of coarse angular fragments of rocks of Upper Mangatu and Basal Tertiary age (see fig. 2).

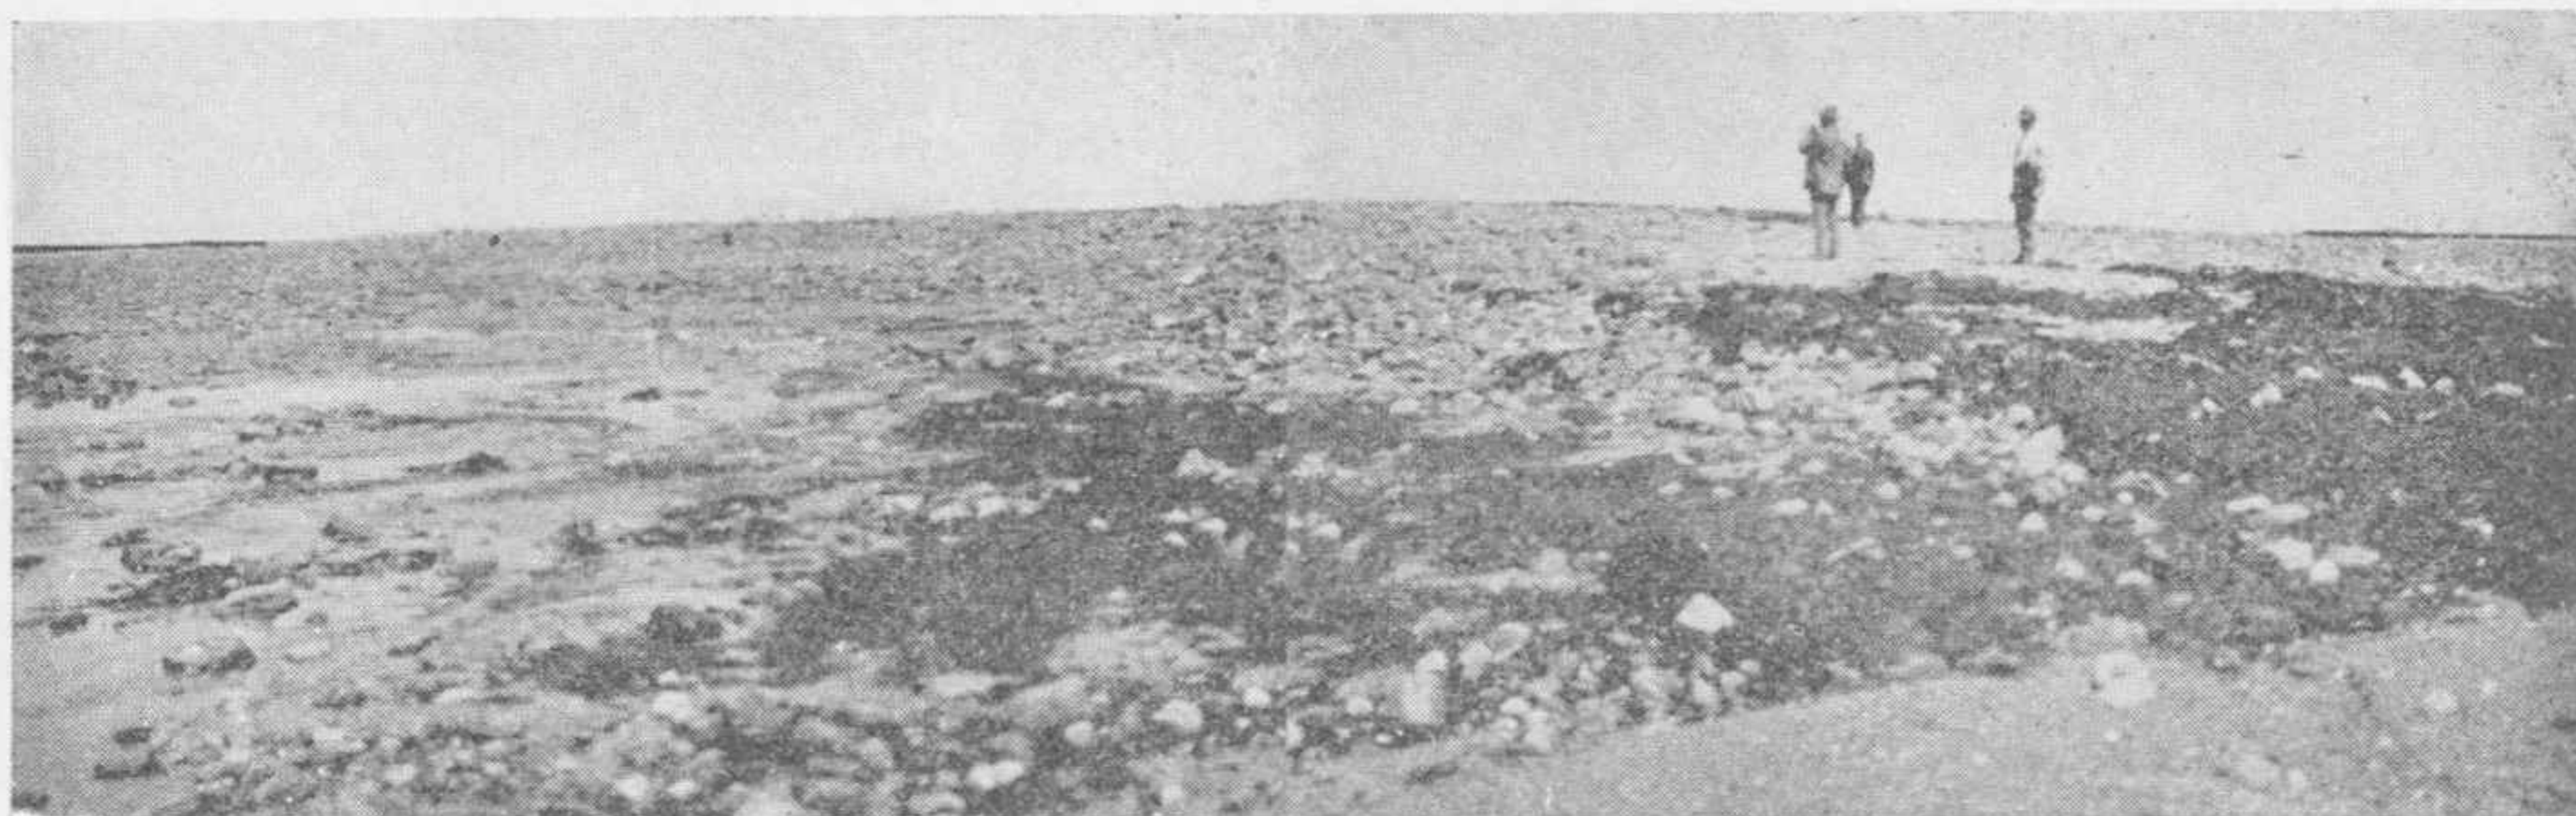
FIG. 1.—Panorama of the newly raised Sponge Bay boulder reef. This area was originally 1 ft. to 2 ft. below low-tide level. The sea shows as a black line on each side of the view.
