N.Z. DEPARTMENT OF SCIENTIFIC AND INDUSTRIAL RESEARCH.

BULLETIN No. 43.

REPORT
OF THE
HAWKE'S BAY EARTHQUAKE
(3rd FEBRUARY, 1931).

**THE HAWKE'S BAY EARTHQUAKE OF
3rd FEBRUARY, 1931.**

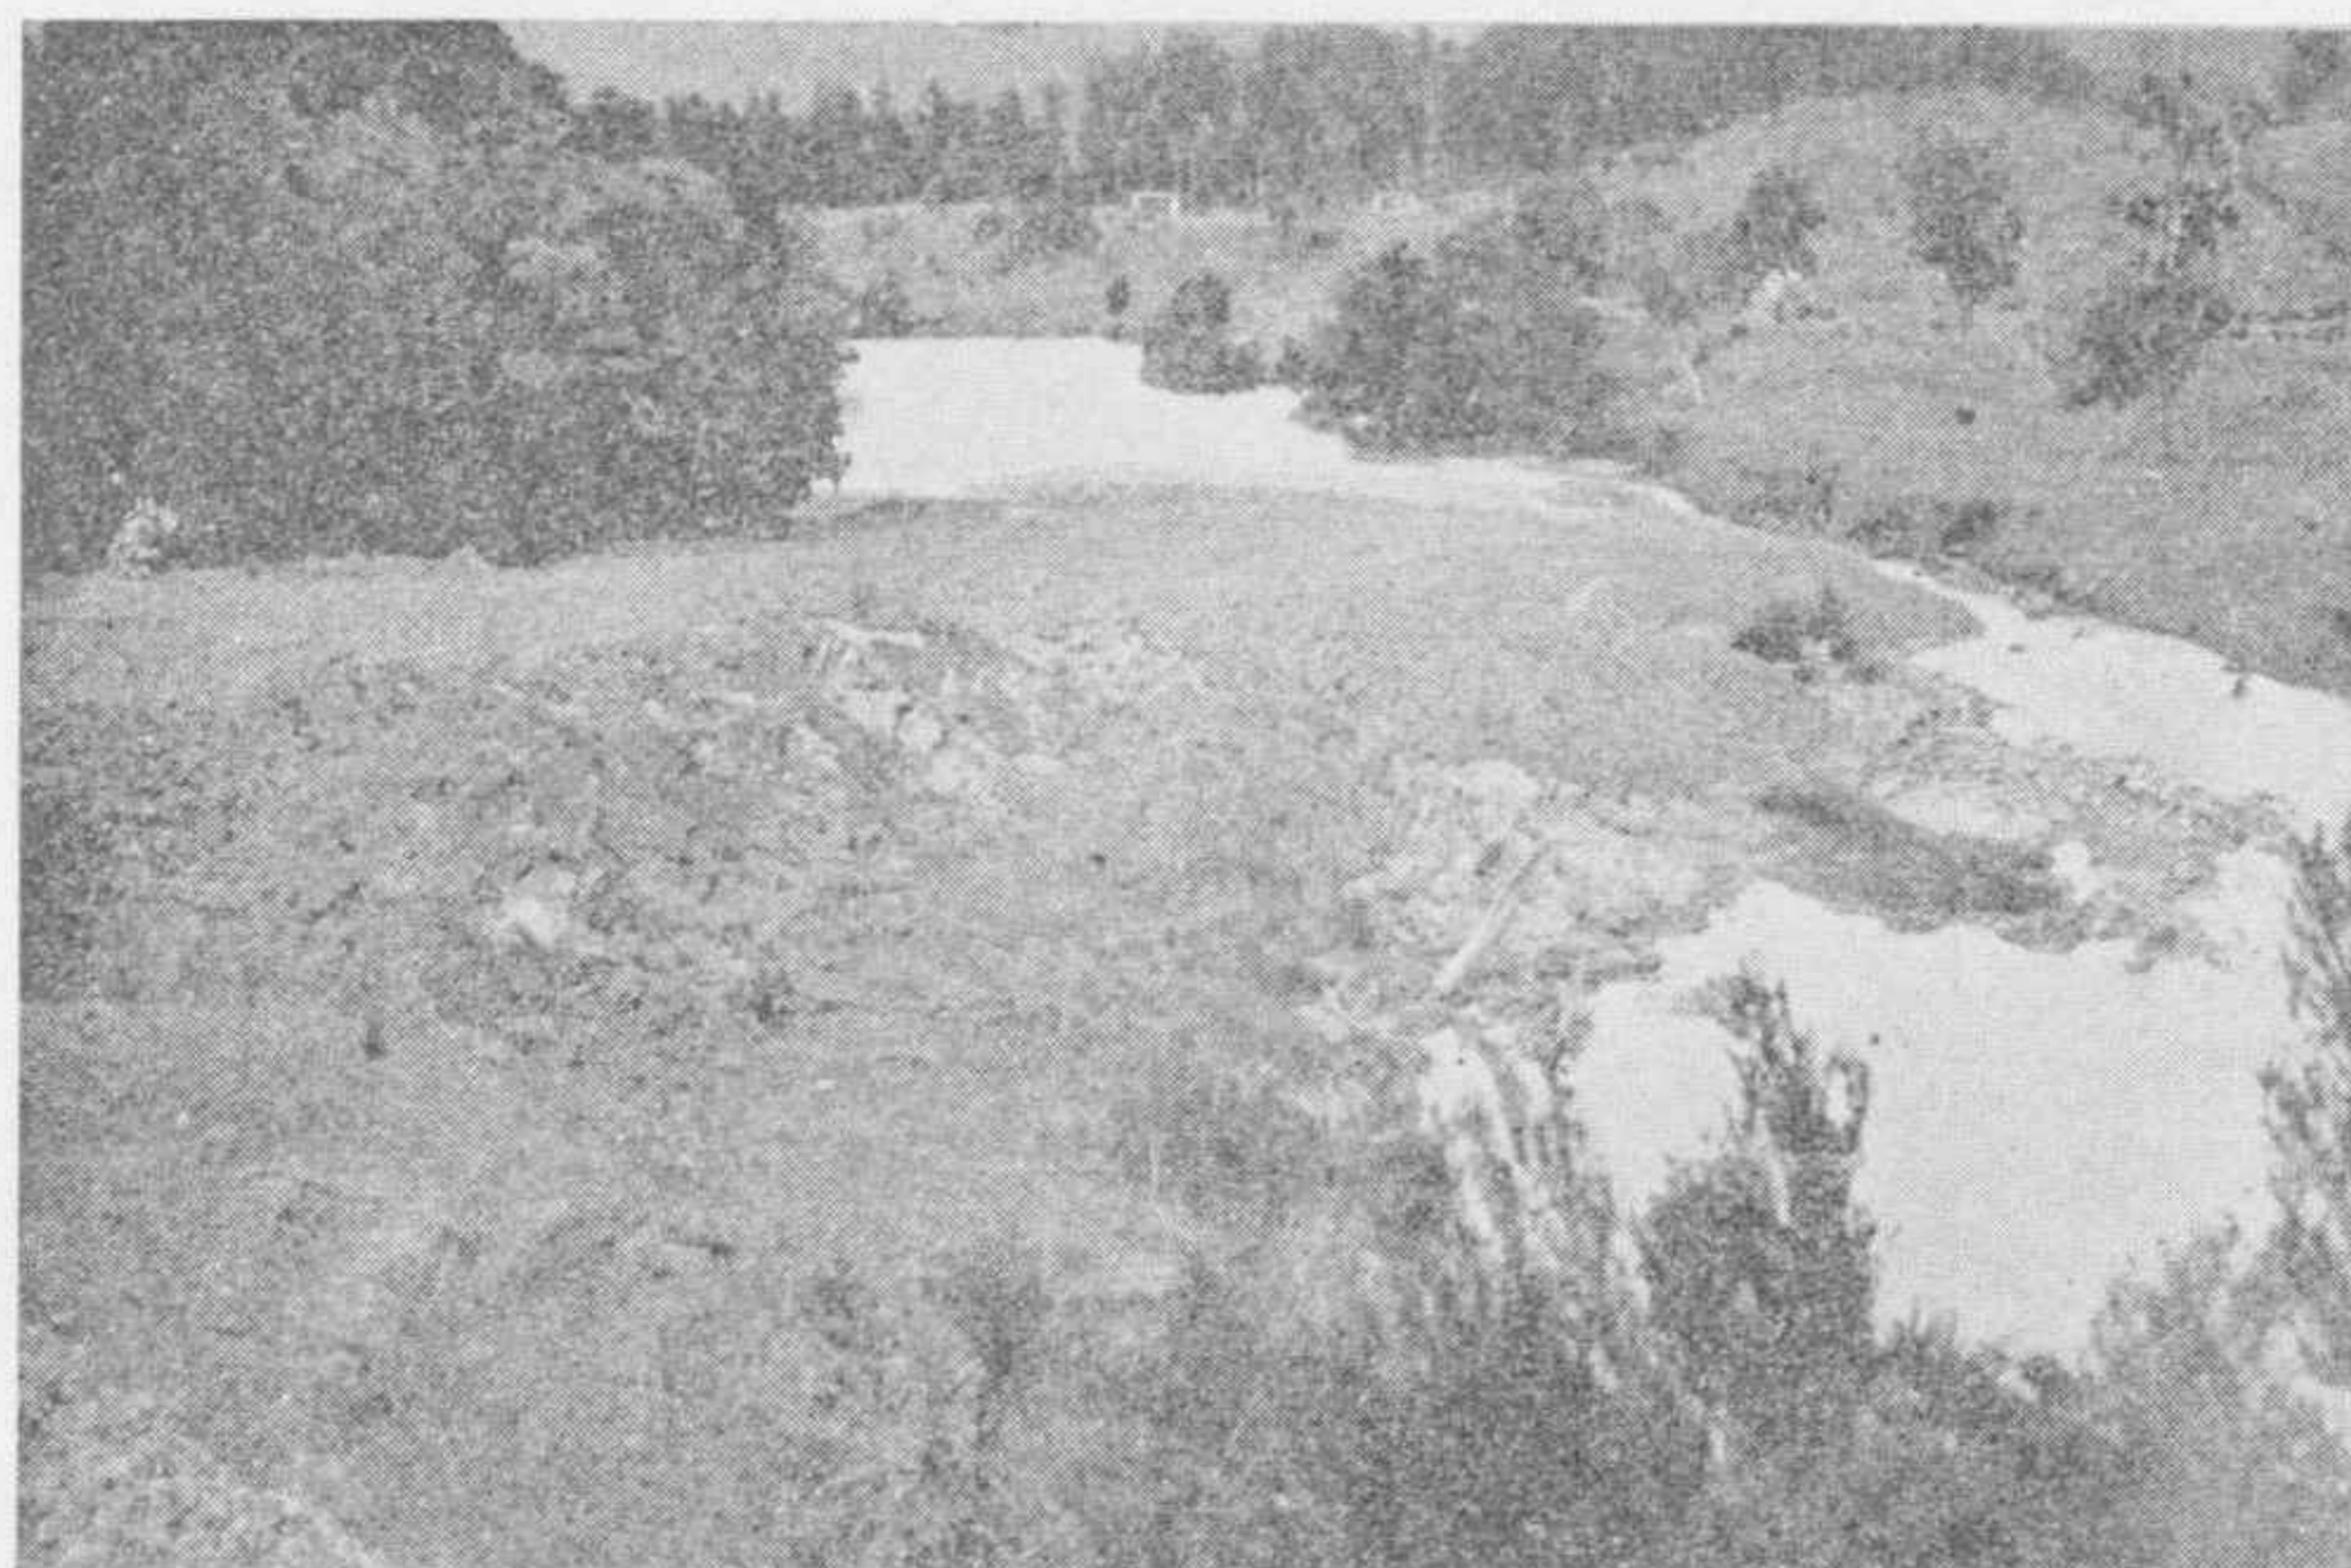
FIG. 3.—Mud blowout on Mr. J. Barnes-Graham's property blocking the Hangaroa River.

mass covered an area of approximately $2\frac{1}{4}$ acres, and has been estimated to be 20,000 tons in weight. As it flowed over the lip of the vent it temporarily blocked the Hangaroa River (see fig. 3).

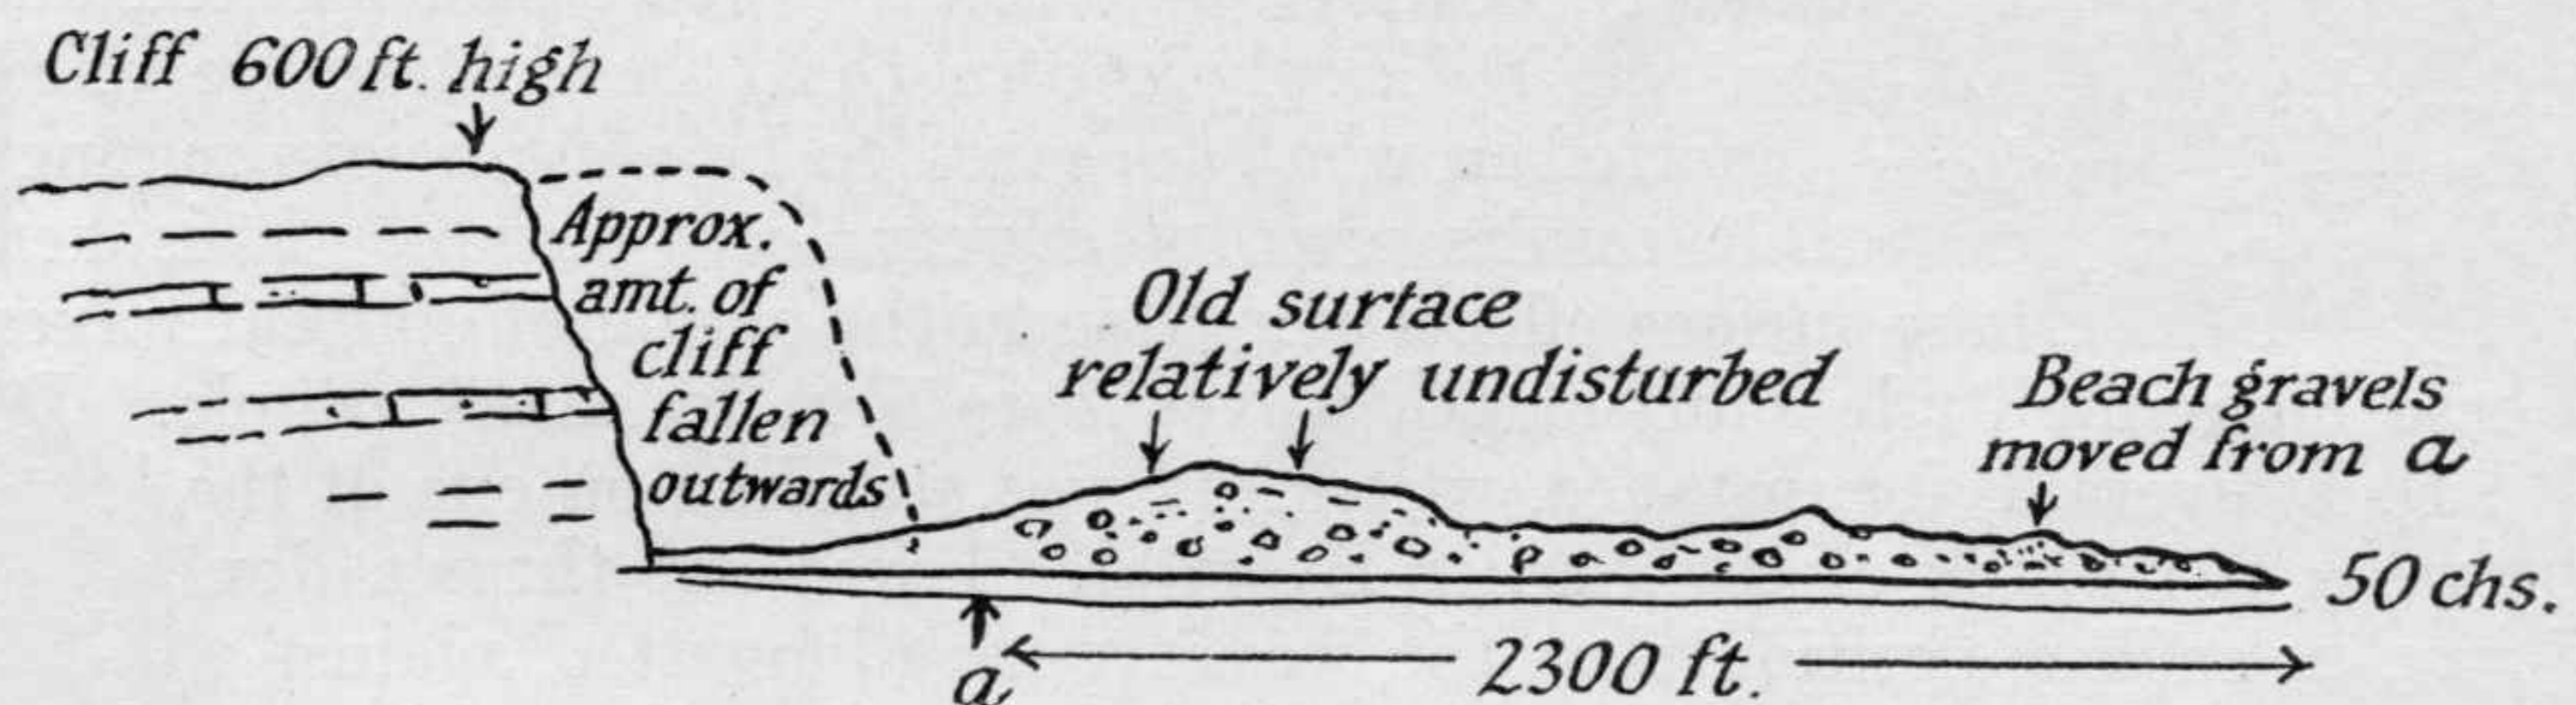
Cross-section of flow slip near Mohaka River mouth shown in Plate V.

In addition, shingle carried from the beach is found far out on the flow slip as well as material derived from the sea-floor below low-tide level. This flow slip involved the movement of 15,000,000 to 20,000,000 cubic yards of material. There is a fourth flow slip two miles north-east of the mouth of the Mohaka River. Plate VIA shows part of its surface on its northern side as well as the tongue of the fifth and last flow slip two miles south-west of the Waihua River.

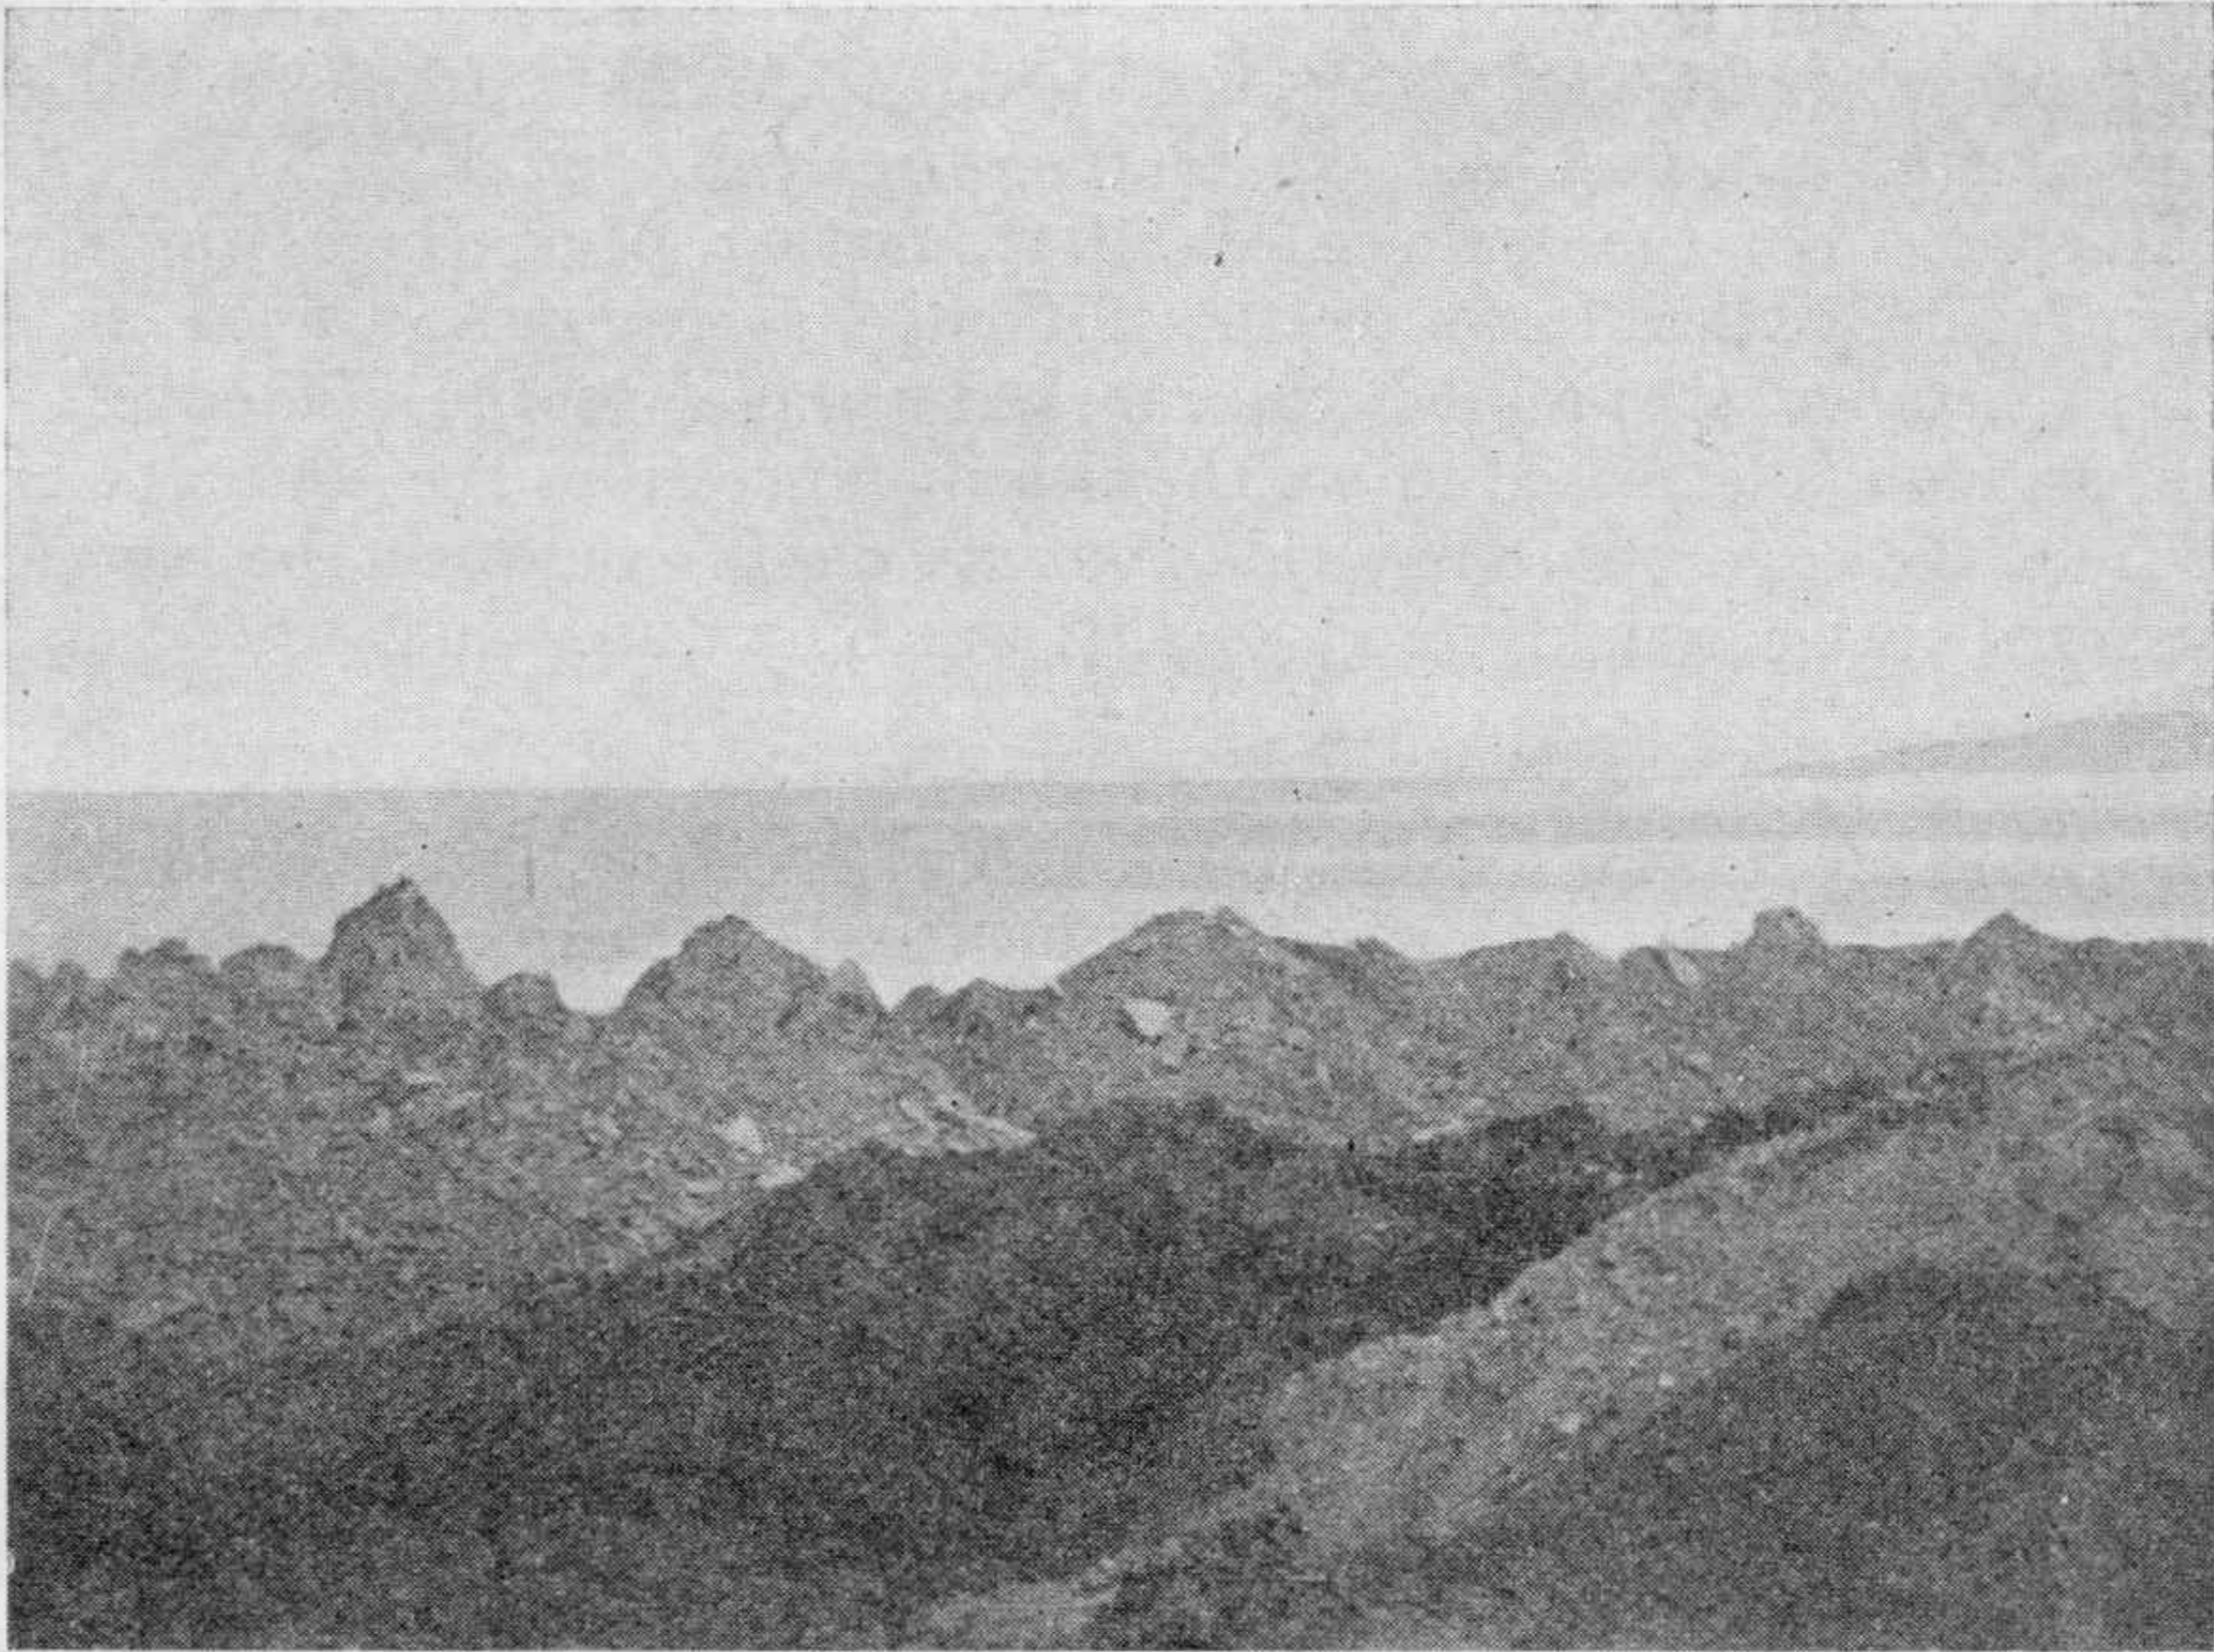
PLATE VIA.—Surface of flow slip two miles north of Mohaka River.

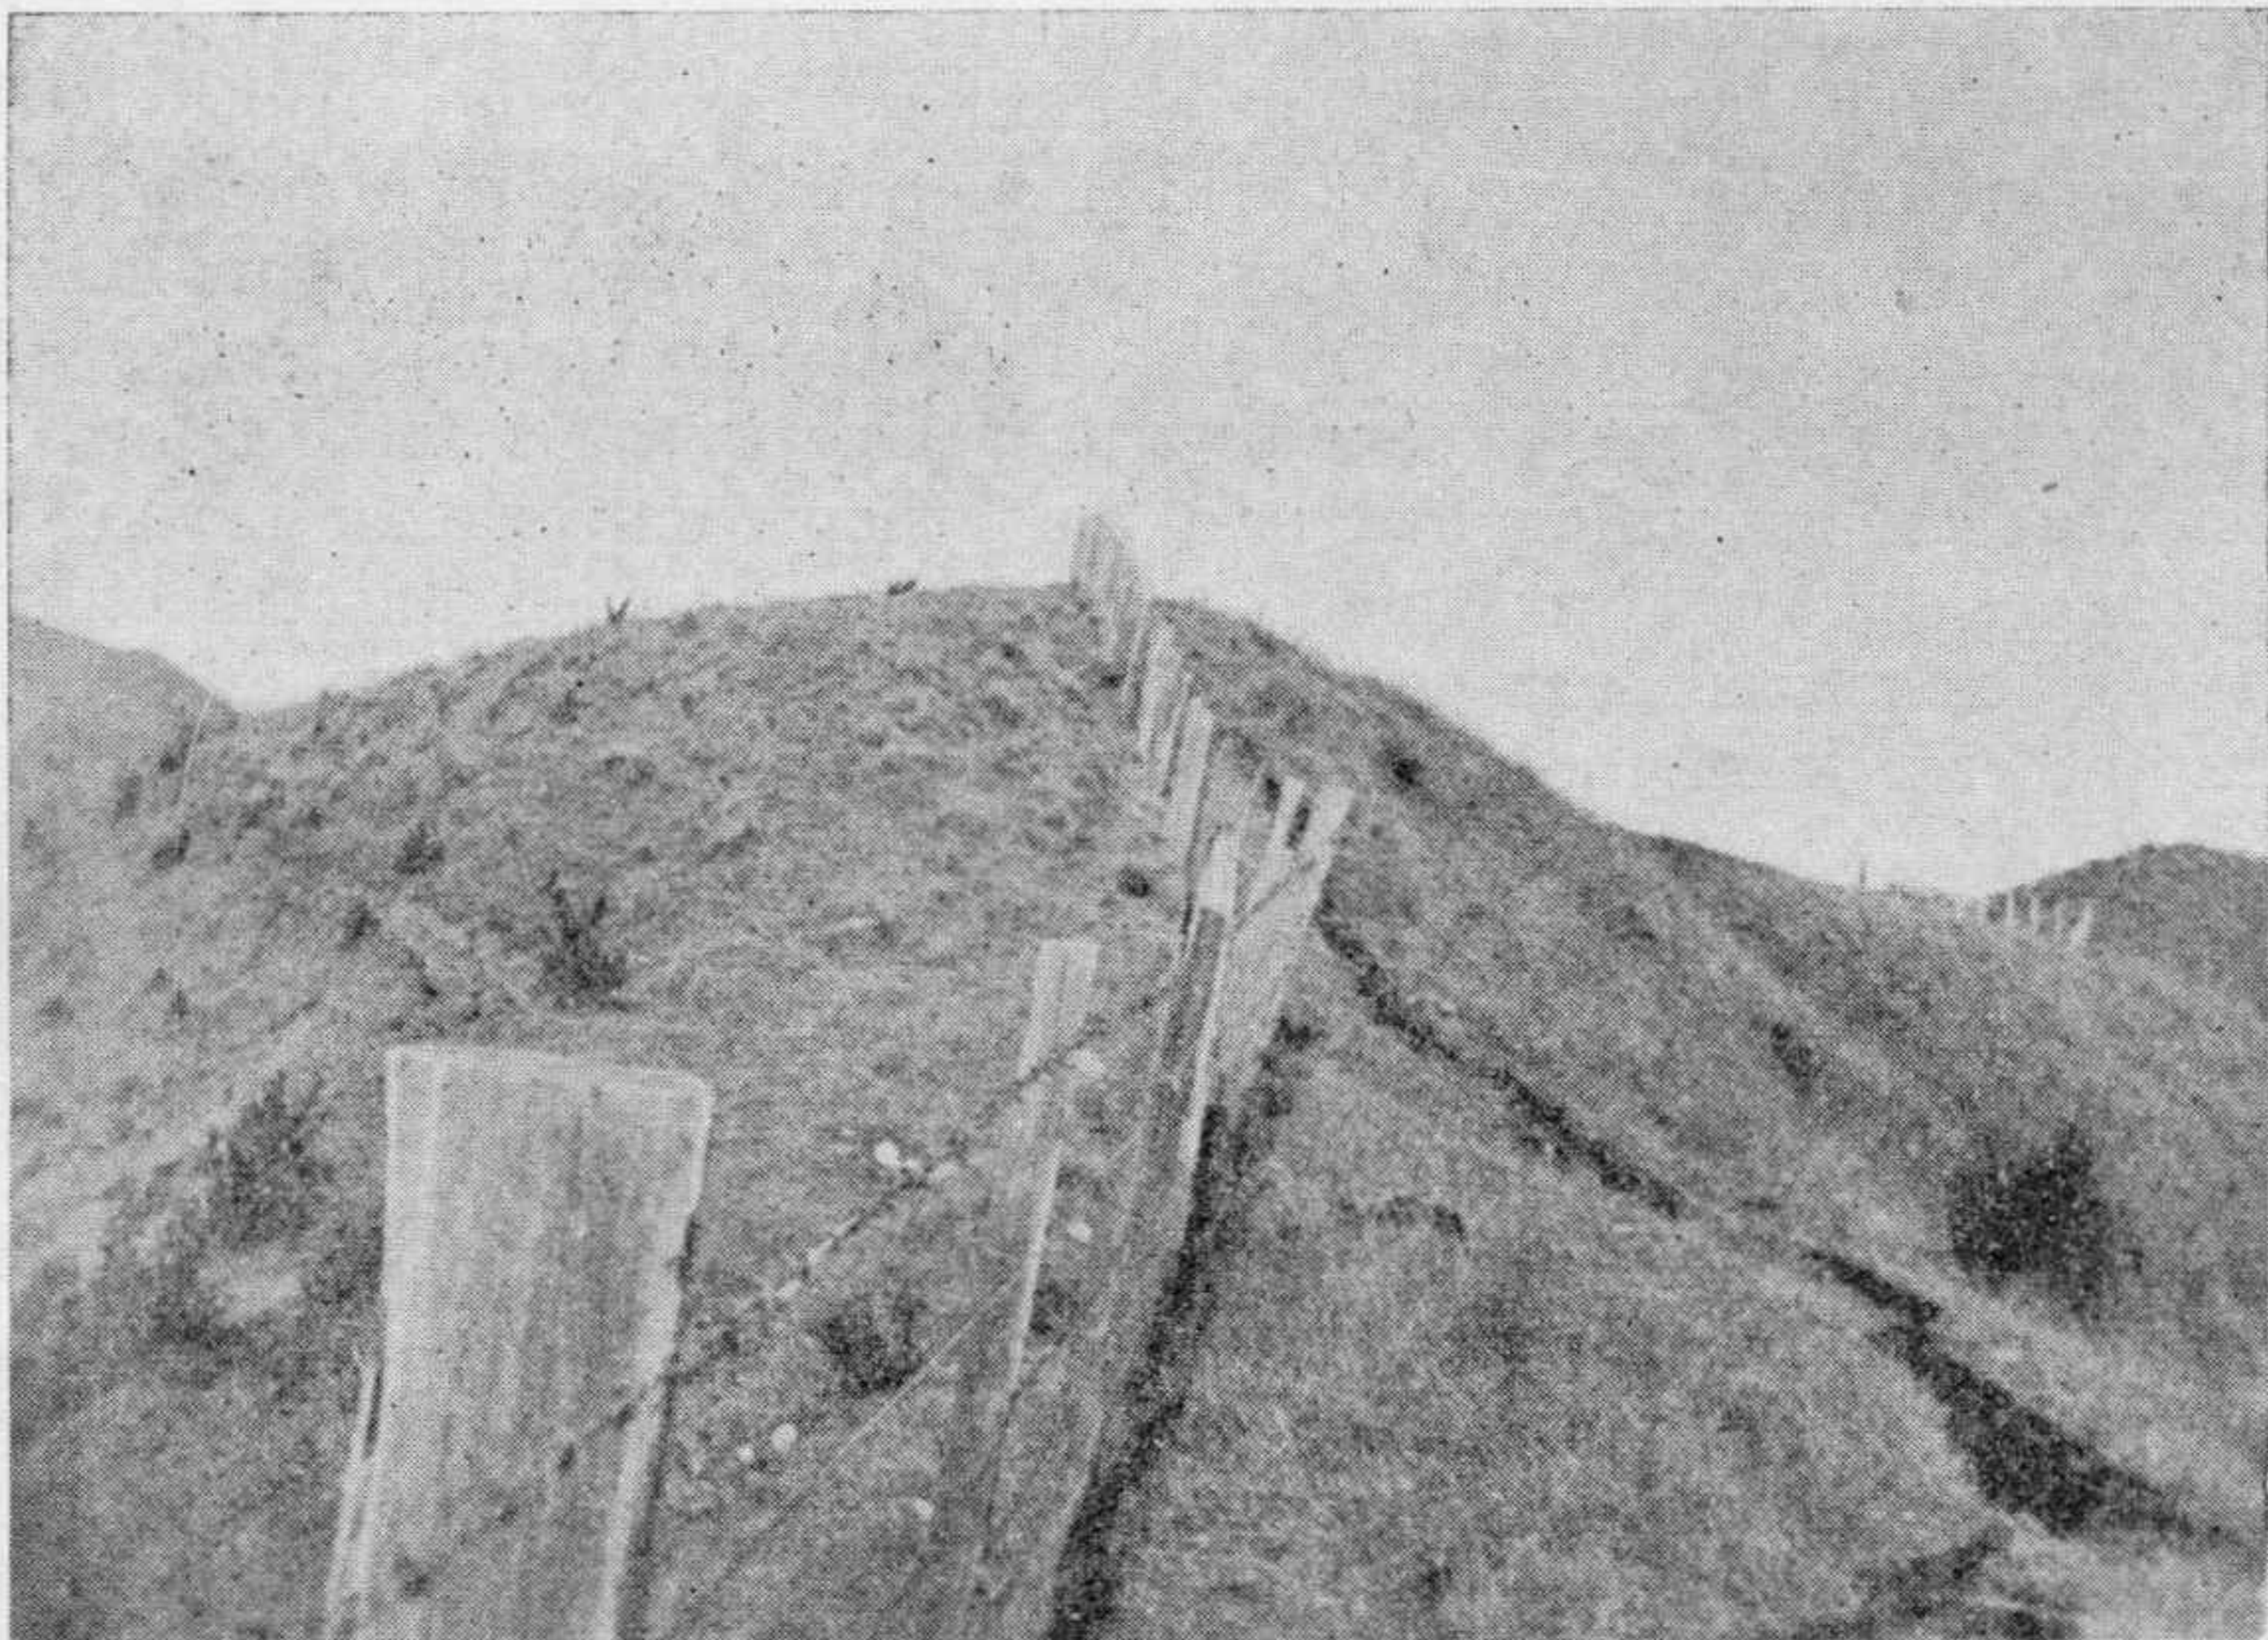
PLATE VII.—Crest of ridge showing surface cracks due to earthquake.
